### Bloomfield Open Cut

### MANAGEMENT PLAN

Doc No: EMP001- Historical Heritage Conservation Management Plan

### Heritage Condition Assessment

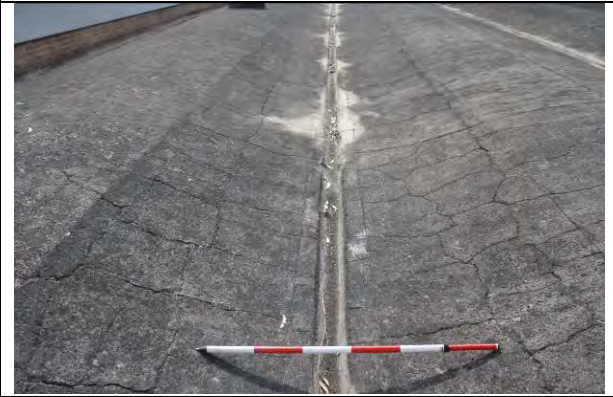
Plate 133

The roof consists of six brick arches that have been covered with bitumen (Plates 130 – 133). Between each of the arches are curved spoon drains that slope from the south towards the north, that exit through the terracotta pipes in the northern brick façade (Plate 133).

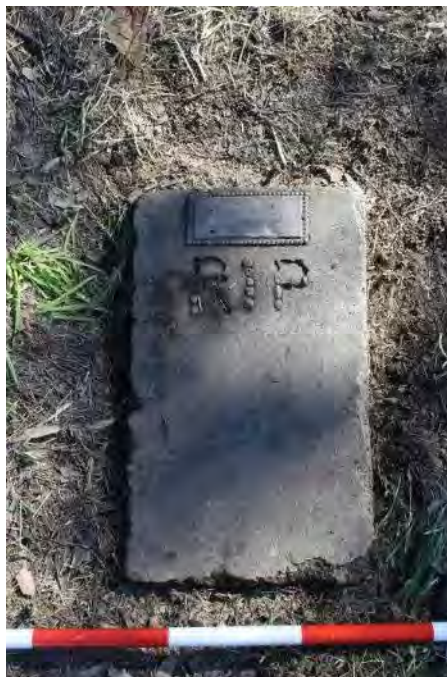
Plate 1

This grave site consisted of a single headstone, approximately 0.5 x 0.38 m, possibly made from concrete, laid directly on ground. There is a decorative name plate at the top (western side) and pebbles laid below marking out “RIP”, some of which are missing. The concrete headstone is cracked and chipped all around the edges (Plate 1).

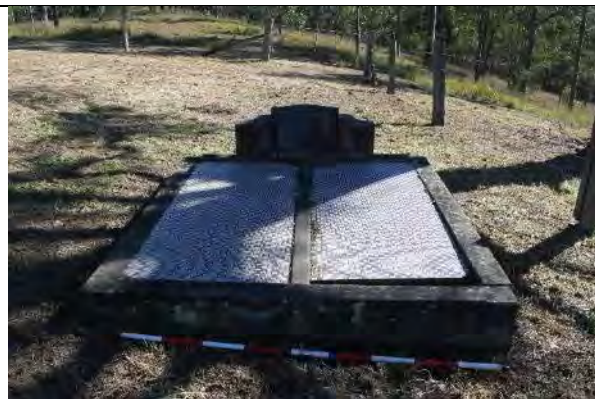
Plate 6

The top of the grave has been tiled over with decorative blue and white tiles. The bottom section of the northern grave has sunken over time. Also, the north-eastern corner of the southern grave has tiles that are missing (Plates 6 and 7). Otherwise the top of the graves appear to be in good condition.

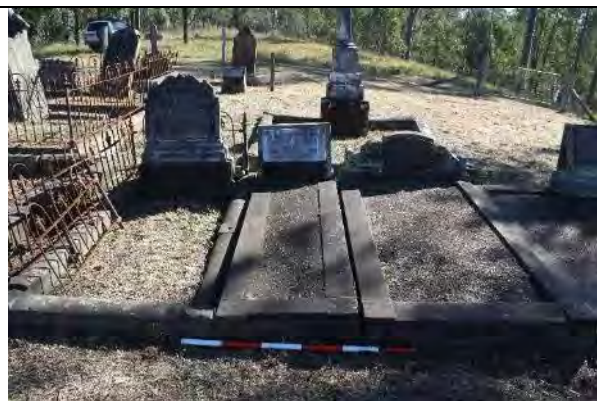
Plate 21

The top of the grave has been covered with a fine pebble aggregate concrete surface. The slab has been laid in one piece. There is no cracking or subsidence present in this surface (Plate 21).

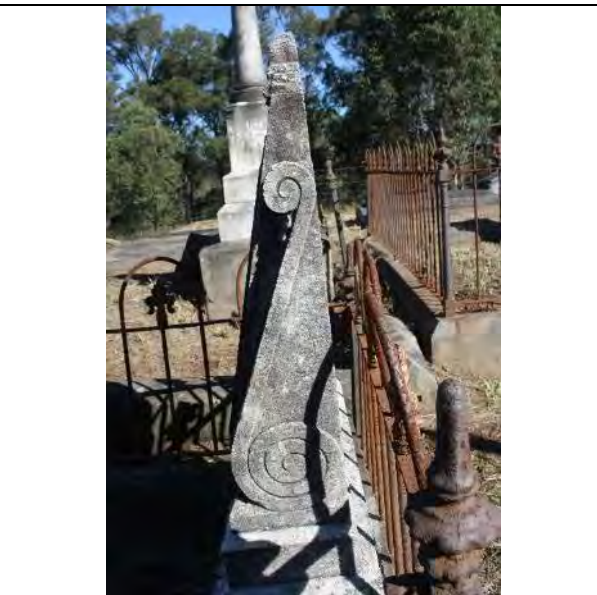
Plate 31

The kerb walls have rounded tops and are squared on the corners which support the wrought iron bow and picket style fence. The northern kerb has subsided at the north-east corner, and has fractured at the south-east corner. The remainder of the kerbed wall is intact and completed. The fence remains installed in the kerbed wall at the western end, and partially installed on the southern kerbing. The lower, eastern end, fence is presently leaning against the southern portion of the remaining fence. The northern kerb wall fence has been removed and is no longer on site (Plates 26, 28, 29 and 31).

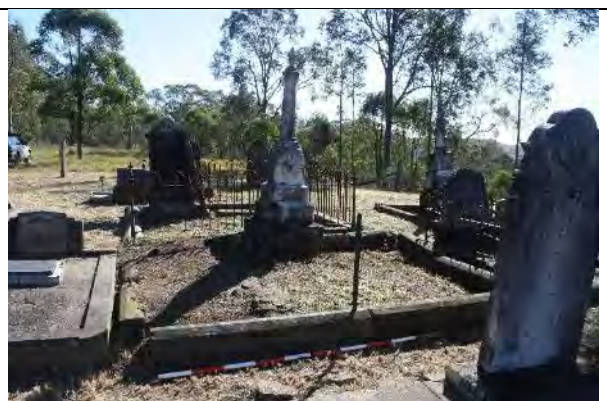
Plate 33

The top of the grave site consists of a small pebble aggregate concrete and grass sections that appear to have subsided along the northern side. The top may also have cracking elsewhere however, with the grass that is growing across the site, it is difficult to tell (Plate 33 and 42).

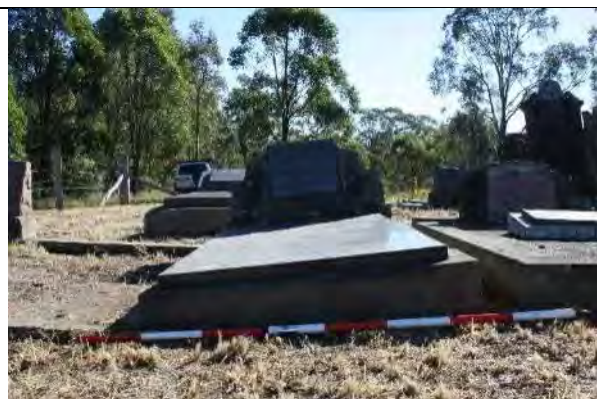
Plate 51

The sandstone kerb walls are all intact and are connected, despite the subsidence that has occurred. A single granite slab forms the cover to the gravestone. The granite slab is intact and does not have any visible cracking. The slab has shifted to the south, however the granite slab has not fallen into the grave (Plates 51 and 54).

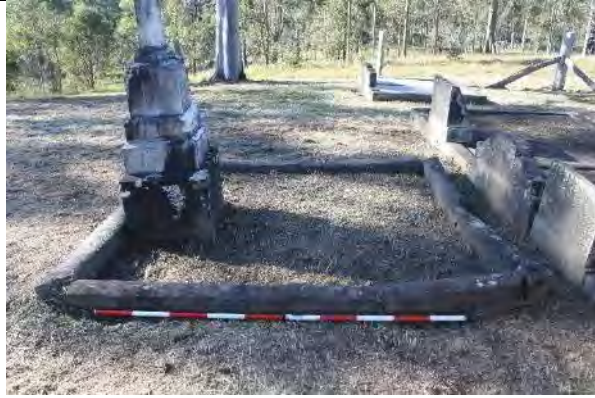
Plate 61

There has been substantial cracking and fracturing of the sandstone kerb wall blocks at the corners and along the mid-point on the eastern wall. There is evidence of a former fence that was installed on top of the kerb wall, however this has been removed and is no longer on site (Plates 61 – 63, 70 – 74).

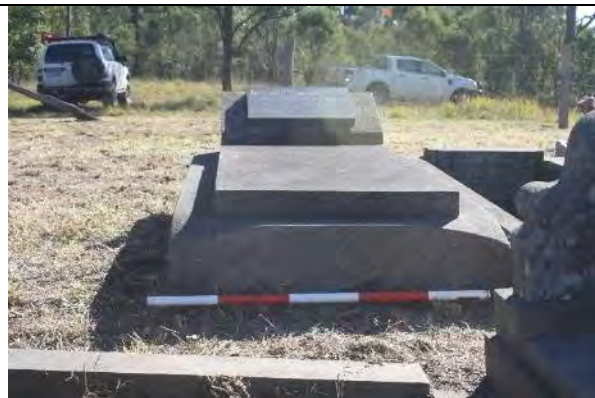
Plate 94

The grave is topped with a single piece of granite. This slab rests on top of the kerbing piece. There does not appear to be any fracturing or cracking to this element (Plates 94 and 97).

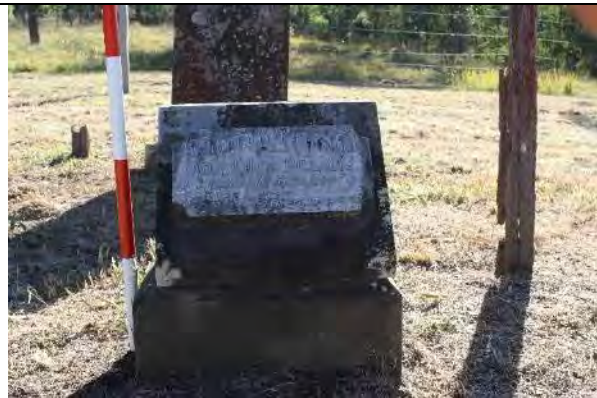
Plate 98

This is a single grave site that includes only the headstone and no other features (Plate 98). The headstone consists of a sandstone plinth at the base that is rectangular with a bevelled edge around the top. The headstone is on top of a single, separate, rectangular sandstone block. A separate granite inscription block is attached to the headstone. The granite piece is rectangular with cut-out rounded corners. The inscription is made of lead lettering, with all lettering present and legible. There is no cracking, fracturing or other damage to the plinth, headstone or granite inscription stone (Plates 98 – 100).

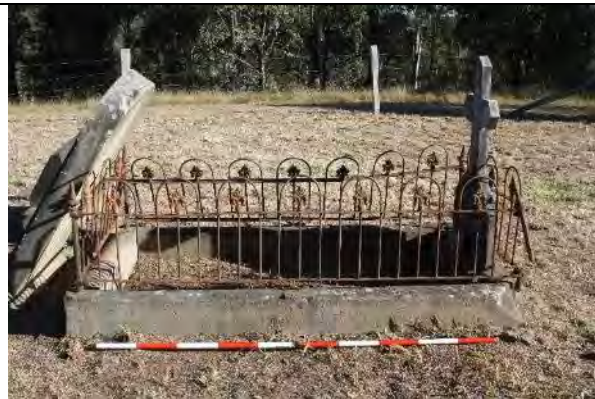
Plate 112

The sandstone kerb walls are made of four sandstone blocks, one on each side of the grave. The sandstone kerb has been shaped to have a curved surface along the top, with squared ends. These are to support the iron fence on top of the kerb wall. The top surface of the kerb walls have exfoliated, but the stones remain intact. The north-west corner of the kerb wall has fractured (Plates 112 and 113). The wrought iron fence is present all around the grave site. The fence is a bow and picket style that has been damaged and pushed inwards and is heavily rusted (Plates 112 and 113).

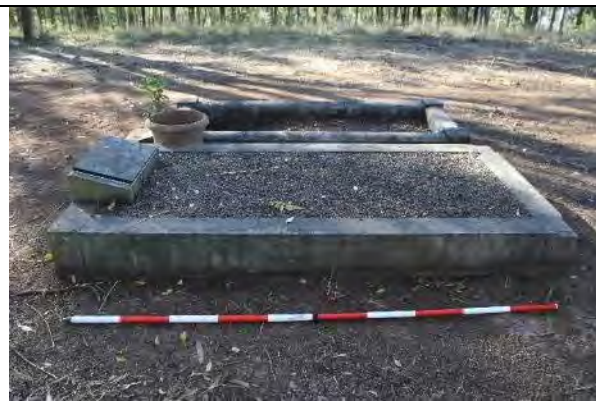
Plate 122

The internal surface of the grave is a pebble aggregate concrete. The surface does not have any signs of cracking or subsiding (Plate 122).
