# **ANNUAL ENVIRONMENTAL MANAGEMENT REPORT 2014**

## **RIX'S CREEK Pty Limited**

## **ANNUAL ENVIRONMENTAL MANAGEMENT REPORT 2014 – RIX’S CREEK COLLIERY**

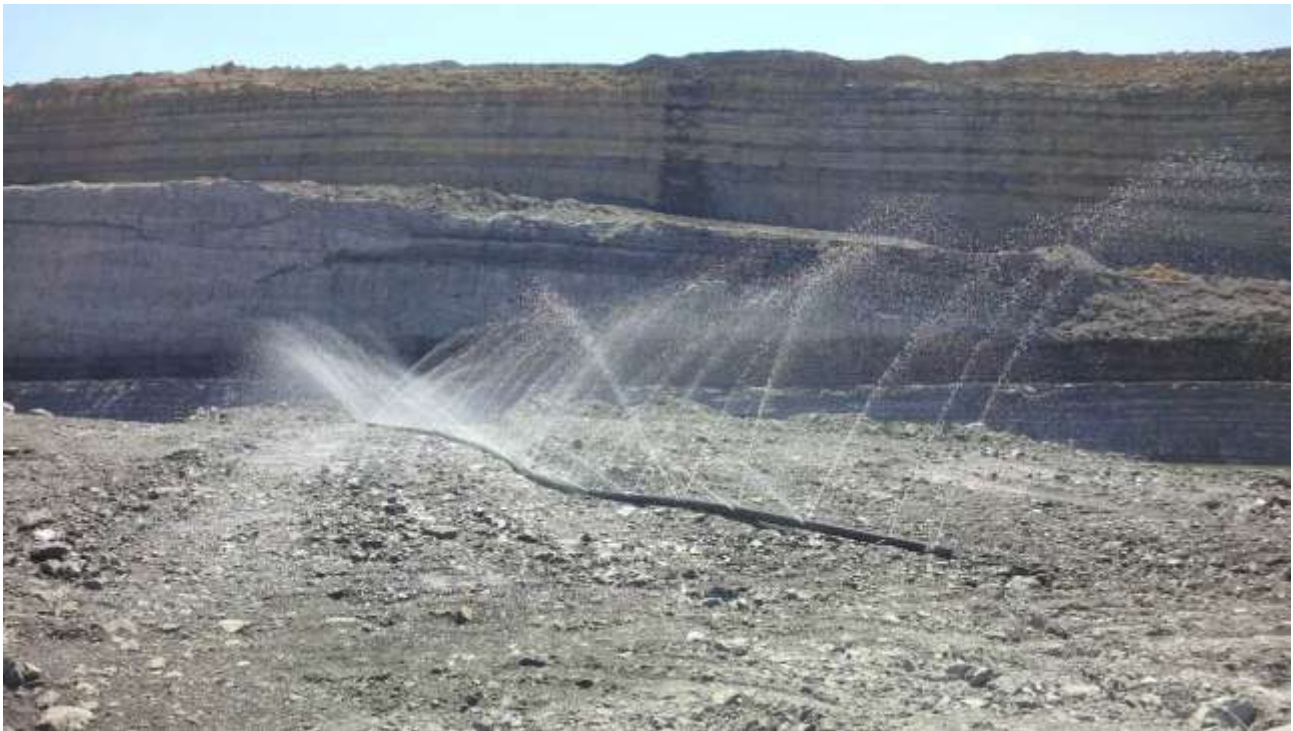
Rix’s Creek has trialled irrigating its blasted benches following a blast being initiated and levelled off prior to an excavator entering the area and removing the blasted dirt. This has helped saturate the top surface layer of the material forcing it to crust and prevent dust lift-off. The irrigation uses water from within the active mining area to essentially wet the area as if rainfall would.

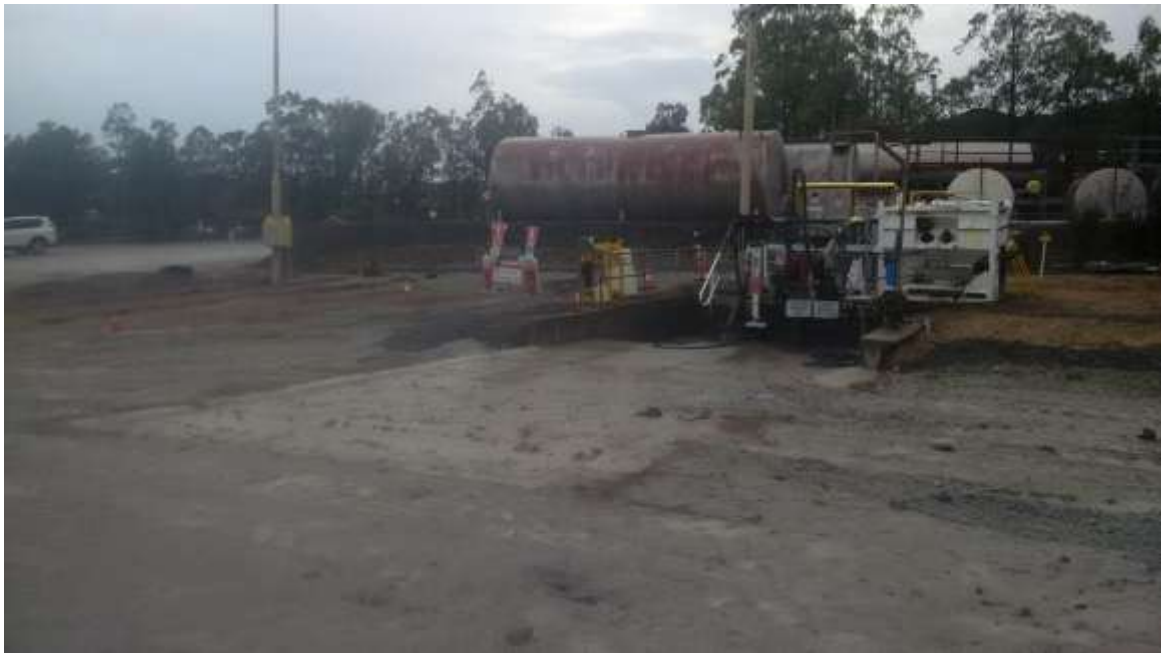
**Plate. 1 New concrete apron at diesel-fill point**

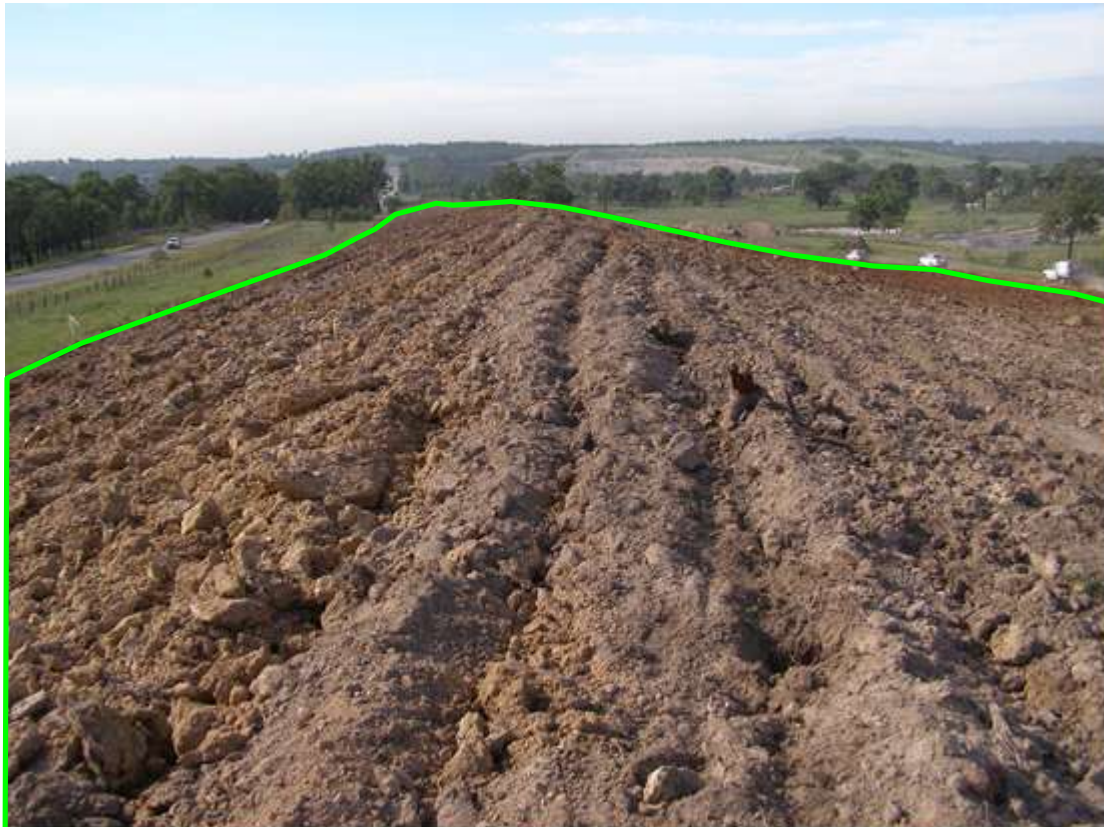
**Plate. 2 West Pit – New England Highway visual bunds (Stage 1) – freshly seeded (March 2014)**

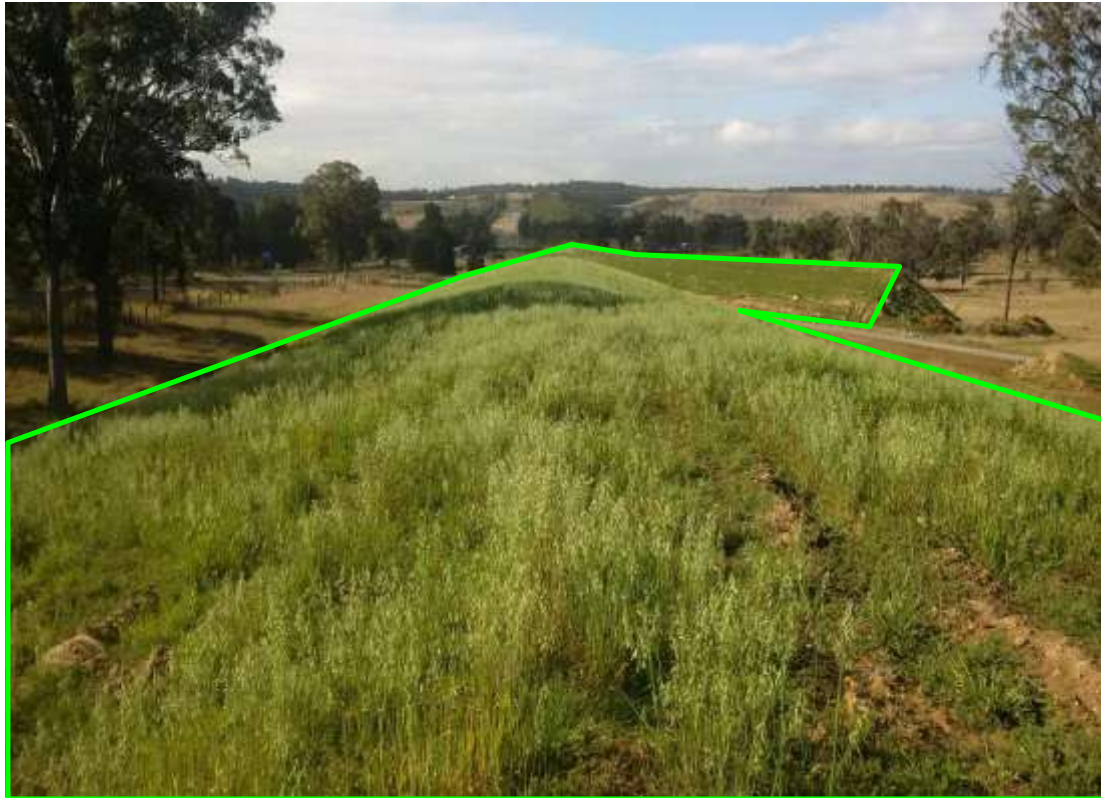
**Plate. 3 West Pit – New England Highway visual bunds (Stage 1) – 4 months after seeding (July 2014)**

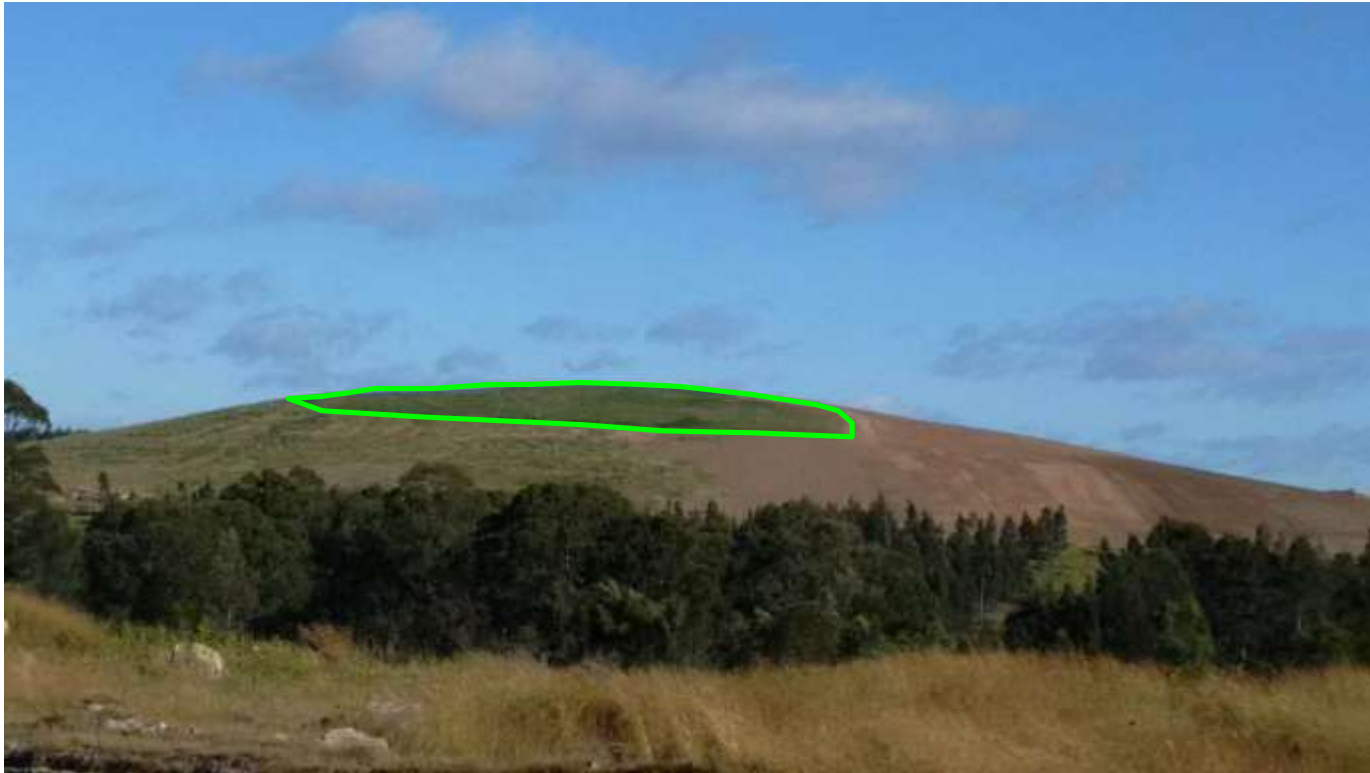
**Plate. 4 Rehabilitation at North Pit Tailing’s Dam #2; (tree area) facing north-west**

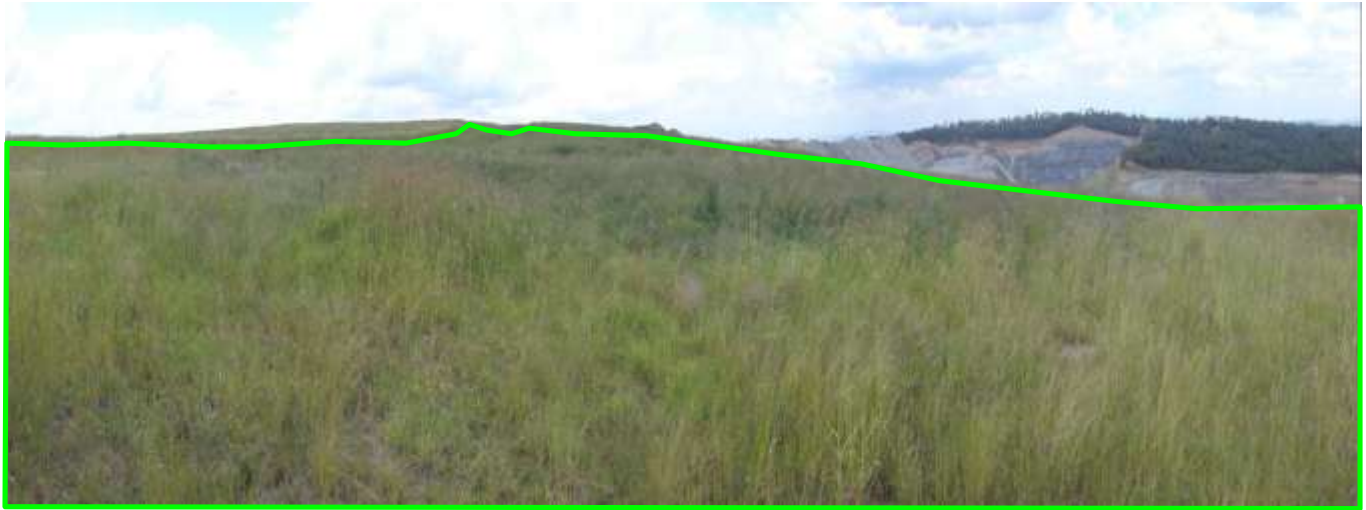
**Plate. 5 North Pit dump (Camberwell RL130) pasture rehabilitation facing west**

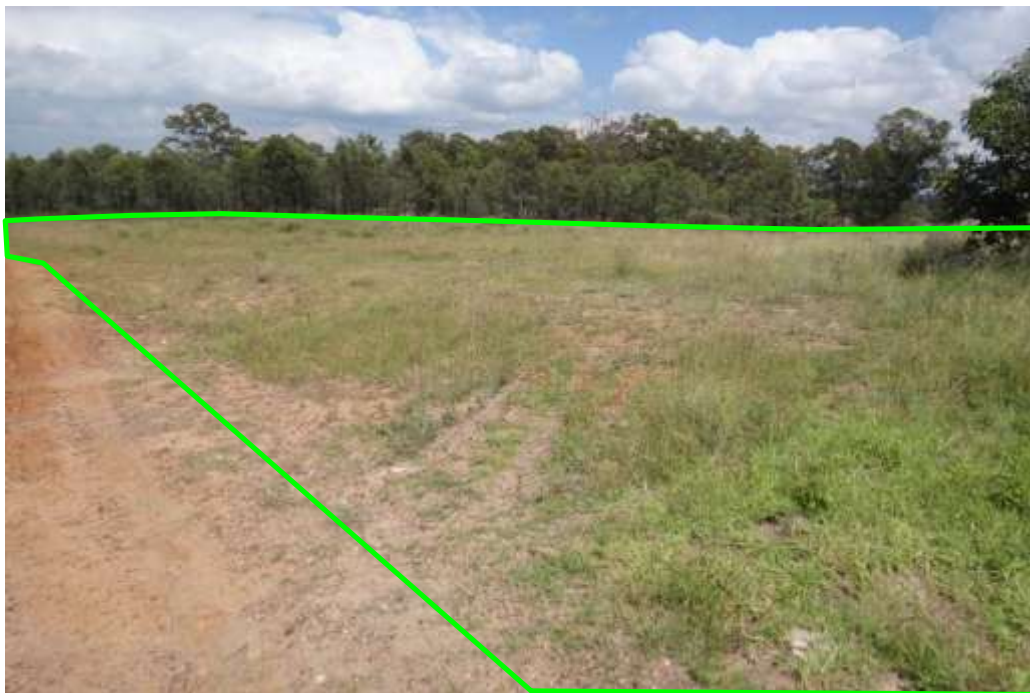
**Plate. 6 North Pit Old North Void drill site**

The area was an area previously cleared for an operation drill pad on unmined land. The area was left after underground mining in this area extracted more coal than previously thought. The slope was overlaid with approximately 100-200 mm of topsoil stockpiled adjacent to the area from when it was stripped via a D6 dozer. Prior to seeding the area was lightly ripped with a tractor with rip lines running across the contour to minimise erosion from surface run-off.

The material used in the construction has no relevant chemical characteristics, acid forming or spontaneous combustion potential. During the seeding process a starter fertiliser was spread at a rate of 200 kg/ha. No cover crop or ameliorants were used. Early indications also show some weed (Galenia and Prickly Pear) which will be monitored and managed accordingly.

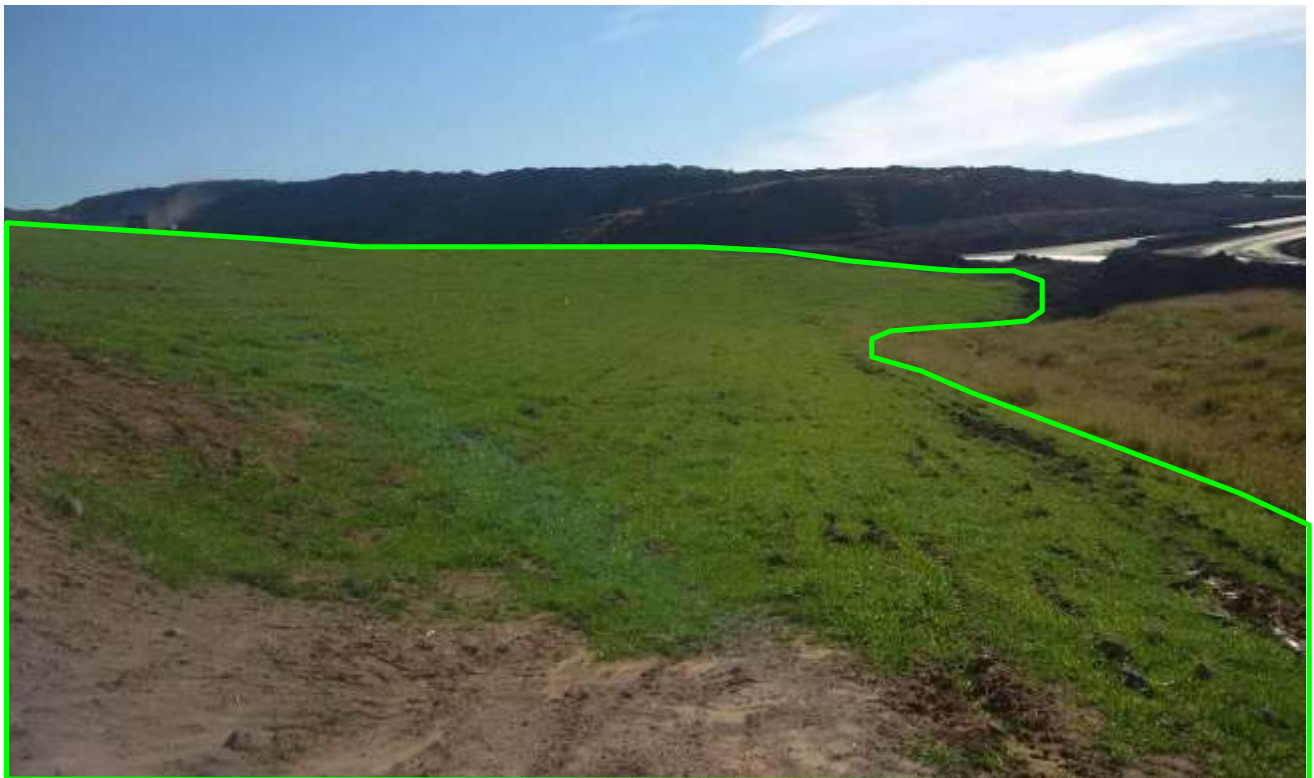
**Plate. 7 North Pit 9-Way batter (Muswellbrook side) facing north-east**

The area was created using overburden from the West Pit operation then clay and subsoil from the West Pit pre-strip was shaped onto a 10 degree slope. This slope was overlaid with approximately 100-200 mm of topsoil from the West Pit pre-strip area. Prior to seeding the area was ripped with a tractor with rip lines running across the contour to minimise erosion from surface run-off.

The material used in the construction has no relevant chemical characteristics, acid forming or spontaneous combustion potential. During the seeding process a starter fertiliser was spread at a rate of 200 kg/ha. No cover crop or ameliorants were used. Early indications also show some weed (Galenia) which will be monitored and managed accordingly.

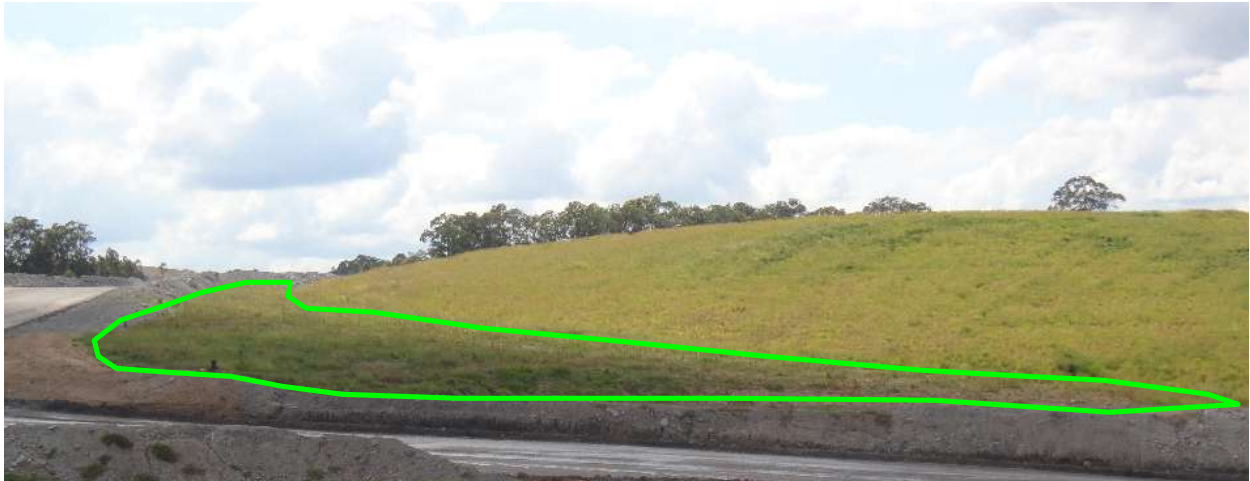
**Plate. 8 North Pit 9-Way batter (Singleton side) facing east**

The area was created using overburden from the West Pit operation then clay and subsoil from the West Pit pre-strip was shaped onto an approximately 6 degree slope. This slope was overlaid with approximately 100-200 mm of topsoil from the West Pit pre-strip area. Prior to seeding the area was spread with biosolids at a rate of 90 tonnes / hectare and ripped into the soil with a tractor. The rip lines were created across the contour to minimise erosion from surface run-off.

The material used in the construction has no relevant chemical characteristics, acid forming or spontaneous combustion potential. During the seeding process a starter fertiliser was spread at a rate of 200 kg/ha. A cover crop was also applied to stabilise the slope, minimise the weed potential and provide good visual amenity towards the New England Highway. Early indications also show some weed (Galenia and Prickly Pear) which will be monitored and managed accordingly. Prickly Pear was sprayed during December 2014 due to the seed being in the freshly stripped topsoil and drier than average conditions.

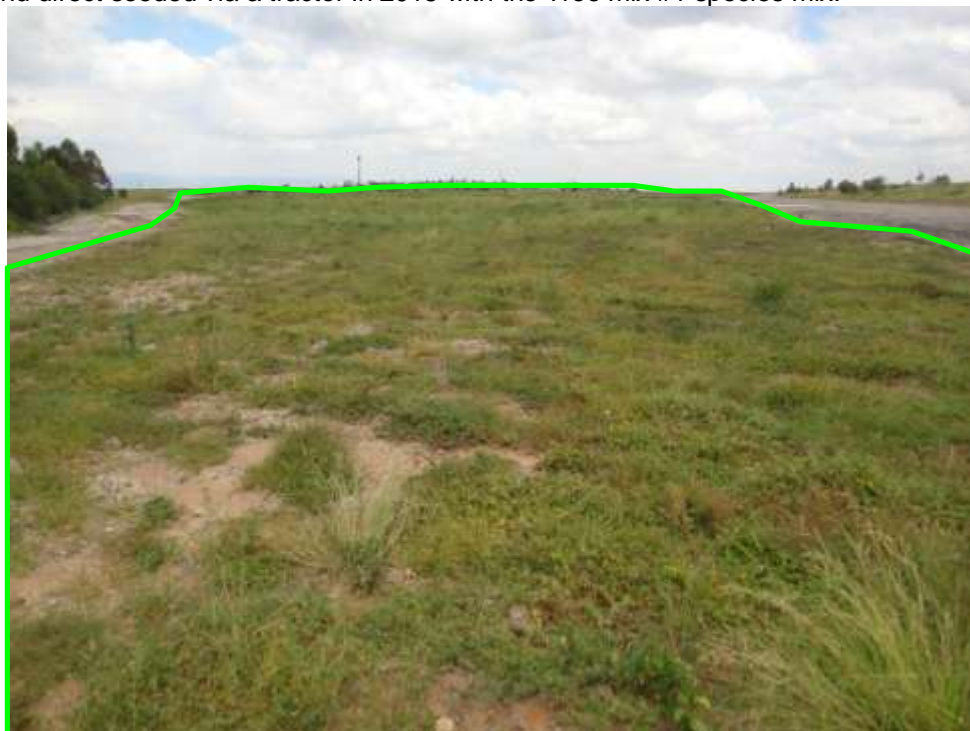
**Plate. 9 North Pit dump (Rix’s triangle) facing west**

The area was created using overburden from the North Pit operation then clay and subsoil from the West Pit pre-strip was shaped onto a generally flat slope. This slope was overlaid with approximately 100-200 mm of topsoil from the West Pit pre-strip area. Prior to seeding the area was spread with biosolids at a rate of 80 tonnes / hectare and ripped into the soil with a tractor. The rip lines were created across the contour to minimise erosion from surface run-off.

The material used in the construction has no relevant chemical characteristics, acid forming or spontaneous combustion potential. During the seeding process a starter fertiliser was spread at a rate of 100 kg/ha. A cover crop was also applied to stabilise the slope and minimise the weed potential. This area will be lightly re-ripped and direct seeded via a tractor in 2015 with the Tree mix #1 species mix.

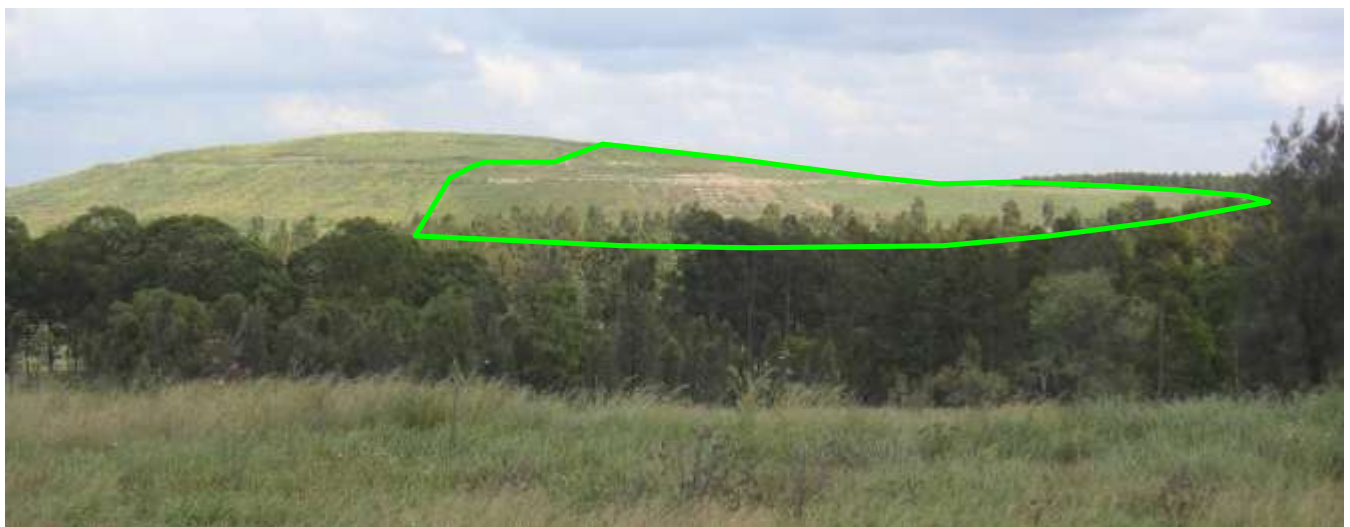
**Plate. 10 Rehabilitation at North Pit Tailing’s Dam #2; (pasture area) facing west**

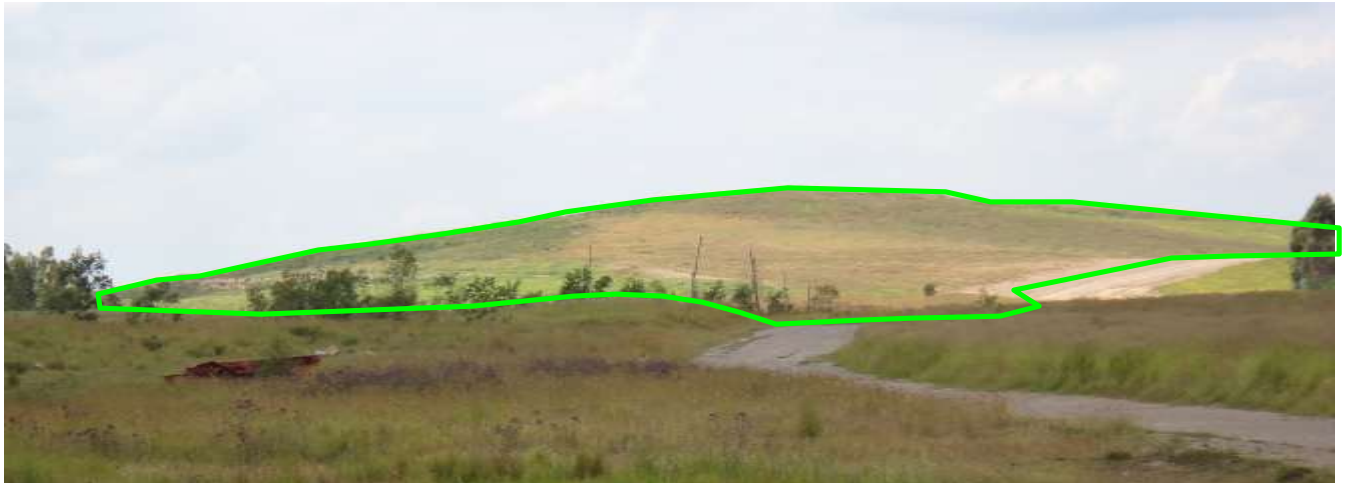
**Plate. 11 Rehabilitation at North Pit Tailing's Dam #2; (pasture area) facing east**

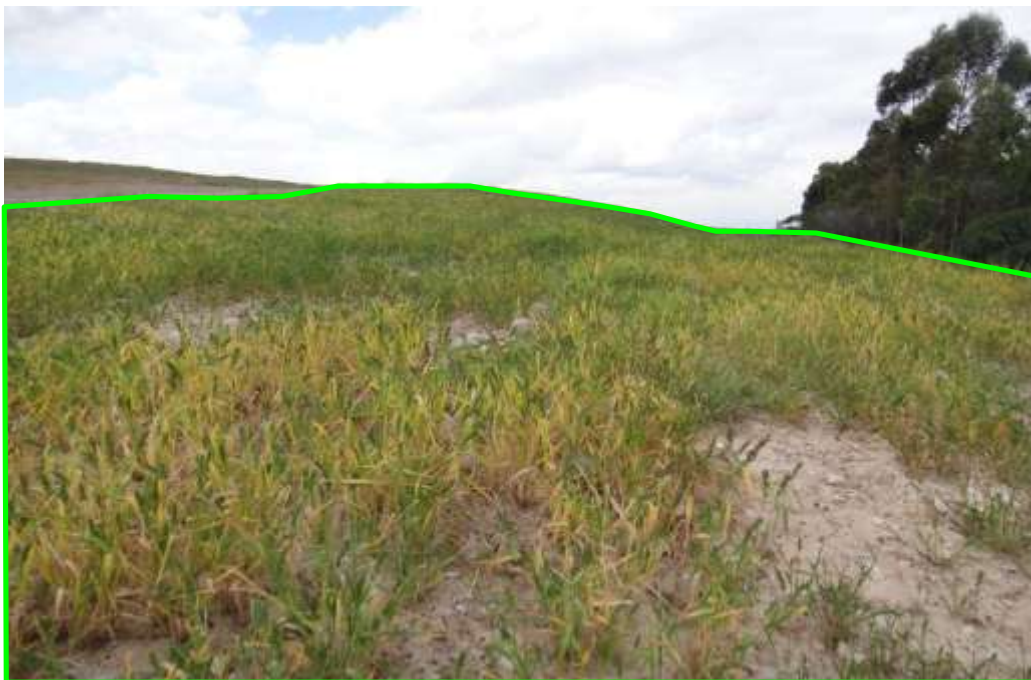
**Plate. 12 Rehabilitation at North Pit Tailing's Dam #2 batter; (tree area) facing south**

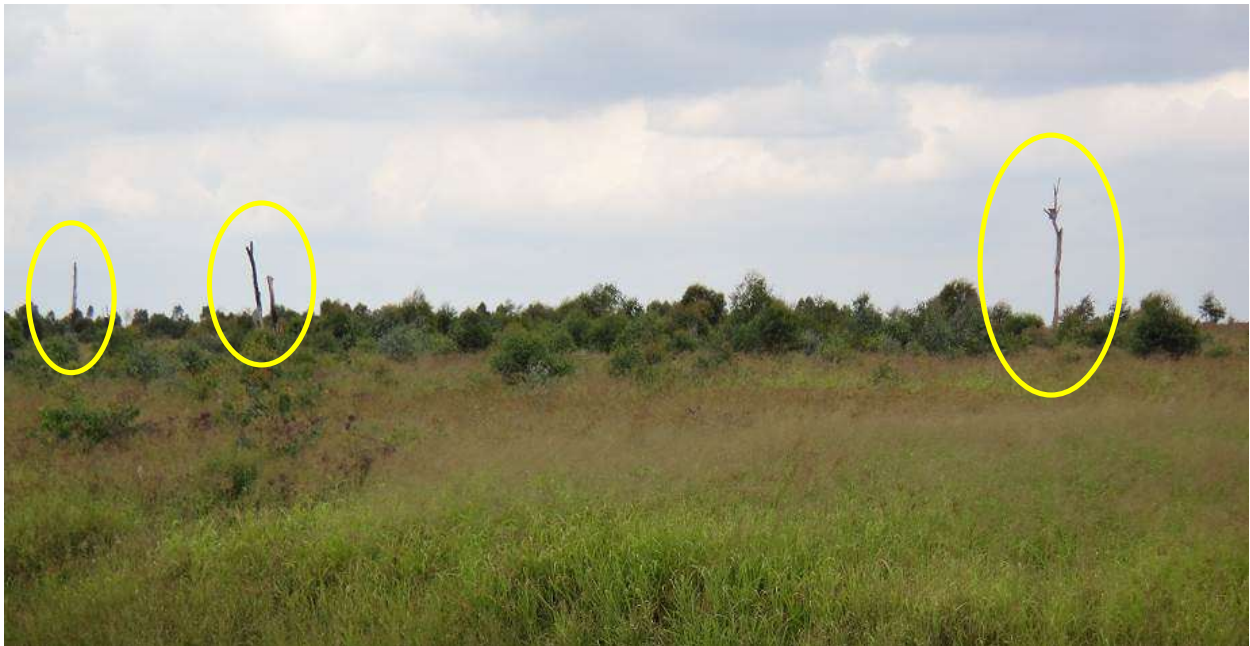
**Plate. 13 Habitat creation on North Pit dump (tree area) facing south-west**
