<b>REPORT TITLE</b>	<b>2015 Annual Review</b>
<b>PREPARED BY</b>	<b>Bloomfield Collieries Pty Ltd &amp; HV Coking Coal Pty Ltd (Glencore)</b>
<b>DATE</b>	<b>March 2016</b>

<b>Name of Mine:</b>	Rix's Creek North (formally known as Integra Open Cut Operations) and Integra Underground Mine - owner HV Coking Coal Pty Limited - ACN 605 492 804 (Glencore)
<b>Name of Operators:</b>	Bloomfield Collieries Pty Ltd - Rix's Creek North Open Cut HV Coking Coal Pty Ltd . Integra underground Mine
<b>Development consent/ project approval:</b>	<b>08_0101: and 08_0102</b>
<b>Titles/Mining Leases:</b>	CL 357, CL 382, ML 1437, ML 1518, ML 1551, ML 1630, ML 1648-1651, ML 1525, EL 5824, ML1676, A440 & A81
<b>MOP Commencement Dates:</b>	UG 23/12/2014; OC 1/10/2014
<b>MOP Completion Dates:</b>	UG 30/07/2017; OC 30/09/2017
<b>Annual Review Commencement Date:</b>	01/01/2015
<b>Annual Review Completion Date:</b>	31/12/2015
<b>Name of Leaseholder:</b>	Bloomfield Collieries Pty Ltd - Open Cut Operations HV Coking Coal Pty Ltd . Underground Operations
<p><b>I, Chris Quinn, certify that this audit report is a true and accurate record of the compliance status of Integra Coal Operations for the period January 1<s

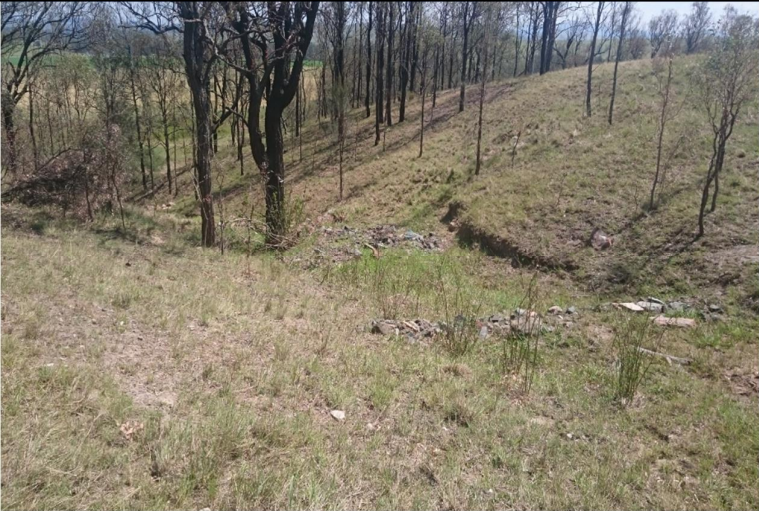
<p>27/11/2015 – Area 1 Geotextile fabric and rock embankments implemented to prevent Gully head erosion</p>		<p>Area 2 - 27/11/2015– Southern end of Area 2</p>

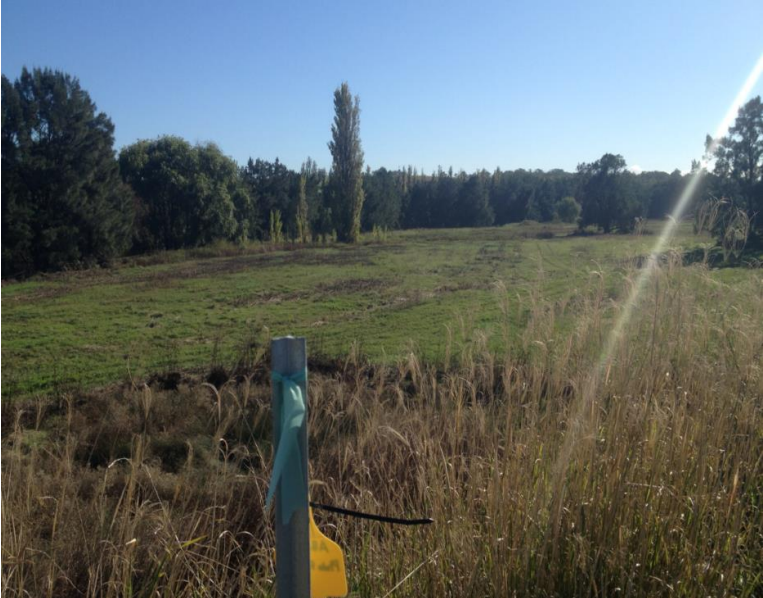
<p>A photograph of a grassy field with a line of trees in the background. A metal post with a yellow tag is in the foreground.</p> <p>Area 4 – slashing and weed control occurred in September 2015 in anticipation for planting of native tubestock</p>	Area 4

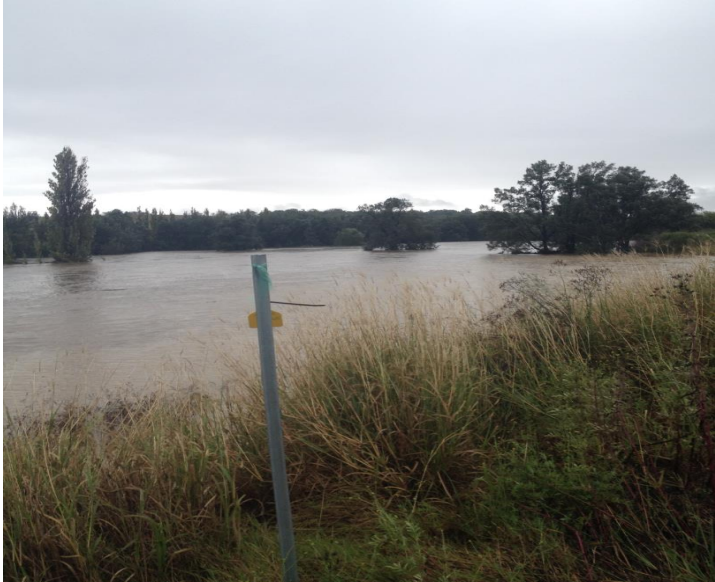
<p>A photograph of a flooded area with a line of trees in the background. A metal post with a yellow tag is in the foreground.</p> <p>Area 4 – April 2015 Flood event that washed away recently planted tube stock</p>
Area 6

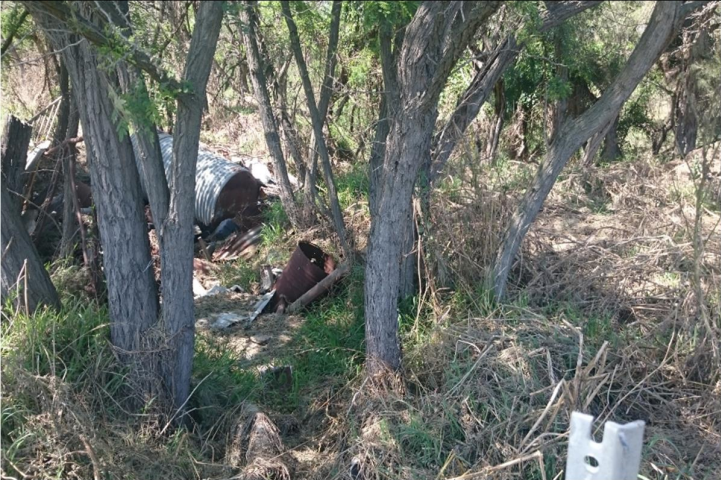
<p>A photograph of a wooded area with a line of trees in the background. A metal post with a yellow tag is in the foreground.</p> <p>Area 6 – Photo point 6b -27/11/15 Weed Management to determine rubbish removal</p>	Area 6

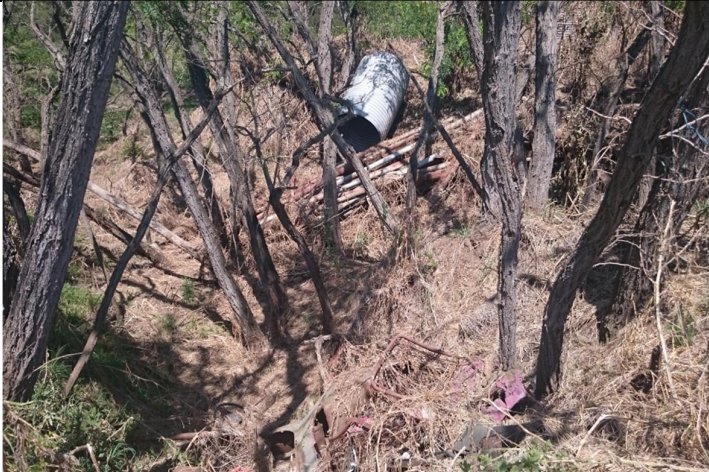
<p>A photograph of a gully head with debris, including a large metal pipe, in a wooded area.</p> <p>Area 6 - Photo point 6c – 27/11/15 Gully head with debris.</p>
