ANNUAL REVIEW 2015

RIX'S CREEK Pty Limited

ANNUAL REVIEW 2015 – RIX’S CREEK COLLIERY

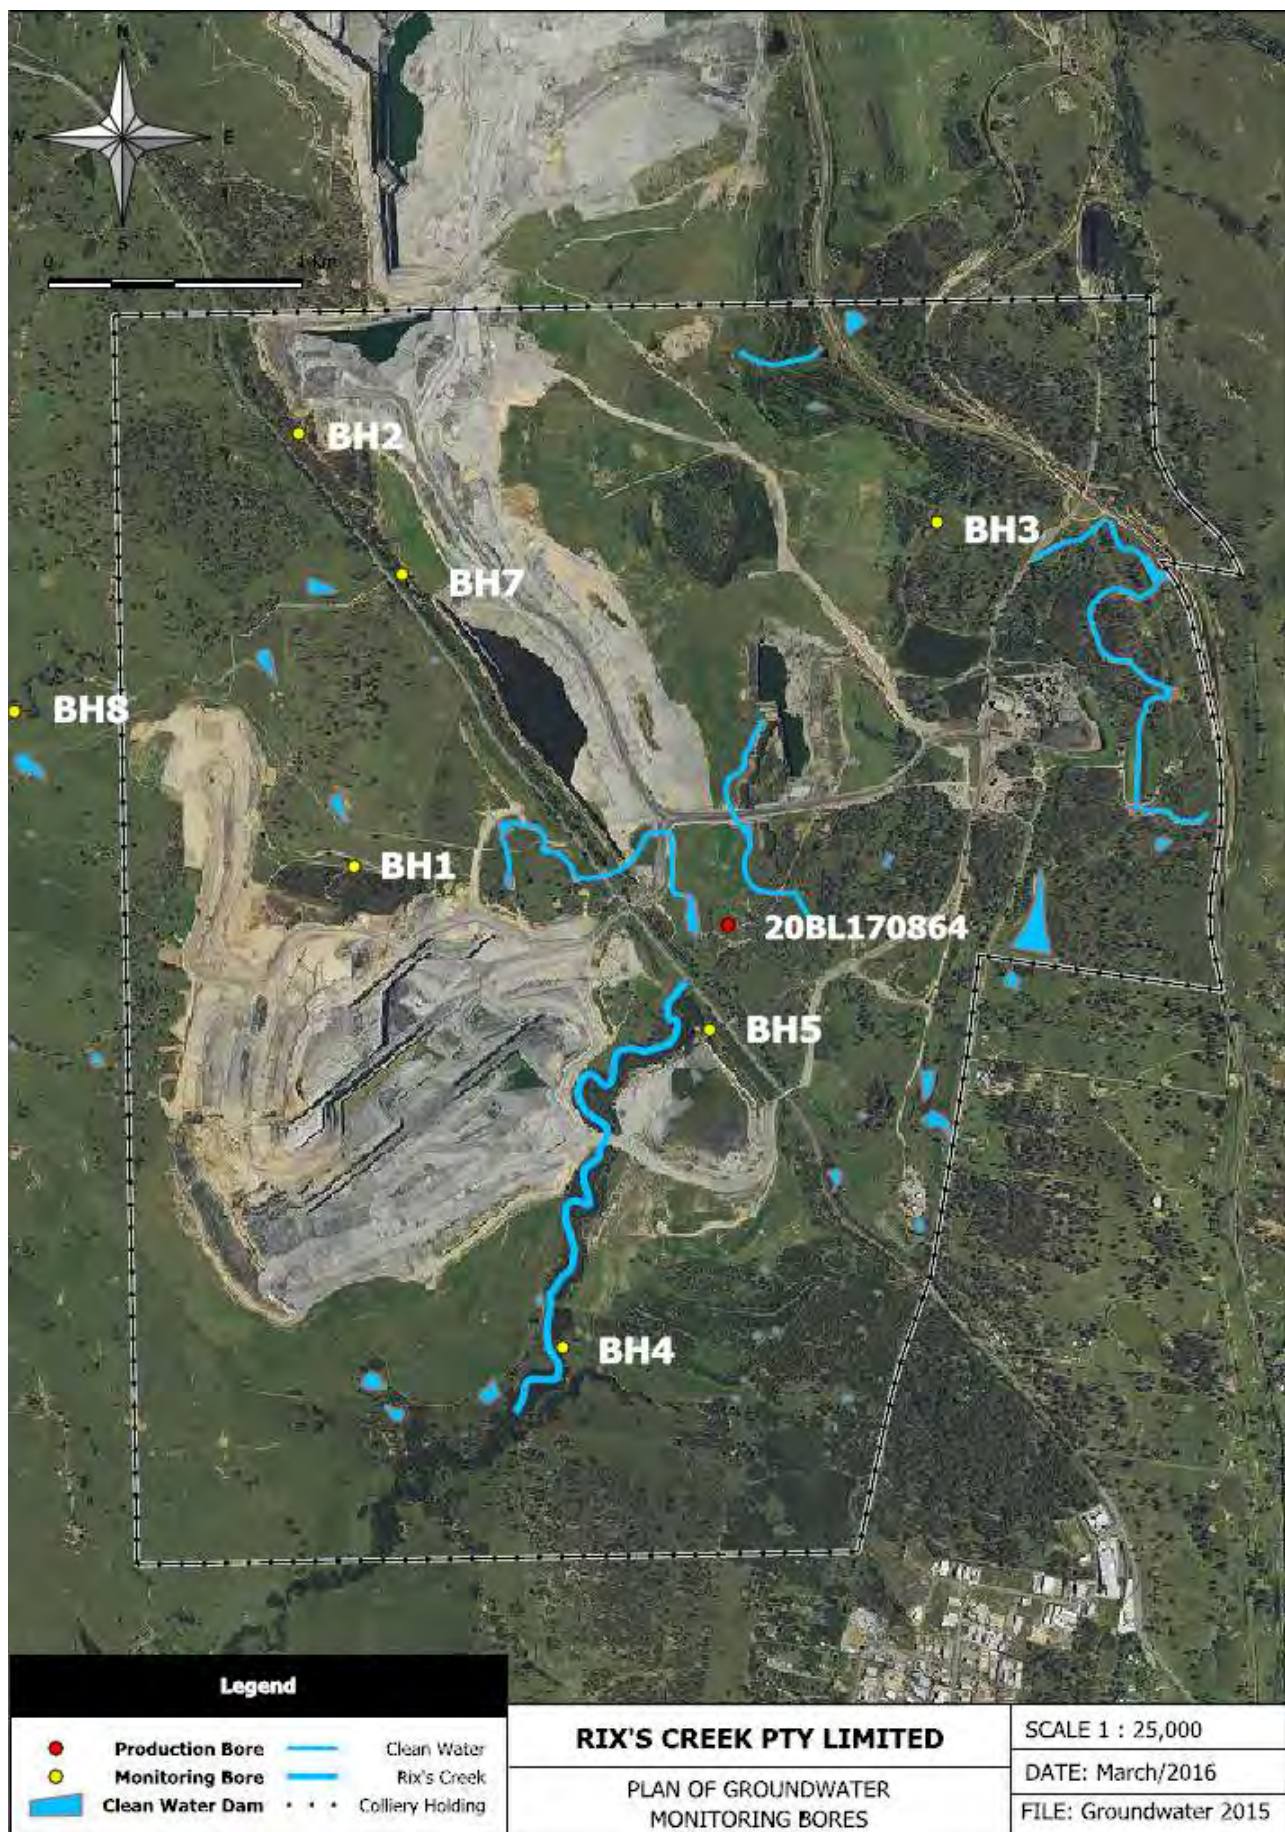
Figure 36. Groundwater Monitoring Network

Bore ID	Easting (UTM84)	Northing (UTM84)	Type	Depth (mbgl)	Location	Screened Aquifer
BH1	323190	6400562	Standpipe Piezometer	130	Middle of basin	Upper / Lower Arties
BH2	322936	6401923	Standpipe Piezometer	90	West of basin, close to outcrop	Lower Barrett
BH3	325457	6401923	Standpipe Piezometer	11	East of waste dump / backfill area	Regolith and shallow coal seams
BH4	323982	6398666	Standpipe Piezometer	10	Rix’s Creek south of Pit 3	Regolith
BH5	324562	6399924	Standpipe Piezometer	66.5	East of Rix’s Creek / tailings emplacement area	Lower Barrett
20BL170864	324633	6400335	Production bore	~70	Above underground workings	All coal seams
BH7	323345	6401709	Standpipe Piezometer	200.5	Bottom of basin	Hebden
BH8	321803	6401175	Standpipe Piezometer	20	Dead Man’s Creek west of coal outcrop	Regolith

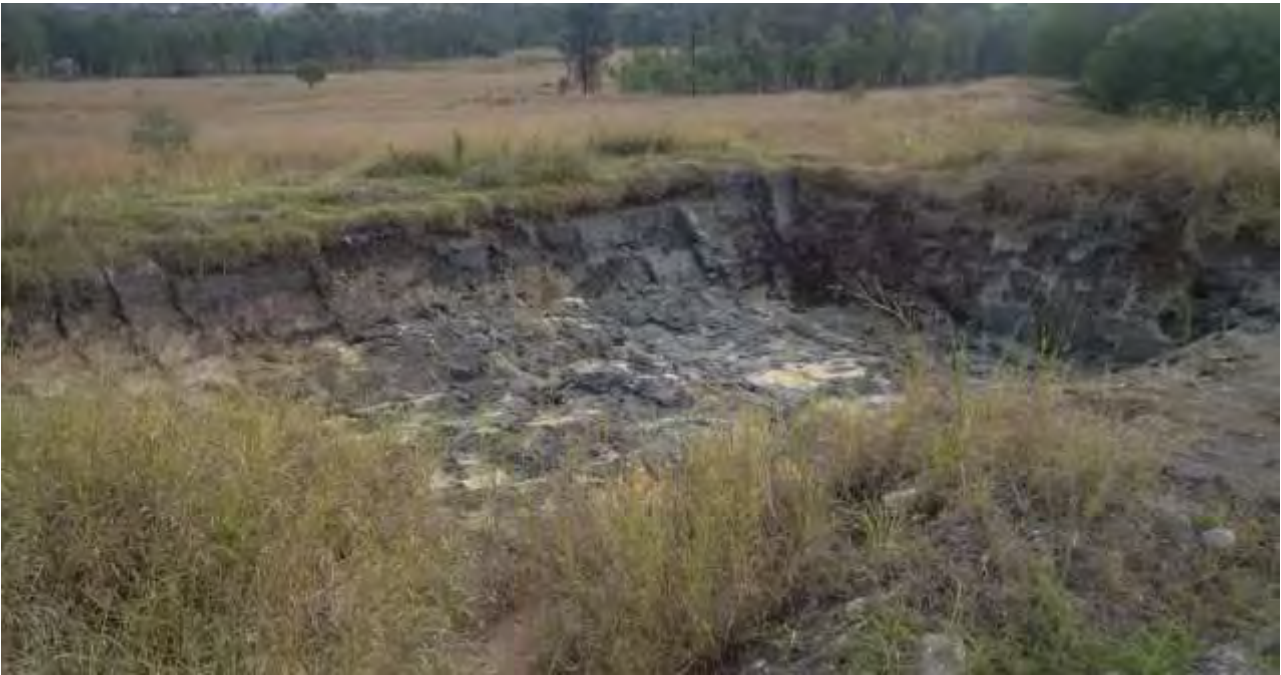
Plate. 2 Evidence of sediment dam cleaned out along North Pit haul road during July 2015

Throughout July 2015 all sediment dams across site were de-silted whilst climatic conditions were dry allowing adequate access and works to take place. A lot of dams contained a high amount of sediment due to the April storm event. This required the use of a long-reach excavator. Several other smaller sediment dams and drainage lines were also cleaned via an on-site backhoe as required throughout the year. These sediment dams contain the same material as that excavated from the open cut operation as well as clays, soil and silt from the natural environment.

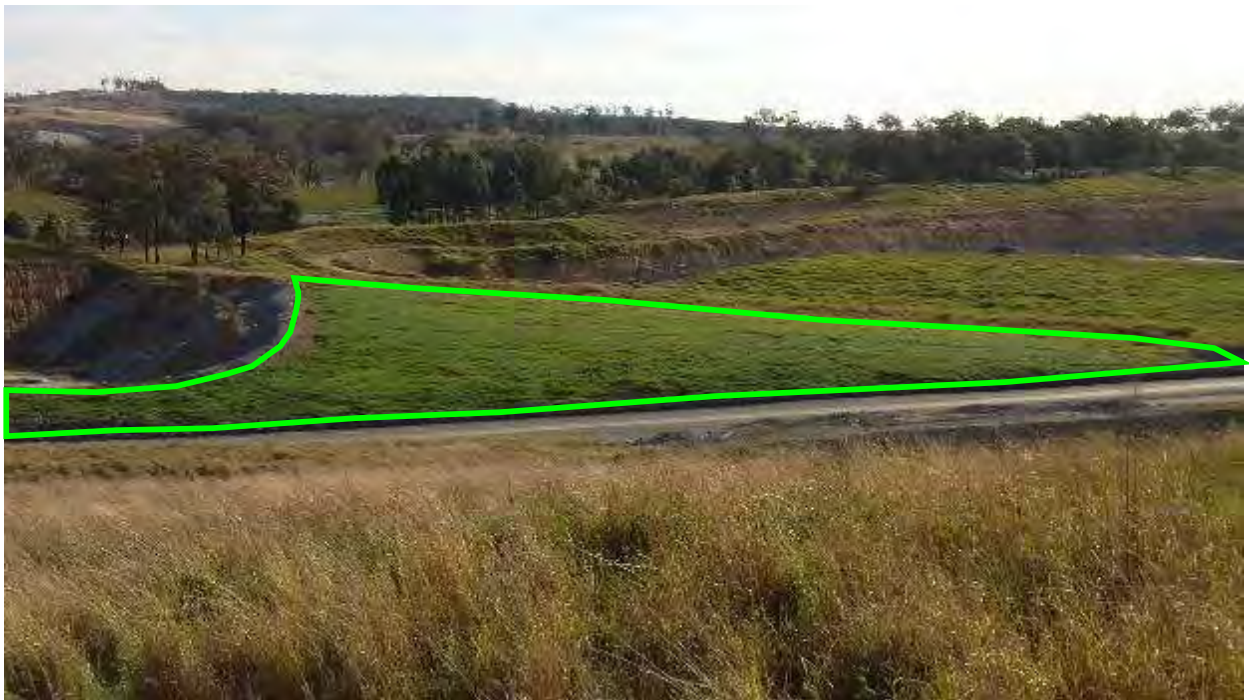
Plate. 3 North Pit – 9-ways tunnel batter (visible from New England Highway) – three months after seeding

The material used in the rehabilitation area has no relevant chemical characteristics, acid forming or spontaneous combustion potential. During the seeding process a starter fertiliser was spread at a rate of 200 kg/ha. Early indications show a moderate to high rate of seedlings emerging. A cover crop was also applied to minimise the weed potential and provide good visual amenity to passing road users. Early indications also show some weed (prickly pear and galenia) which will be monitored and managed accordingly.

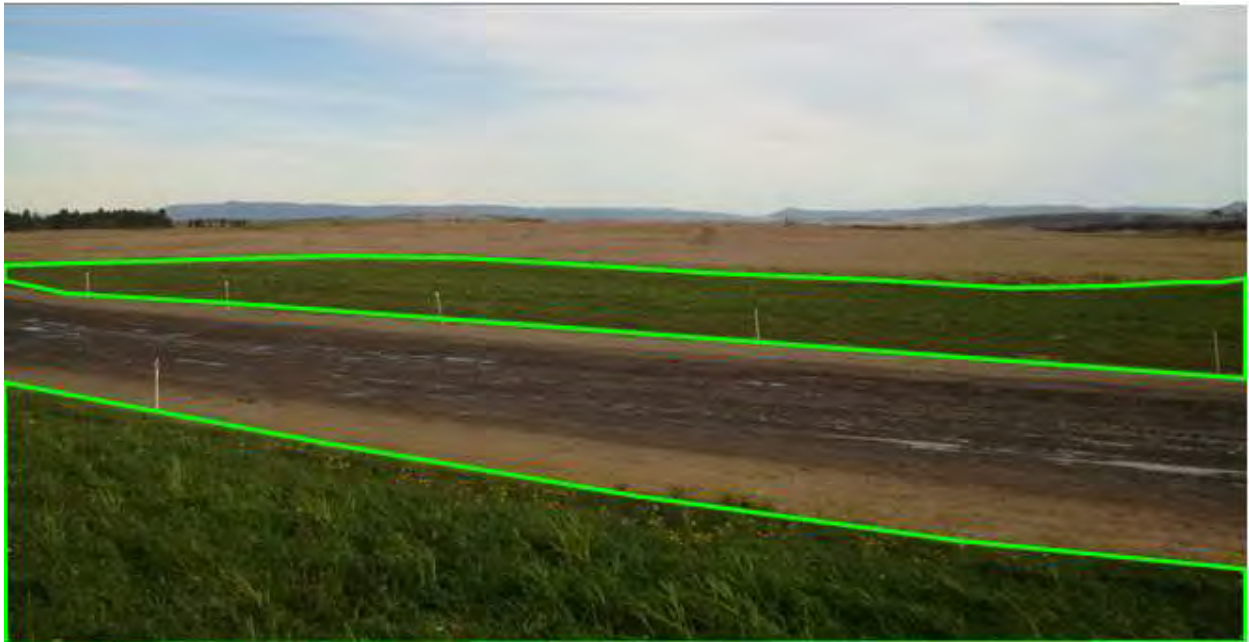
Plate. 4 North Pit RL140 (north of 4 ha pasture trial area) facing south

The area was created using overburden from the West Pit operation to fill to final design level then clay and subsoil from the West Pit pre-strip was shaped onto a 2-10 degree slope of the area and overlaid with approximately 100-200 mm of topsoil using a D10 dozer. The topsoil was from the West Pit pre-strip area. Prior to seeding the area was spread with biosolids at a rate of 80 tonnes / hectare and ripped into the soil with a tractor with rip lines running across the contour to minimise erosion from surface run-off.

The material used in the construction has no relevant chemical characteristics, acid forming or spontaneous combustion potential. During the seeding process a starter fertiliser was spread at a rate of 200 kg/ha. Early indications show a moderate to high rate of seedlings emerging. A cover crop was also applied to stabilise the slope and minimise the weed potential. Early indications also show some weed (galenia) which will be monitored and managed accordingly. The area was also rock-rolled via a tractor and drum-roller during May 2015 minimising the amount of surface rocks creating a smoother pasture area.

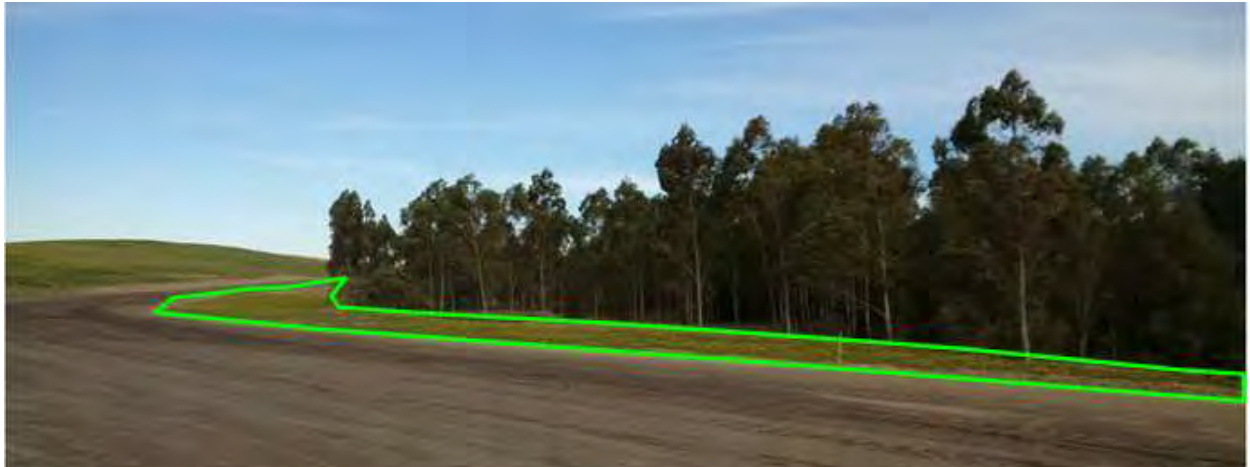
Plate. 5 North Pit dump RL140 north of tree stand (adjacent to TD#2) tree rehabilitation facing south

(galenia and scotch thistle) which will be monitored and managed accordingly.

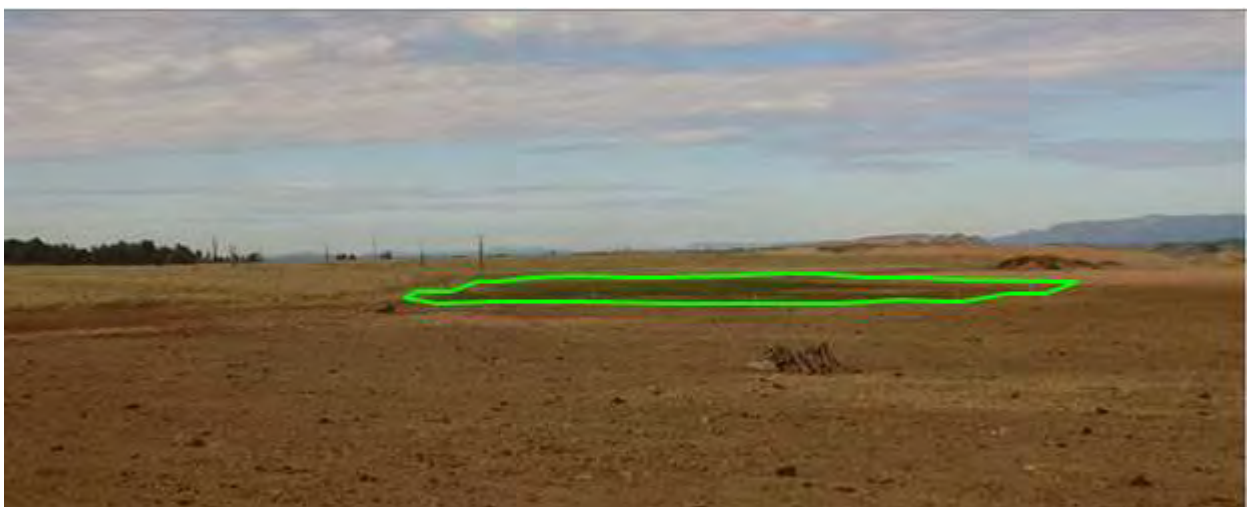
Plate. 6 North Pit RL140 Dump (tree's)

The area was created using overburden from the West Pit operation then clay and subsoil from the West Pit pre-strip was overlaid onto a 1-2 degree slope. The clay and subsoil was shaped approximately 300-500 mm thick. This was then overlaid with approximately 100-200 mm of topsoil using a D10 dozer. The topsoil was from the West Pit pre-strip area. Prior to seeding the area was spread with biosolids at a rate of 40 tonnes / hectare and ripped into the soil with a tractor with rip lines running across the contour to minimise erosion from surface run-off.

The material used in the construction has no relevant chemical characteristics, acid forming or spontaneous combustion potential. During the seeding process a starter fertiliser was spread at a rate of 100 kg/ha. Early indications also show some weed (galenia and prickly pear) which will be monitored and managed accordingly. This area forms part of a habitat corridor being created across the North Pit dump from Tailing's Dam #2 across to Deadman's Hill on the New England Highway.

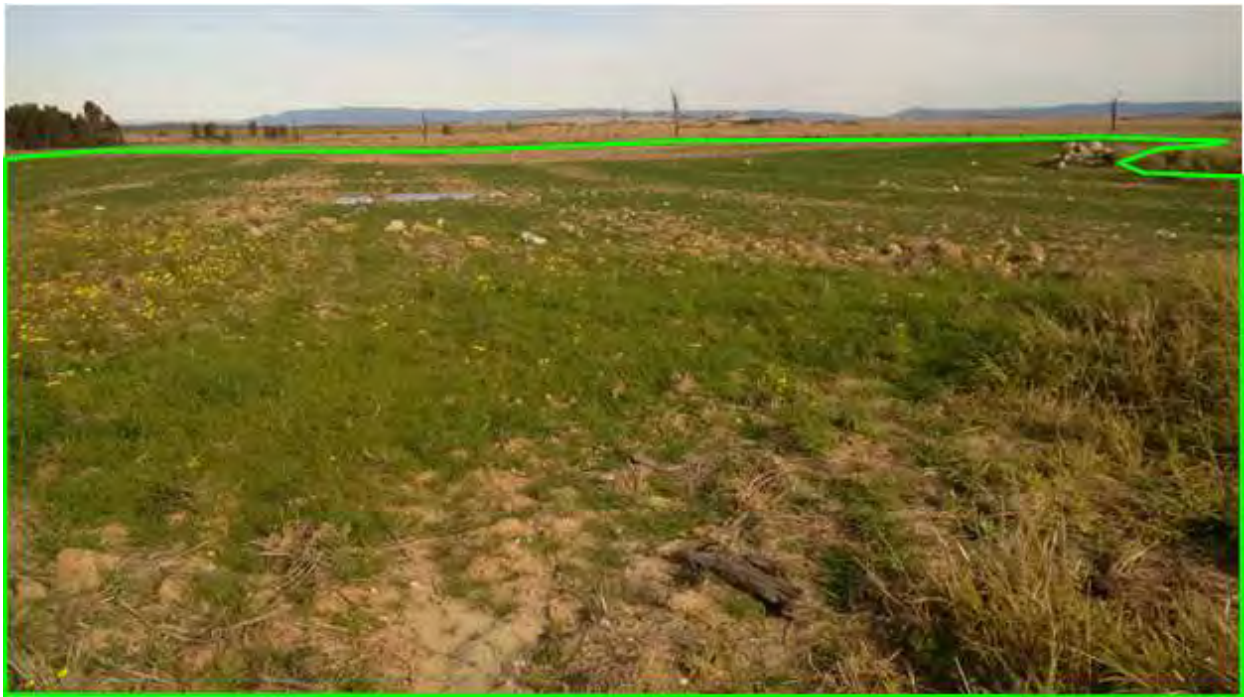
Plate. 7 North Pit RL140 Decommissioned Road (rehabilitated during April) facing south-east

The area was created using overburden from the North Pit operation. It was ripped via a D6 dozer due to compaction from being used as a road then clay and subsoil from the West Pit pre-strip was shaped onto the 1-2 degree slope. This slope was overlaid with approximately 100-200 mm of topsoil from the adjacent North Pit topsoil stockpile area using a D6 dozer. Prior to seeding the area was spread with biosolids at a rate of 80 tonnes / hectare and ripped into the soil with a tractor with rip lines running across the contour to minimise erosion from surface run-off.

The material used in the construction has no relevant chemical characteristics, acid forming or spontaneous combustion potential. During the seeding process a starter fertiliser was spread at a rate of 200 kg/ha. No cover crop was used. Early indications also show some weed (galenia) which will be monitored and managed accordingly. Some rock and timber structures were also created throughout the area as habitat for ground-dwelling creatures.

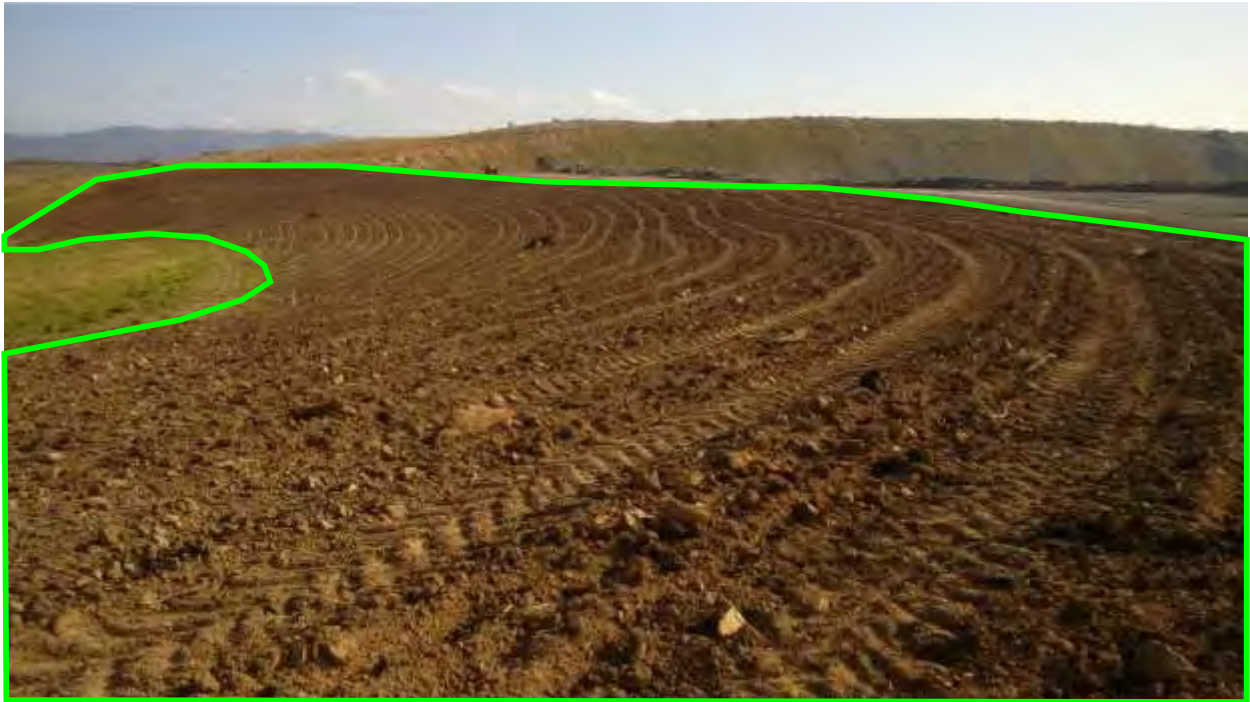
Plate. 9 West Pit dump (valley facing Maison Dieu) facing west – photo taken after direct seeding

The West Pit (valley facing Maison Dieu) site was rehabilitated in July 2015 totalling 2.0 ha. This area was direct seeded via a tractor using pasture species (Pasture mix #2).

The area was created using overburden from the West Pit operation then clay and subsoil from the West Pit pre-strip was shaped onto an approximately 10 degree slope. This slope was overlaid with approximately 100-200 mm of topsoil from the West Pit pre-strip area and pushed out via D10 dozer. Prior to seeding the area was spread with biosolids at a rate of 90 tonnes / hectare and ripped into the soil with a tractor. The rip lines were created across the contour to minimise erosion from surface run-off.

The material used in the construction has no relevant chemical characteristics, acid forming or spontaneous combustion potential. During the seeding process a starter fertiliser was spread at a rate of 200 kg/ha. A cover crop was also applied to stabilise the slope, minimise the weed potential and provide good visual amenity towards the Maison Dieu residential area and New England Highway. Early indications also show some weed (galenia) which will be monitored and managed accordingly. Some rock and timber structures were also created throughout the area as habitat for ground-dwelling creatures.

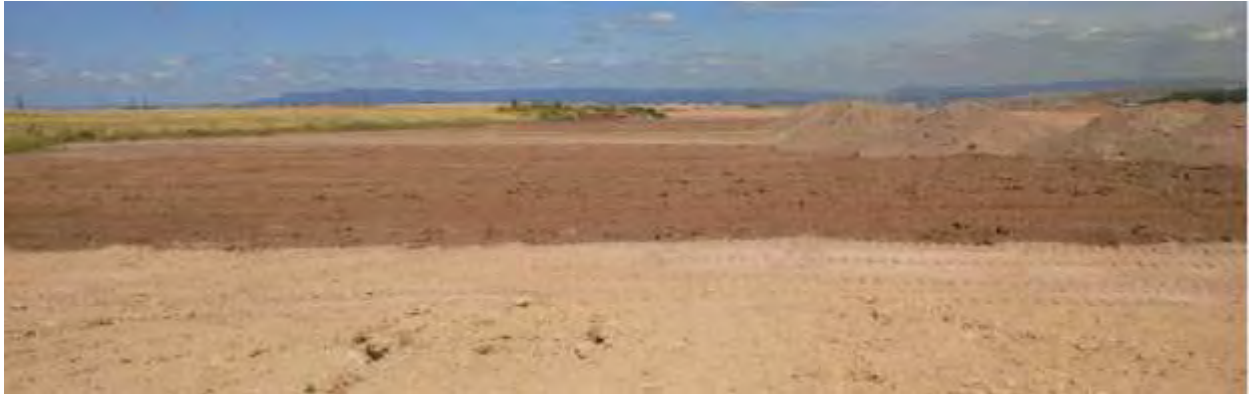
Plate. 11 North Pit RL140 dump facing south – photo taken while spreading topsoil over subsoil

were created across the contour to minimise erosion from surface run-off.

The material used in the construction has no relevant chemical characteristics, acid forming or spontaneous combustion potential. During the seeding process a starter fertiliser was spread at a rate of 200 kg/ha. Early indications also show some weed (scotch thistle and galenia) which will be monitored and managed accordingly. Some rock and timber structures were also created throughout the area as habitat for ground-dwelling creatures.

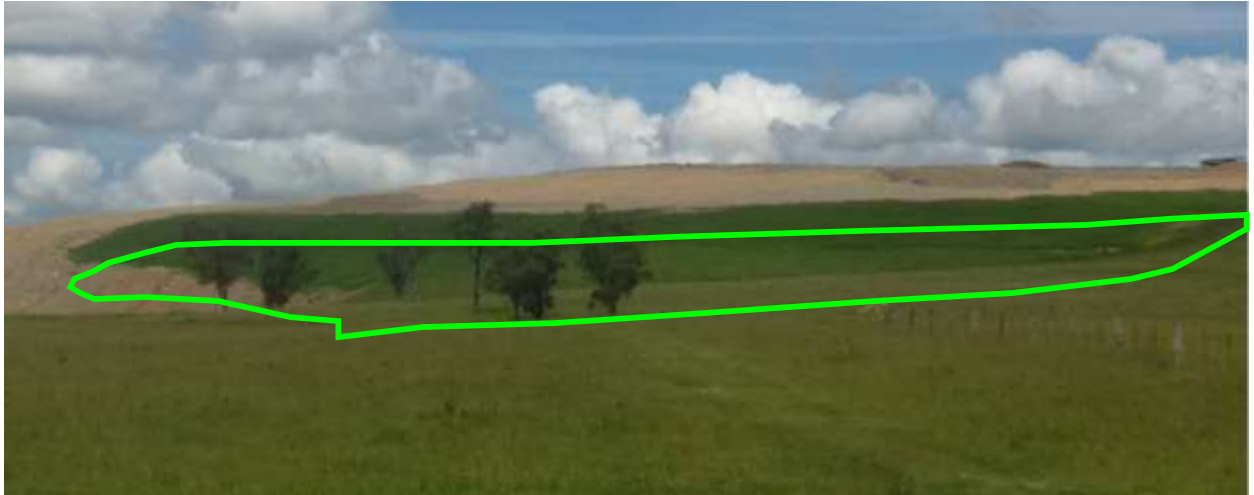
Plate. 13 West Pit - Out of Pit Dump (low batter) rehabilitation facing east

The material used in the construction has no relevant chemical characteristics, acid forming or spontaneous combustion potential. During the seeding process a starter fertiliser was spread at a rate of 200 kg/ha. A cover crop was also applied to stabilise the slope and minimise the weed potential. Two contour banks were also installed across the slope with a D10 dozer at a fall of 0.5 degree's. These banks were installed to minimise erosion down the 10 degree batter. To date the banks have worked effectively.

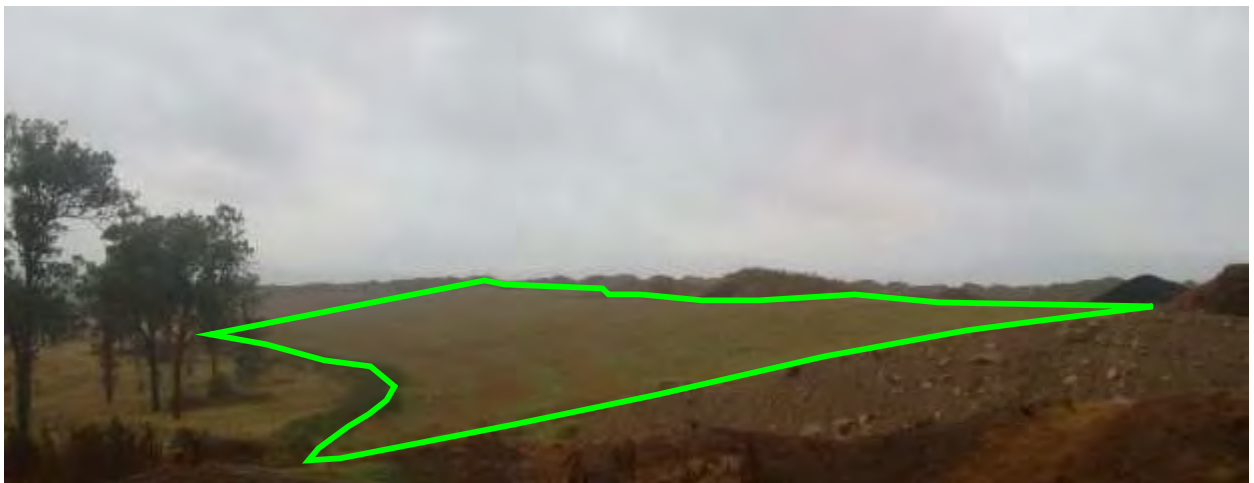
Plate. 14 West Pit - Out of Pit Dump (top batter) rehabilitation facing north

The area was created using overburden from the West Pit operation then shaped into a 10 degree slope with a D10 dozer. The whole area was overlaid with approximately 100-200 mm of topsoil from the West Pit Out of Pit Dump stripped area. Prior to seeding the area was spread with biosolids at a rate of 90 tonnes / hectare and ripped into the soil with a tractor. The rip lines were created across the contour to minimise erosion from surface run-off.

The material used in the construction has no relevant chemical characteristics, acid forming or spontaneous combustion potential. During the seeding process a starter fertiliser was spread at a rate of 200 kg/ha. A cover crop was also applied to stabilise the slope and minimise the weed potential.

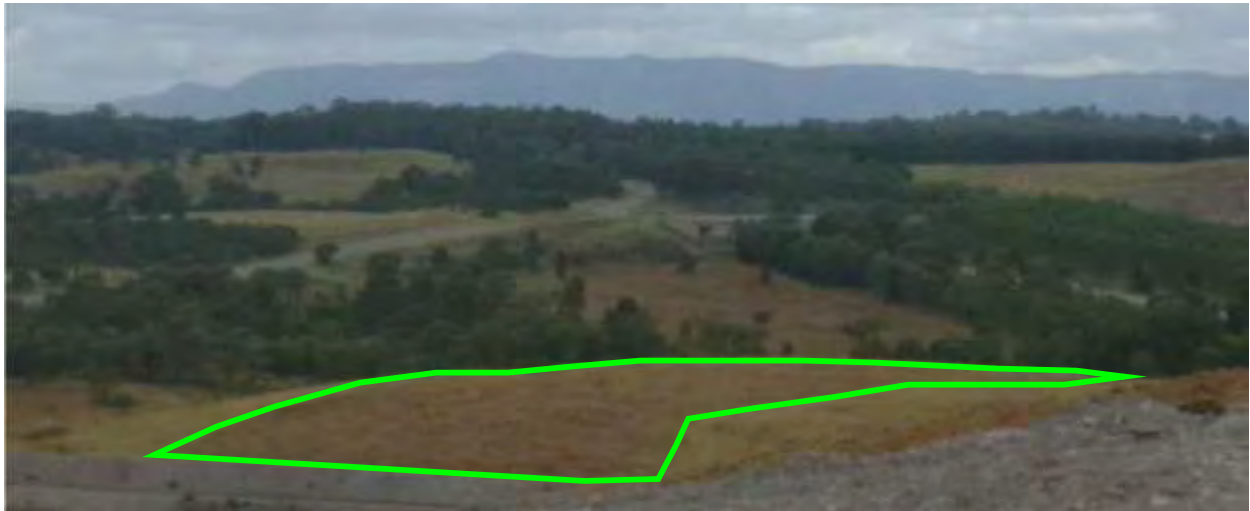
Plate. 15 Rehabilitation at North Pit 9-ways facing south

This area was created using overburden from the North Pit operation that was stockpiled on the site and required shaping to final design. The slope of the area varies from 2 – 10 degrees. The whole area was overlaid with approximately 100-200 mm of topsoil from the West Pit pre-strip area. Prior to seeding the area was spread with biosolids at a rate of 90 tonnes / hectare and ripped into the soil with a tractor. The rip lines were created across the contour to minimise erosion from surface run-off.

The material used in the construction has no relevant chemical characteristics, acid forming or spontaneous combustion potential. During the seeding process a starter fertiliser was spread at a rate of 200 kg/ha. A cover crop was also applied to stabilise the slope and minimise the weed potential.

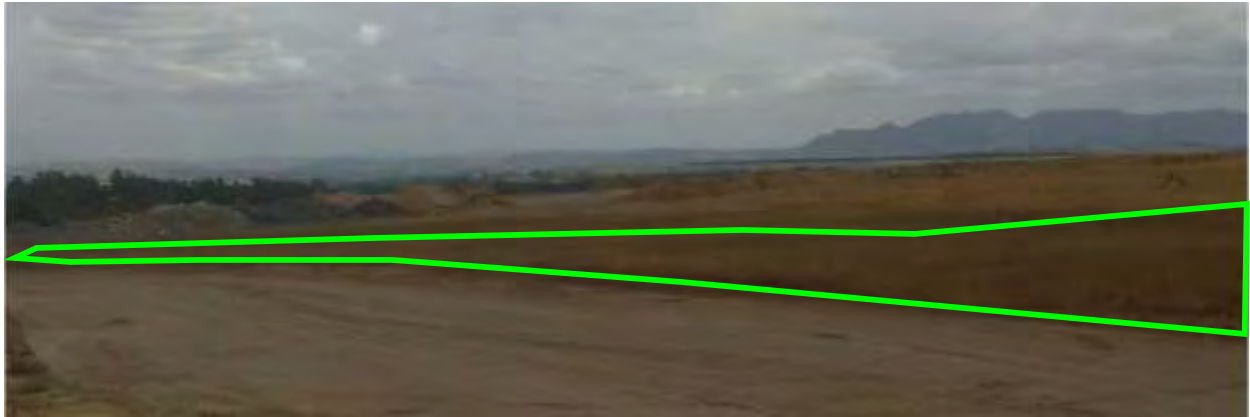
Plate. 16 Rehabilitation at North Pit RL140 dump facing north

The area was created using overburden from the West Pit operation then clay and subsoil (300-500 mm thick) from the West Pit pre-strip was shaped onto a generally flat slope. This 1-2 degree slope was overlaid with approximately 100-200 mm of topsoil from the West Pit pre-strip area. Prior to seeding the area was spread with biosolids at a rate of 90 tonnes / hectare and ripped into the soil with a tractor. The rip lines were created across the contour to minimise erosion from surface run-off.

The material used in the construction has no relevant chemical characteristics, acid forming or spontaneous combustion potential. During the seeding process a starter fertiliser was spread at a rate of 200 kg/ha. Some rock and timber structures were also created throughout the area as habitat for ground-dwelling creatures.

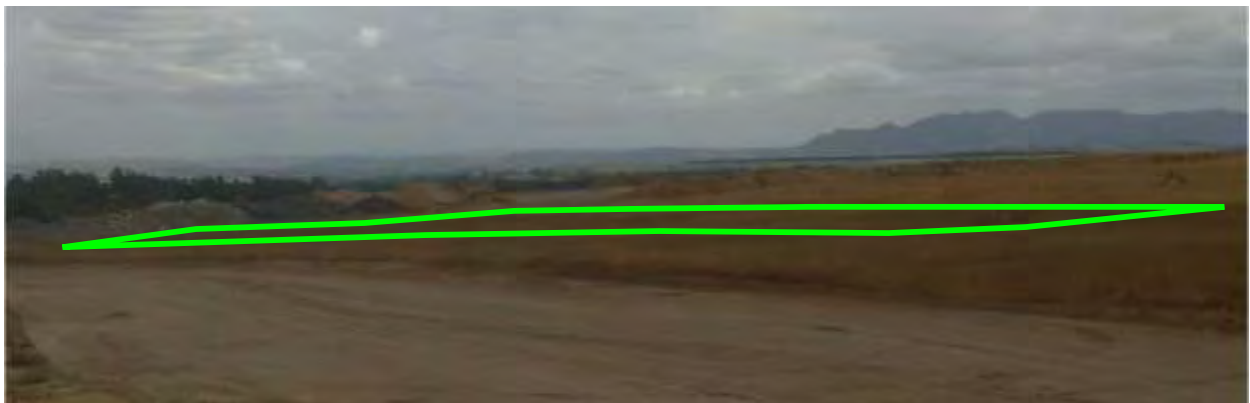
Plate. 17 Rehabilitation at North Pit RL140 dump facing north

The area was created using overburden from the West Pit operation then clay and subsoil (300-500 mm thick) from the West Pit pre-strip was shaped onto a generally flat slope. This 1-2 degree slope was overlaid with approximately 100-200 mm of topsoil from the West Pit pre-strip area. Prior to seeding the area was spread with biosolids at a rate of 40 tonnes / hectare and ripped into the soil with a tractor. The rip lines were created across the contour to minimise erosion from surface run-off.

The material used in the construction has no relevant chemical characteristics, acid forming or spontaneous combustion potential. During the seeding process a starter fertiliser was spread at a rate of 100 kg/ha. Some rock and timber structures were also created throughout the area as habitat for ground-dwelling creatures.

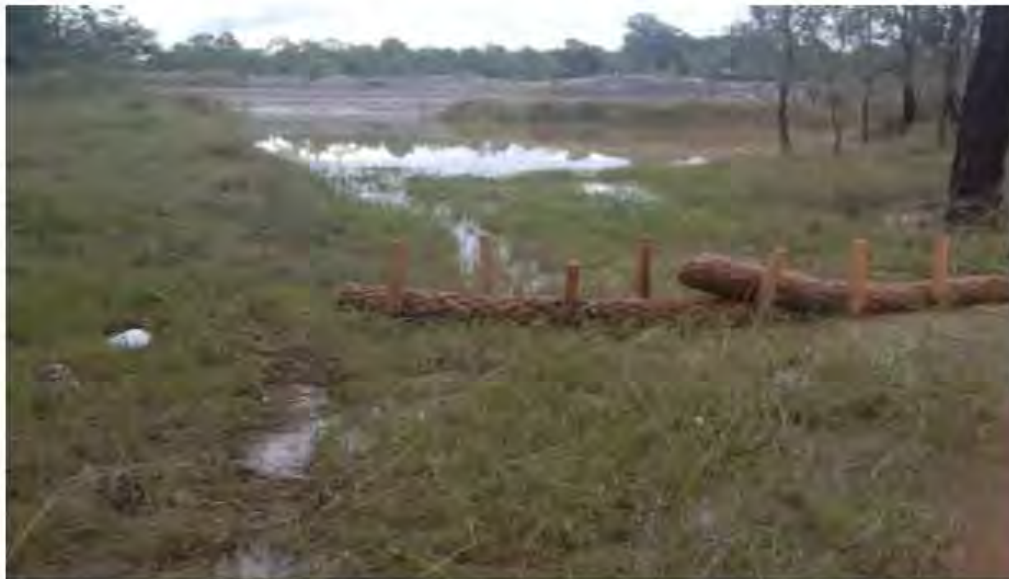
Photograph 1: Sediment Dam North.

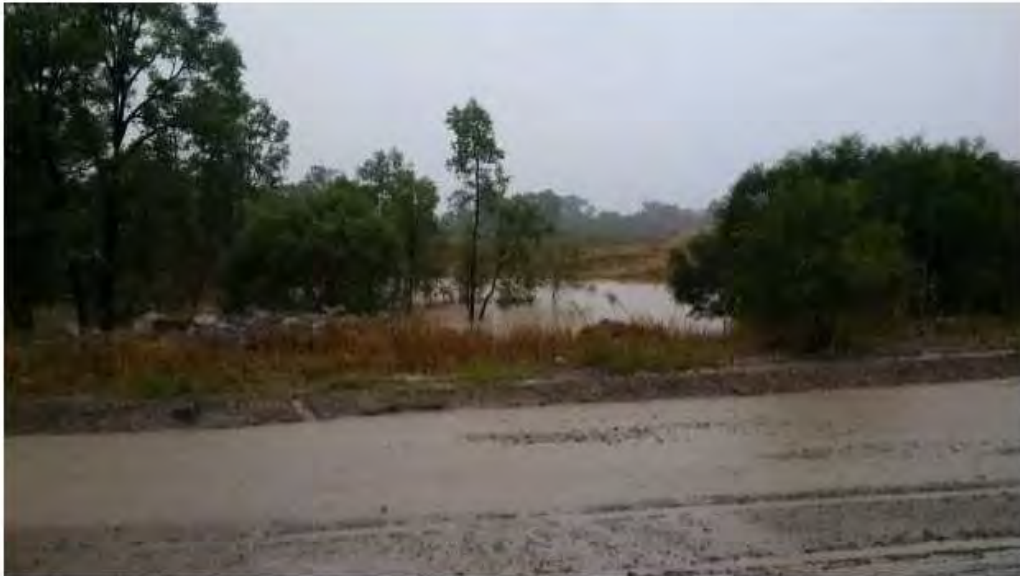
Photograph 1A: Flow in Rix's Creek adjacent to Sediment dam north.

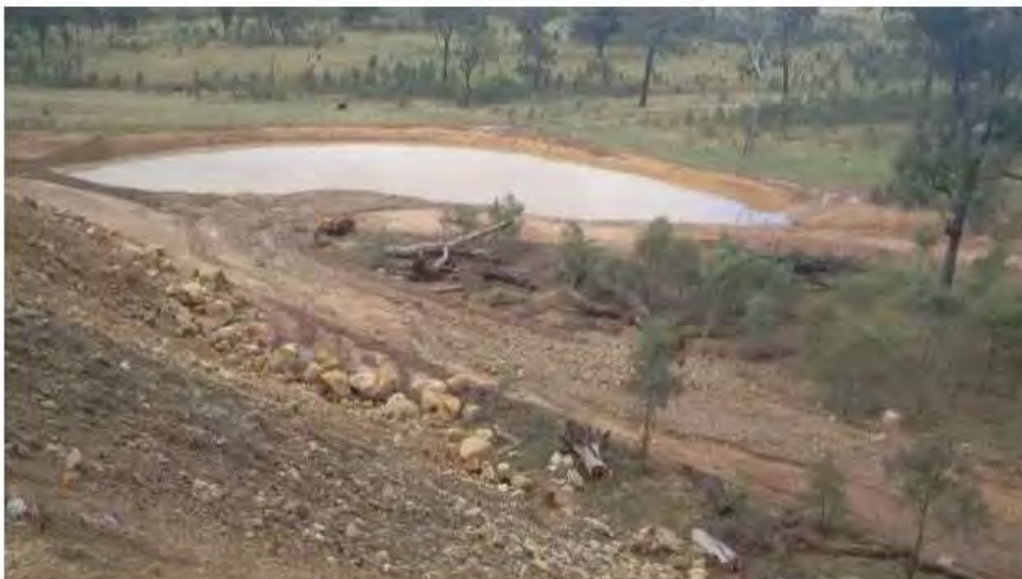
Photograph 2: West Pit out-of-pit-dump Sediment Dam (East).

- ◆ Sediment dam north, Photograph 1,
 - ◆ West Pit out-of-pit-dump Sediment Dam (East), Photograph 2,
 - ◆ West Pit out-of-pit-dump Sediment Dam (West), Photograph 3.

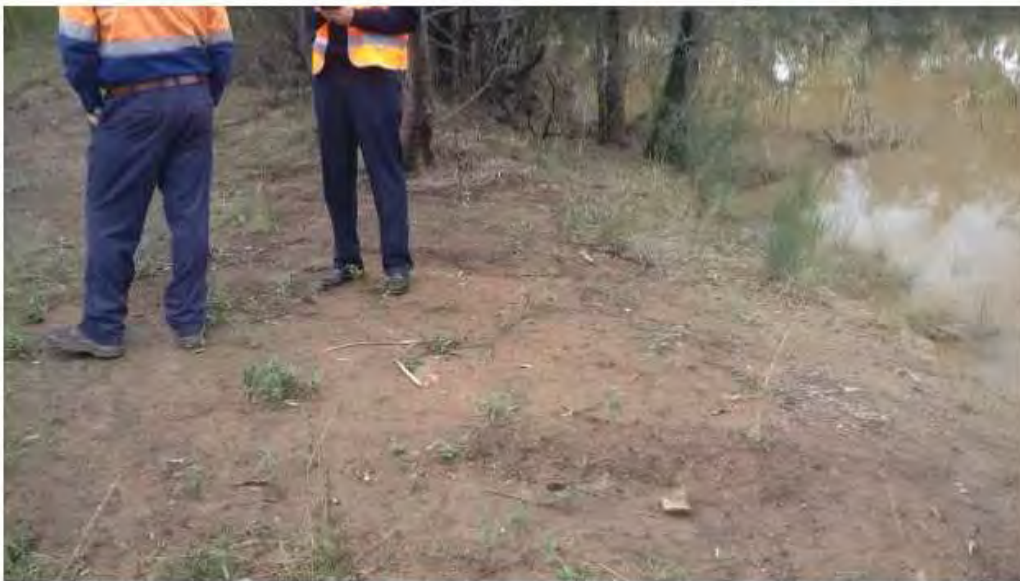
Photograph 4: Clean Water Diversion Dam

- ☐ The clean water diversion dam bank overtopped into the rail loader containment dams. Photograph 4.
- ☐ The capacity of the overflow of the clean water diversion dam had been restricted with vegetation growth and debris collected in the vegetation.
