# ANNUAL REVIEW

## 2016

### RIX'S CREEK Pty Limited

**ANNUAL REVIEW 2016 – RIX’S CREEK COLLIERY**

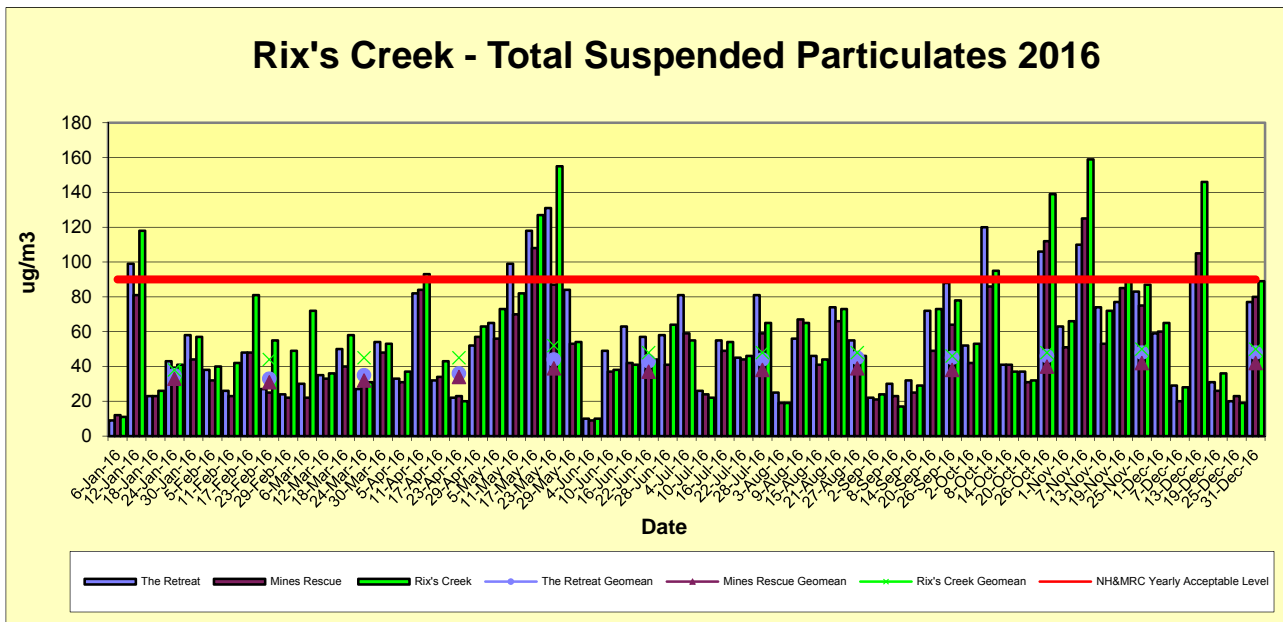
**Figure 16. Total Suspended Particulates 2016**

The average TSP results for 2016 decreased at all of the three sites – Mines Rescue by 2.6  $\mu\text{g}/\text{m}^3$ , Rix’s Creek by 1.7  $\mu\text{g}/\text{m}^3$  and The Retreat by 3.9  $\mu\text{g}/\text{m}^3$  when compared to the 2015 average TSP results. Refer to Table 18 above.

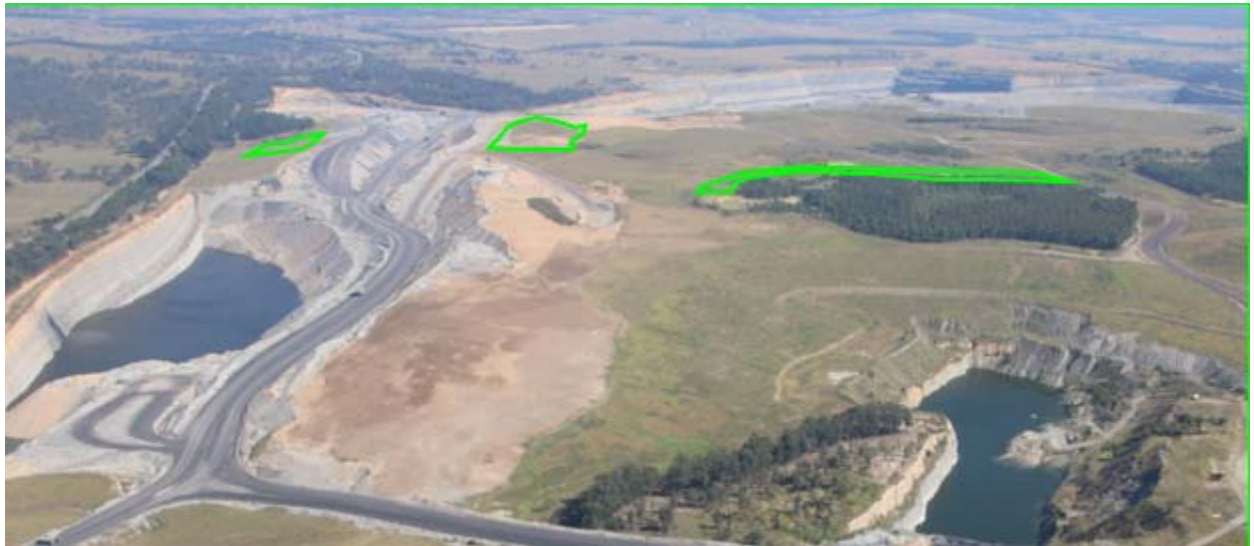
**Plate. 1 Arties Pit – pin dump batter (visible from New England Highway) and RL140 dump – tree seeded areas**

The material used in the construction has no relevant chemical characteristics, acid forming or spontaneous combustion potential. During the seeding process a starter fertiliser was spread at a rate of 100 kg/ha. A cover crop was also applied to minimise the erosion and weed potential. Early indications also show some weed (galenia and scotch thistle) which will be monitored and managed accordingly. To date a low amount of seedlings are emerging due to below average rainfall conditions.

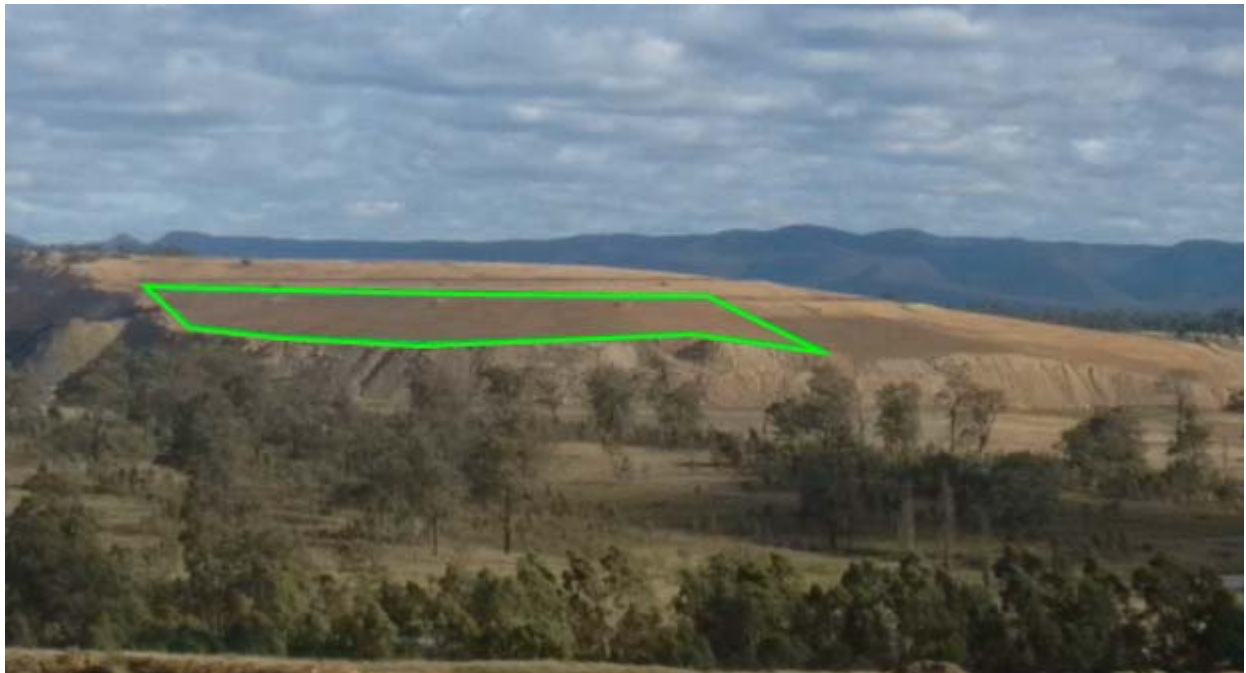
**Plate. 3 West Pit out of pit dump (highway batter) facing south-west across New England Highway**

cover crop was also applied to stabilise the slope and minimise the weed potential. Some rock and timber structures were also created throughout the area as habitat for ground-dwelling creatures.

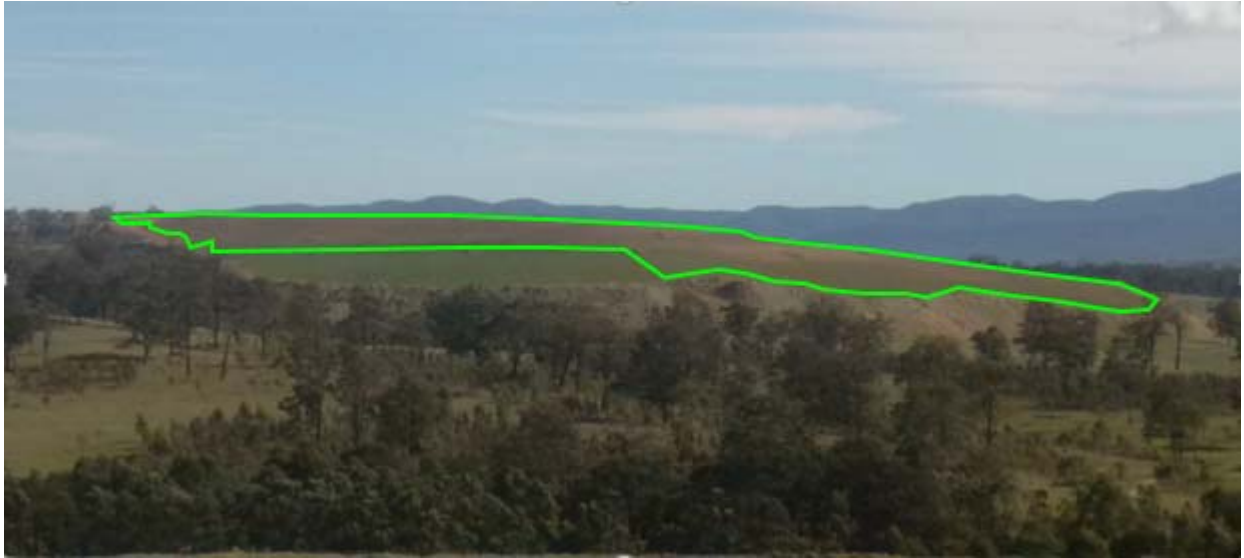
**Plate. 5 West Pit Out of Pit dump facing south-west across New England Highway**

cover crop was also applied to stabilise the slope, minimise the weed potential and provide good visual amenity towards the New England Highway. Some rock and timber structures were also created throughout the area as habitat for ground-dwelling creatures.

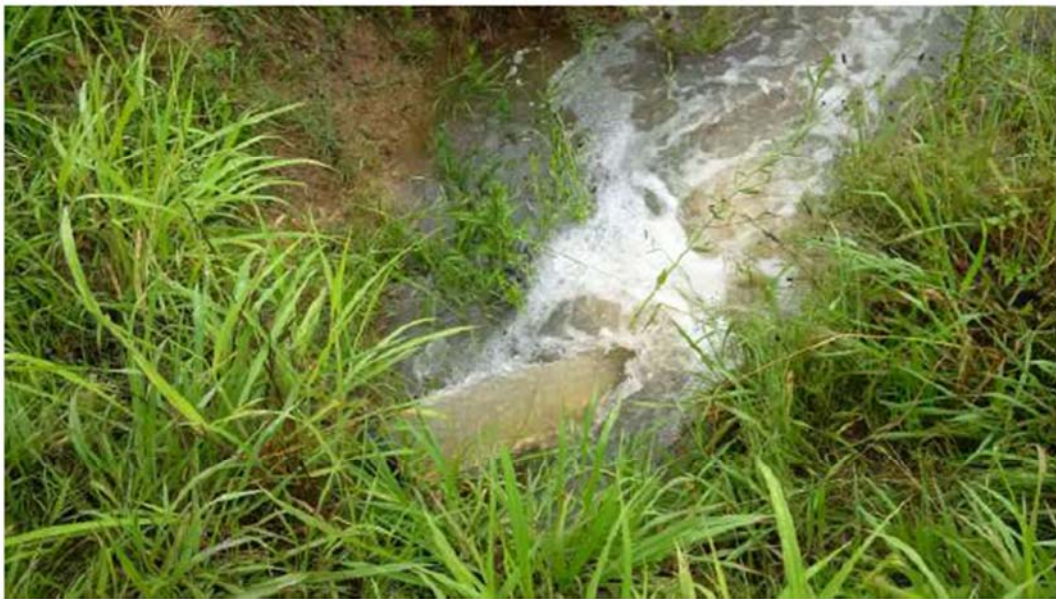
Photograph 1: Rail Loader Containment Dam Overflow.

- ❑ The 142 mm of rain received in December 2015 would have provided recharge to soil moisture. December average rainfall is 74 mm.
- ❑ The above average December rain meant water levels in the rail loader containment dams was still high when the January rainfall event occurred, 141.5 mm rain over four consecutive days. The pump to lower water levels in the dams had been running continuously since mid-December. . Photographs 1 & 1A
- ❑ Review of the storage capacity of the rail loader containment dams using a daily water balance model (Appendix I) indicated they would not have overflowed in this rainfall event or any rainfall event since their construction prior to 1993 from internal catchment runoff.
- ❑ The rail loader containment dams were constructed prior to the commissioning of the rail loader back in 1993.

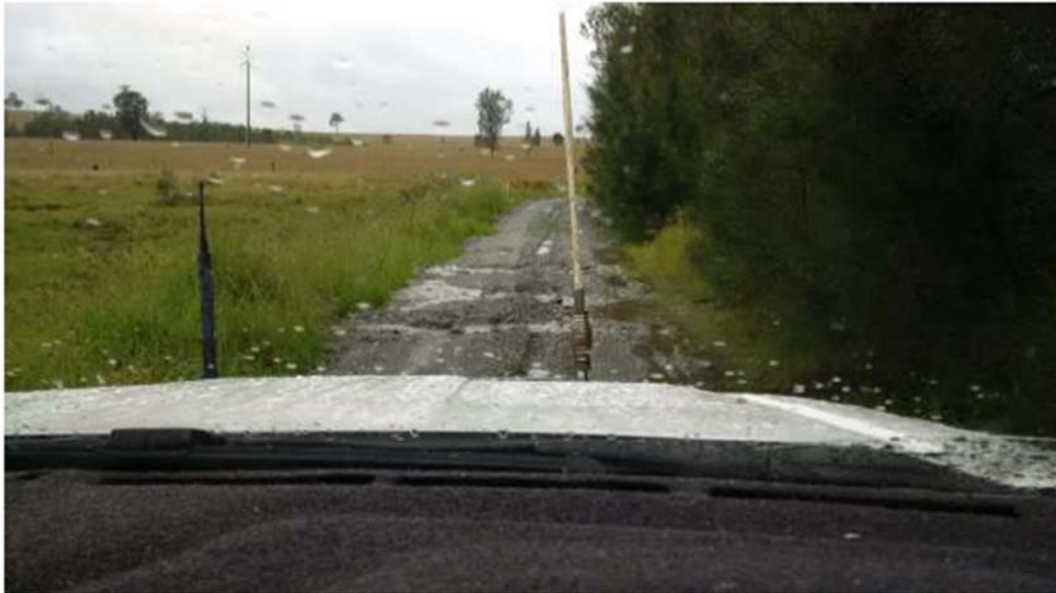
Photograph 1A: Rail Loader Containment Dam Wall Overflow.

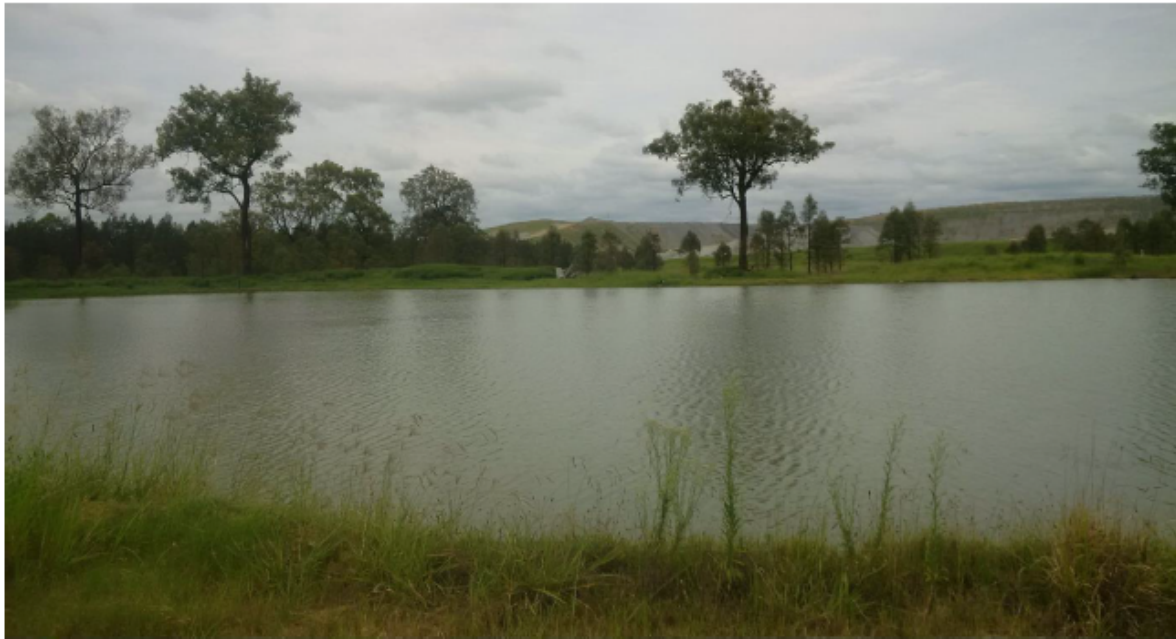
**Photograph 1: Image of DWD3 West Pit storage**

- The 244.5 mm of rain received in January had increased dam levels and soil moisture across site;
- The flow conditions in Rix’s Creek due to recent rainfall made it difficult to find if any water had entered the Creek;
- The additional pumping of water out of the west pit into DWD3 was higher than the DWD3 pump; and
- The low spot in the southern dam wall combined with long vegetation made inspections difficult for shift supervisors reviewing dam levels and an effective overflow back into the west pit.

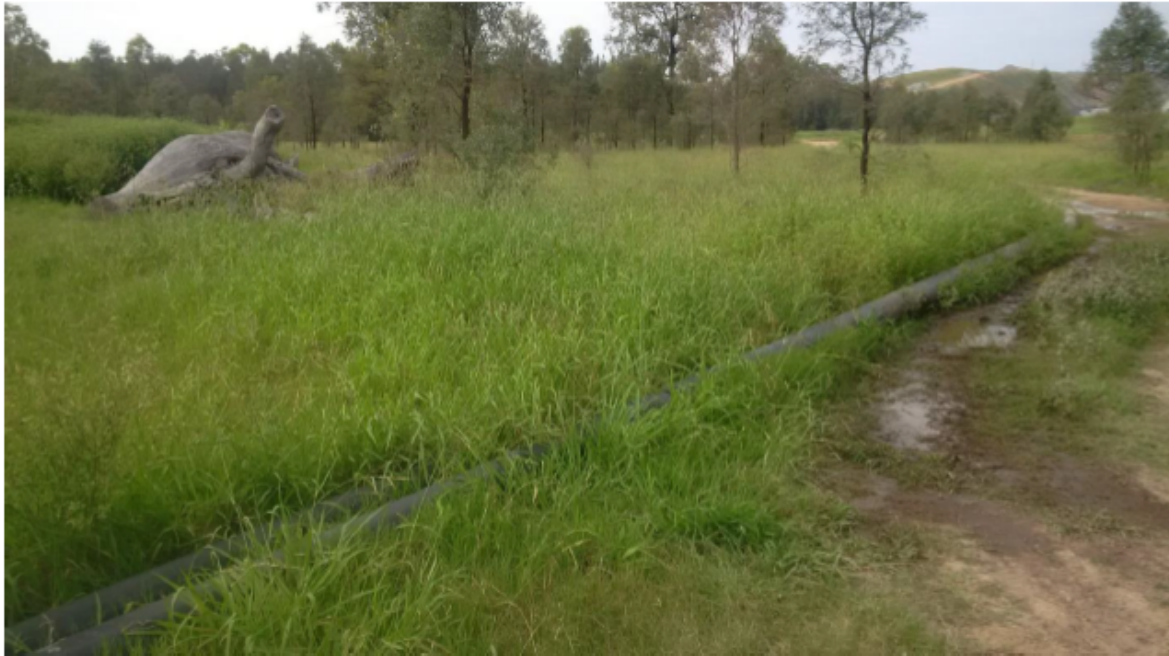
**Photograph 2: Area of potential seepage into Rix’s Creek**
