Rix's Creek Mine 2017 Annual Review

ANNUAL REVIEW 2017 – RIX'S CREEK MINE

Rixs Creek North & Rixs Creek South

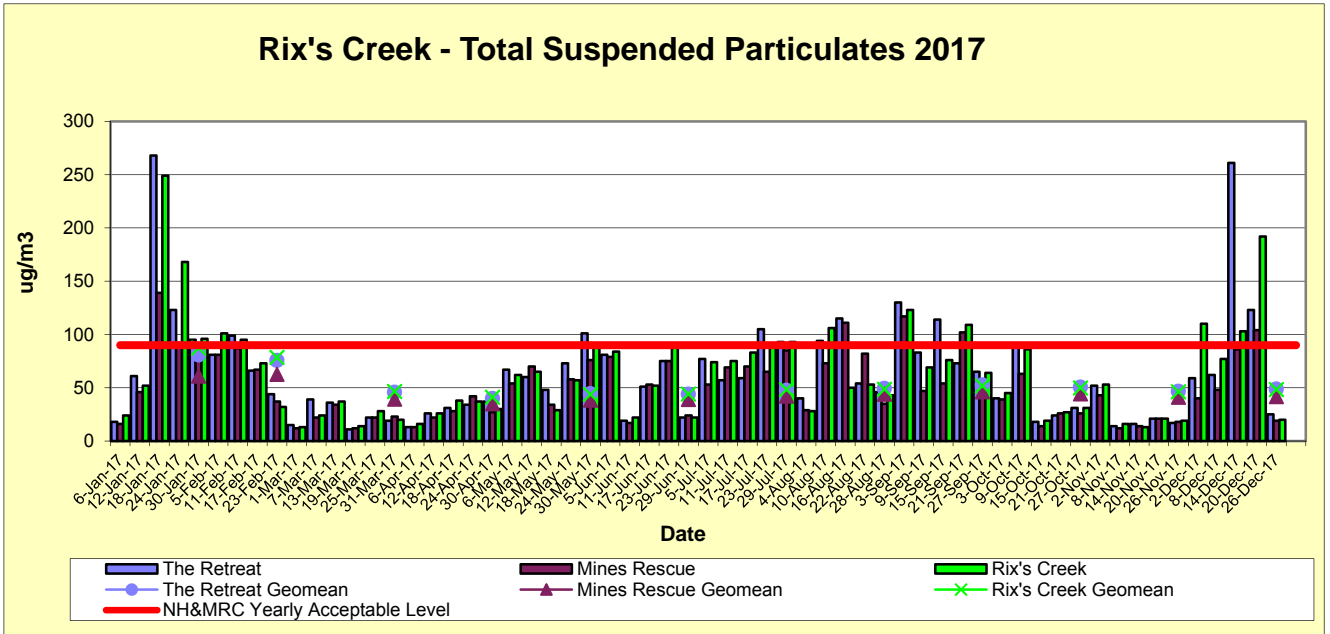
Figure 13 Total Suspended Particulates 2017

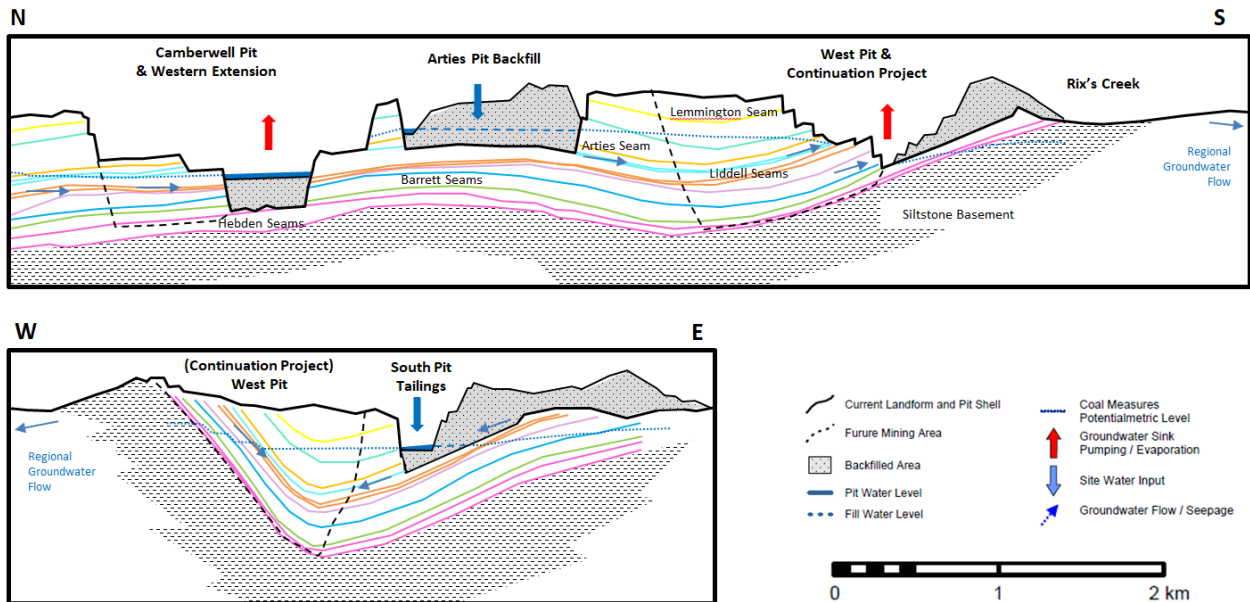
Figure 20 Conceptual Hydrogeological Cross Section

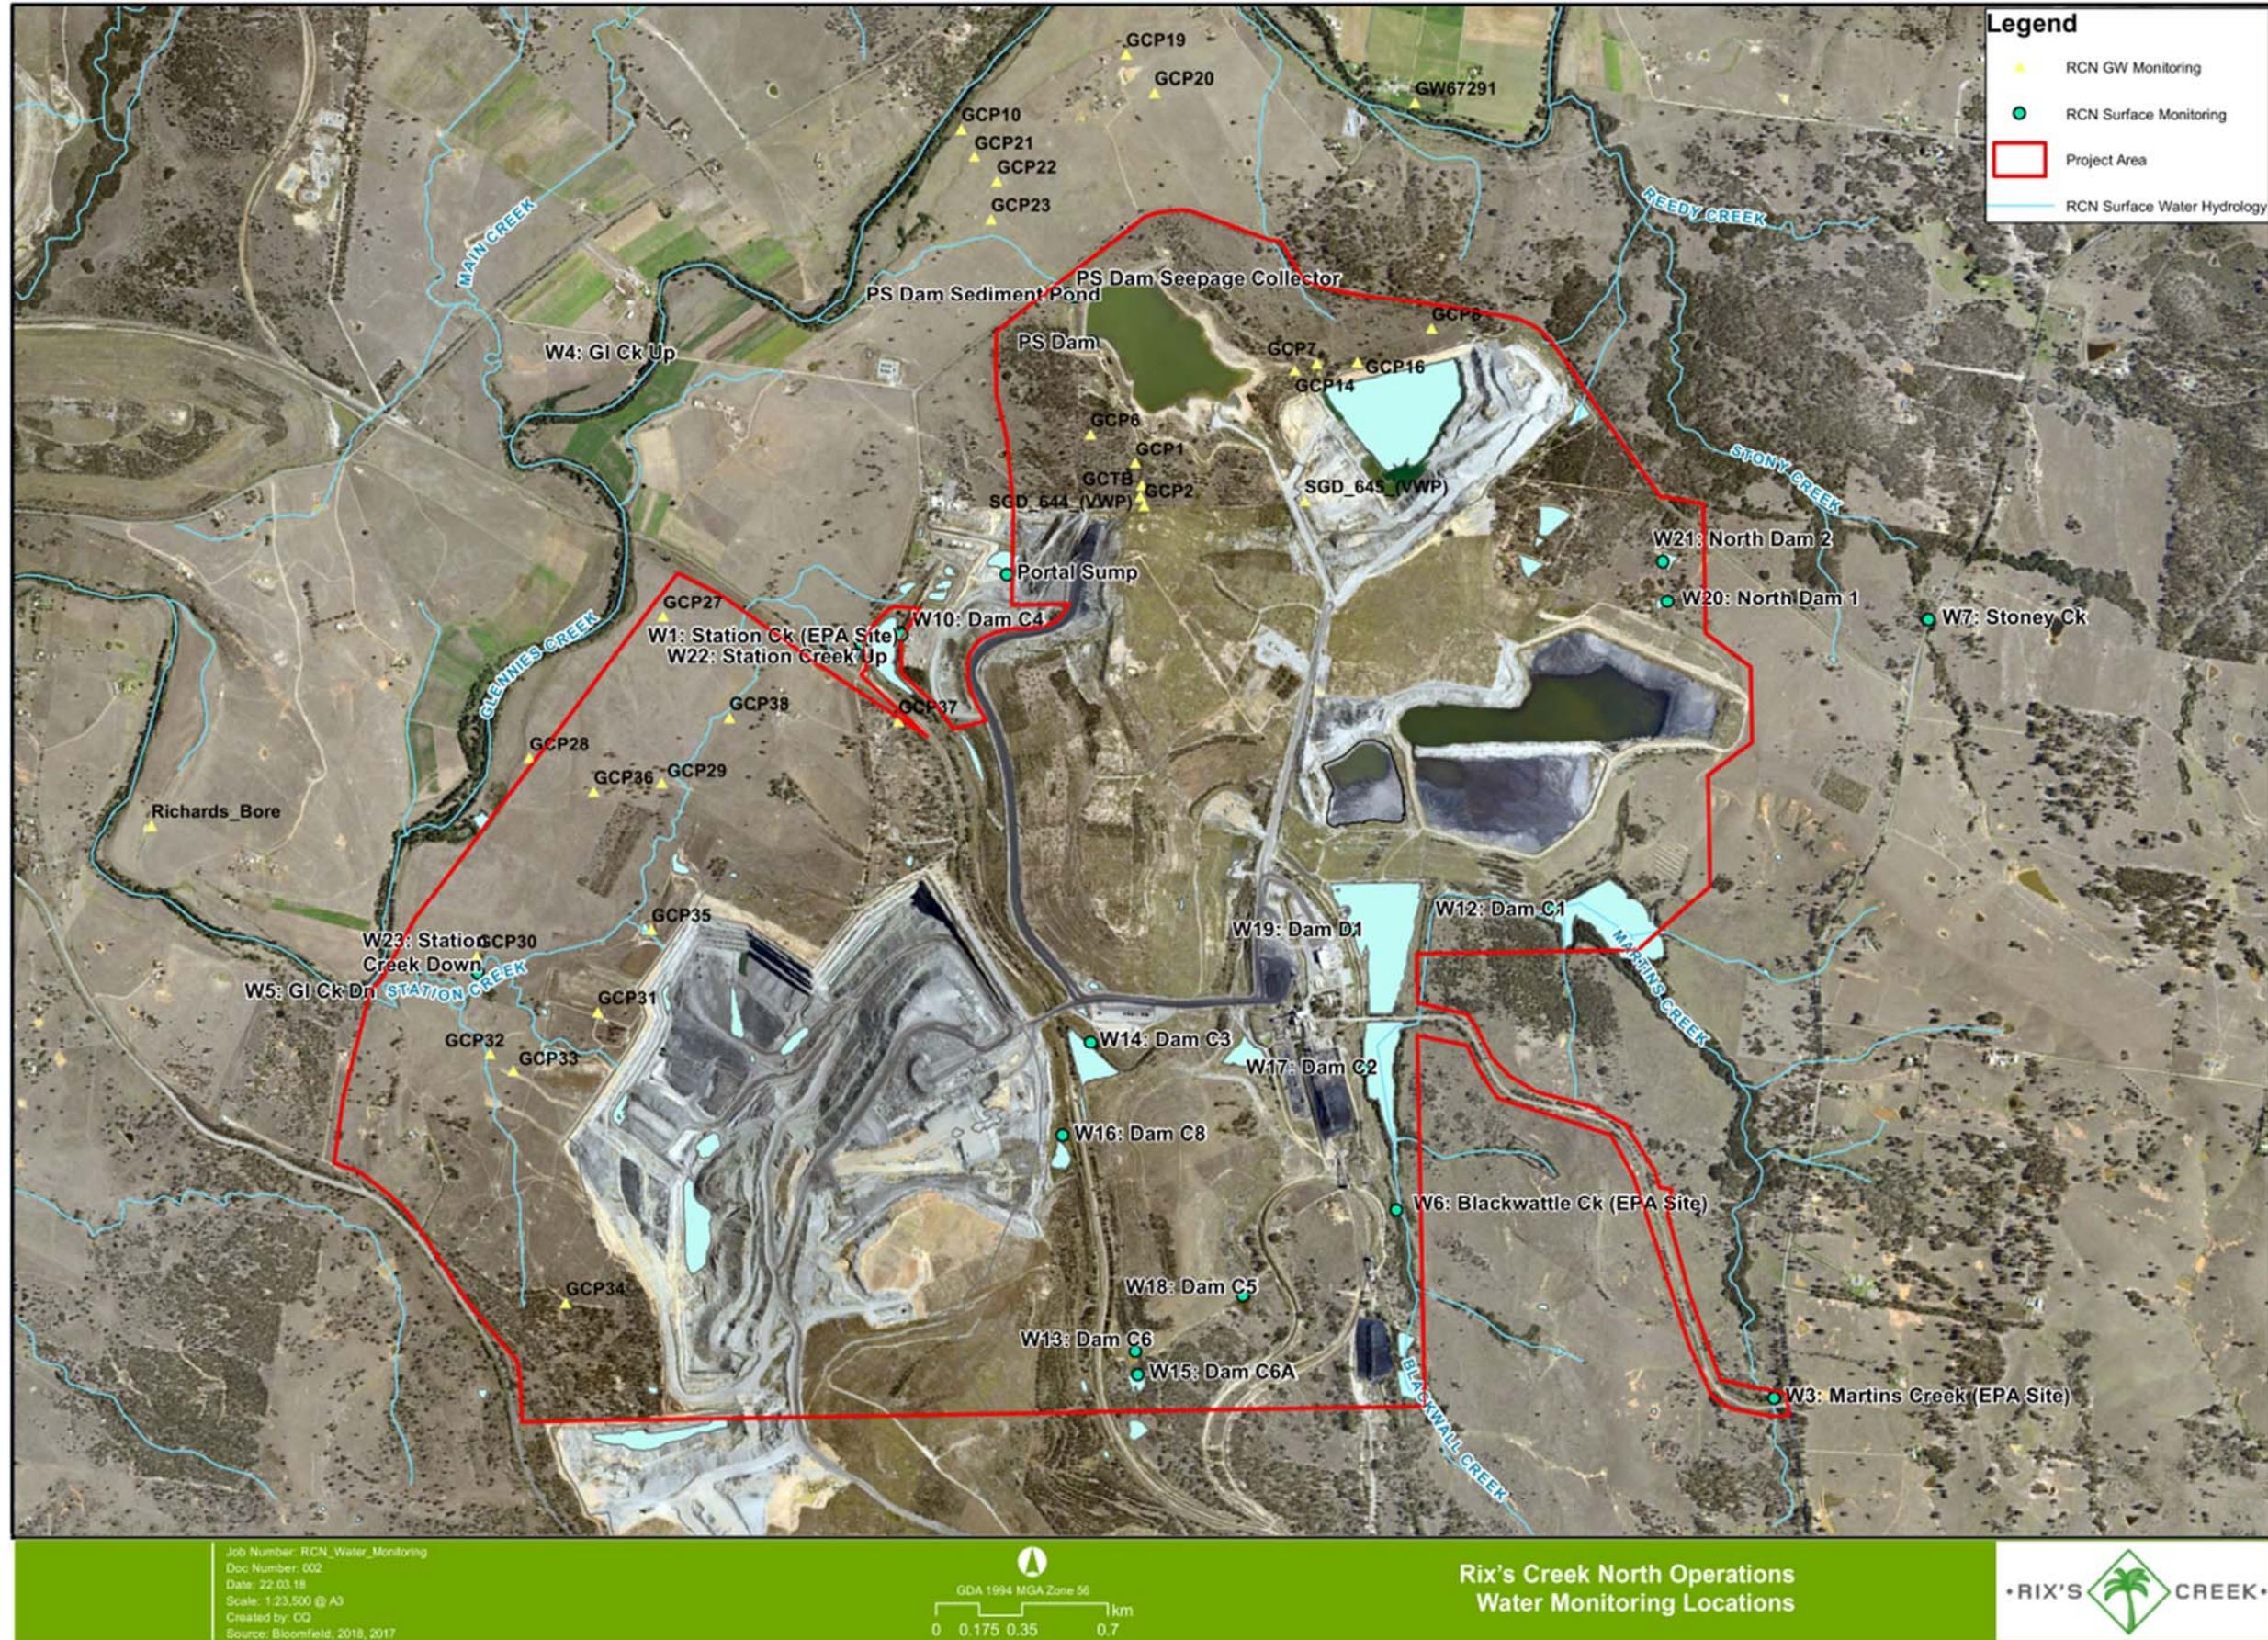
Figure 24. Rix's Creek North Ground and Surface Water Monitoring sites

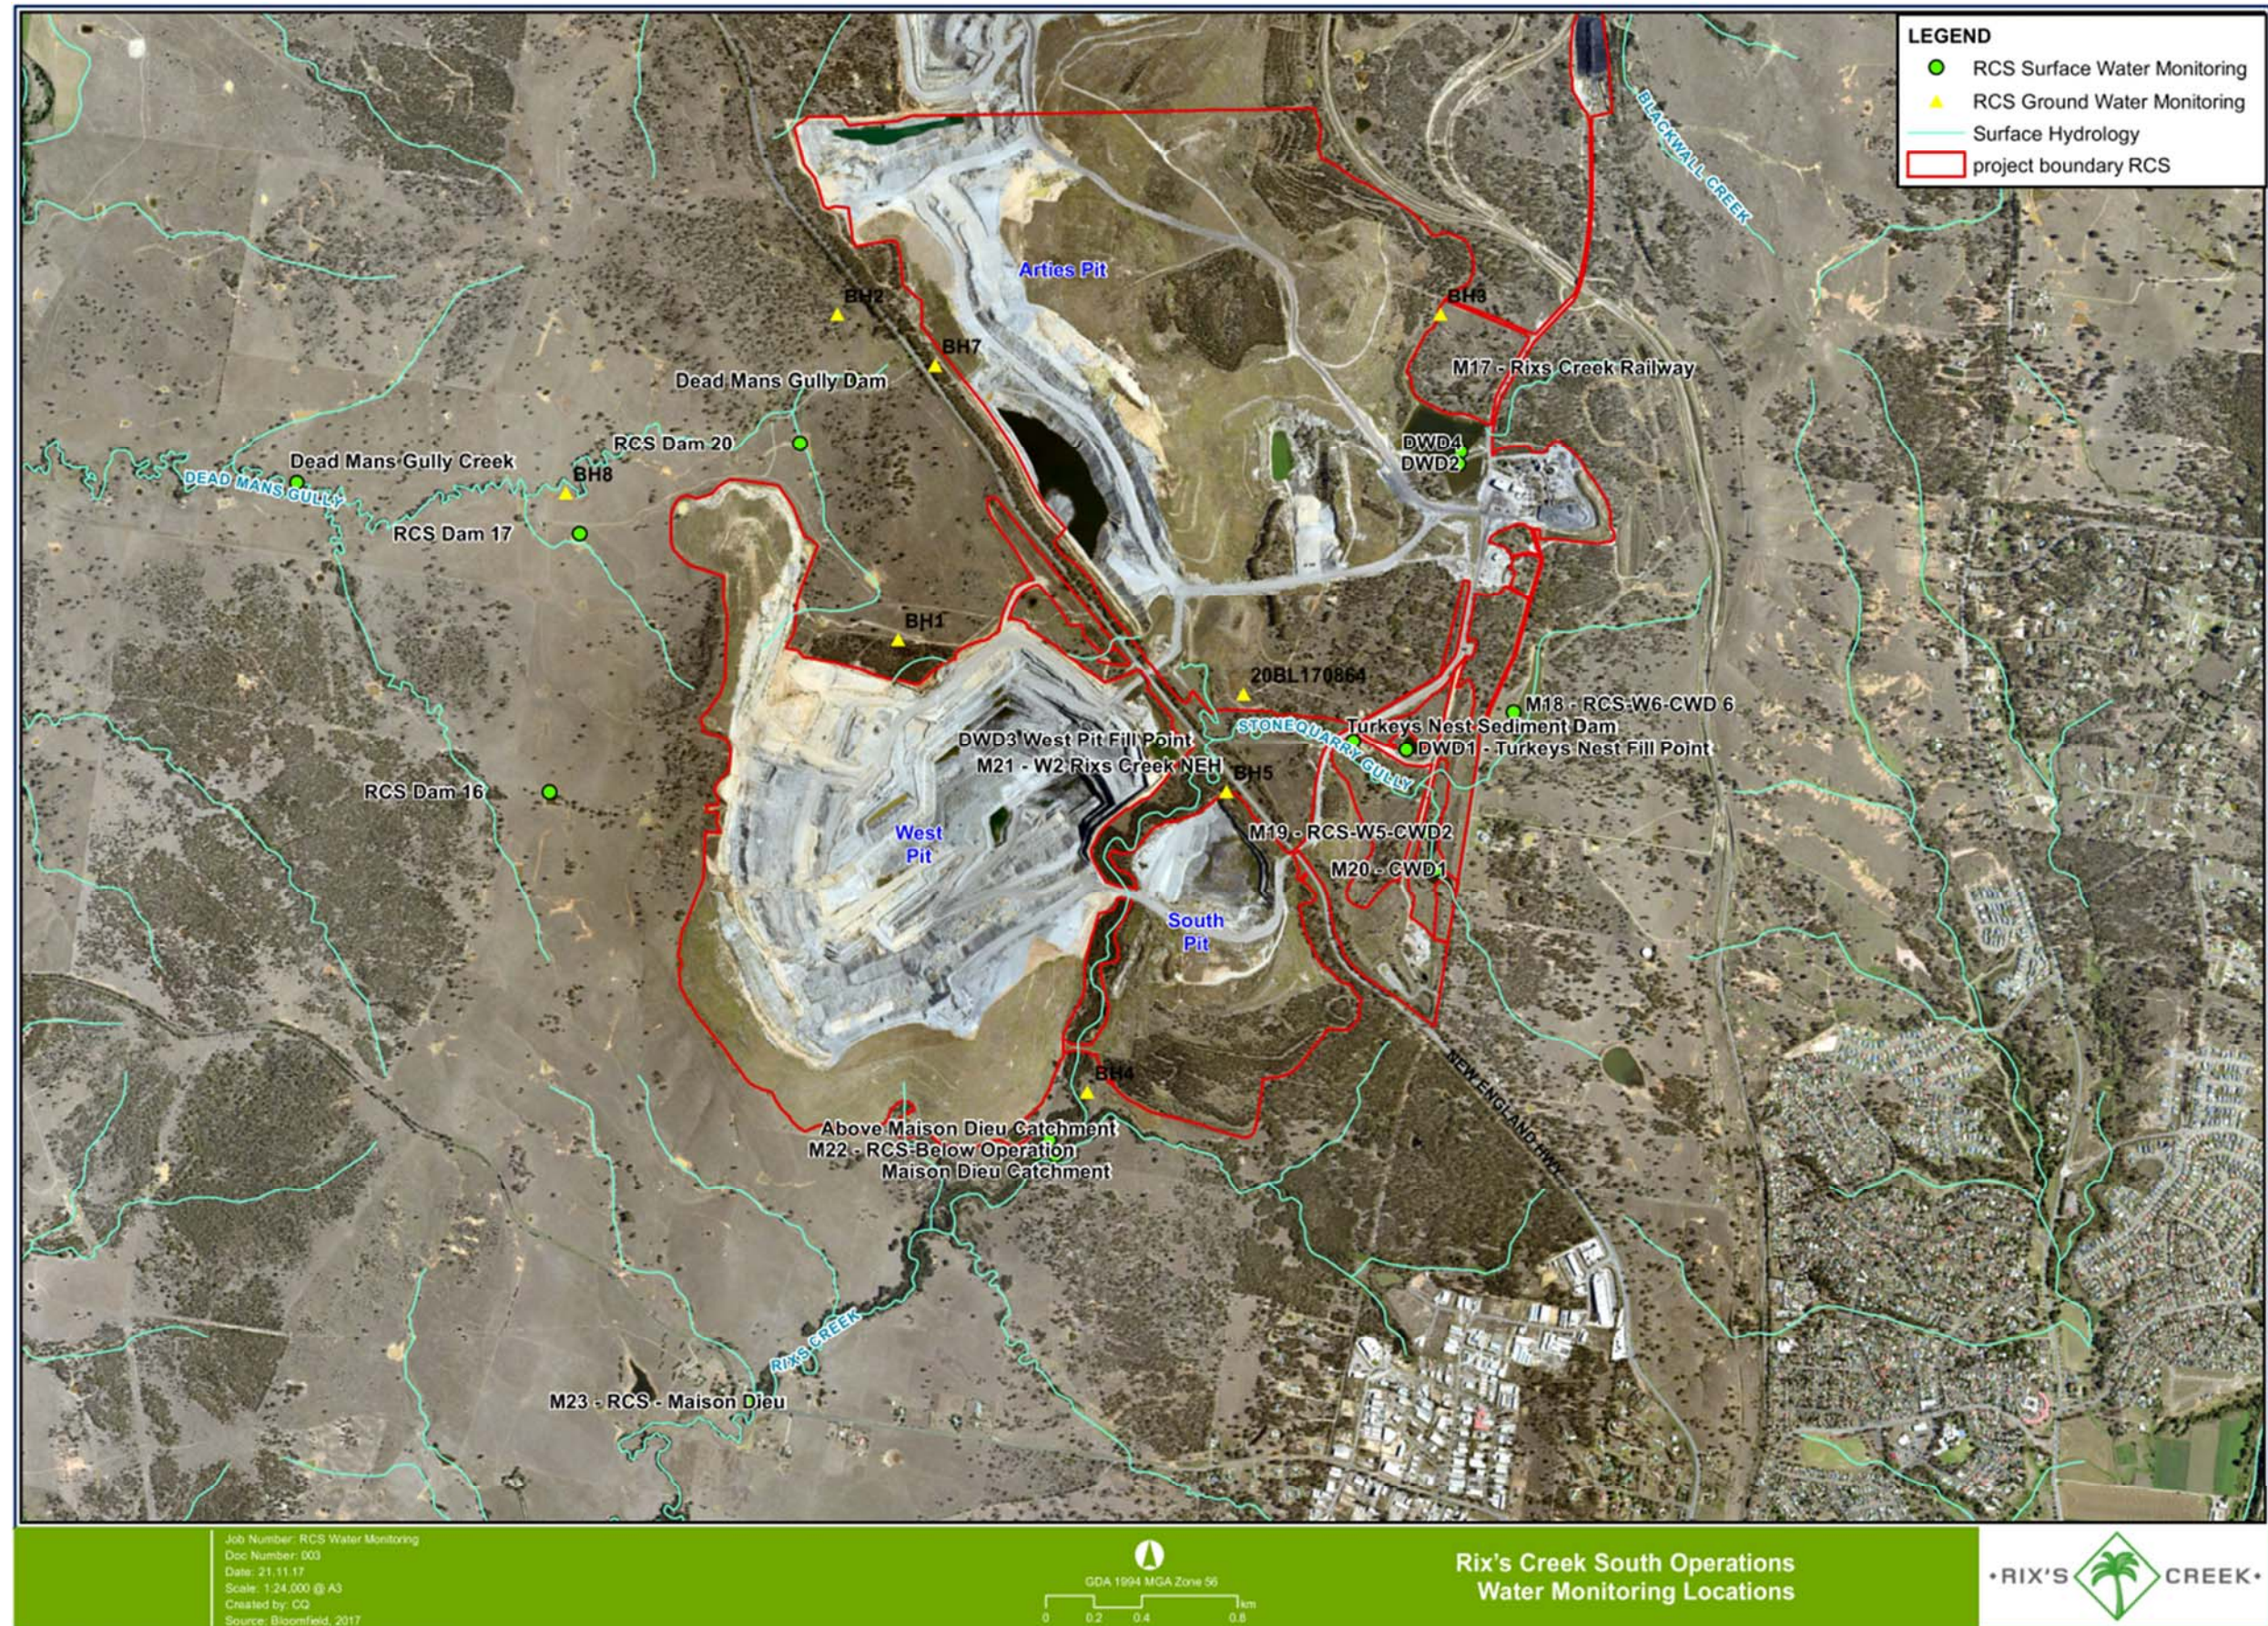
Figure 25. Rix's Creek South Groundwater Monitoring sites

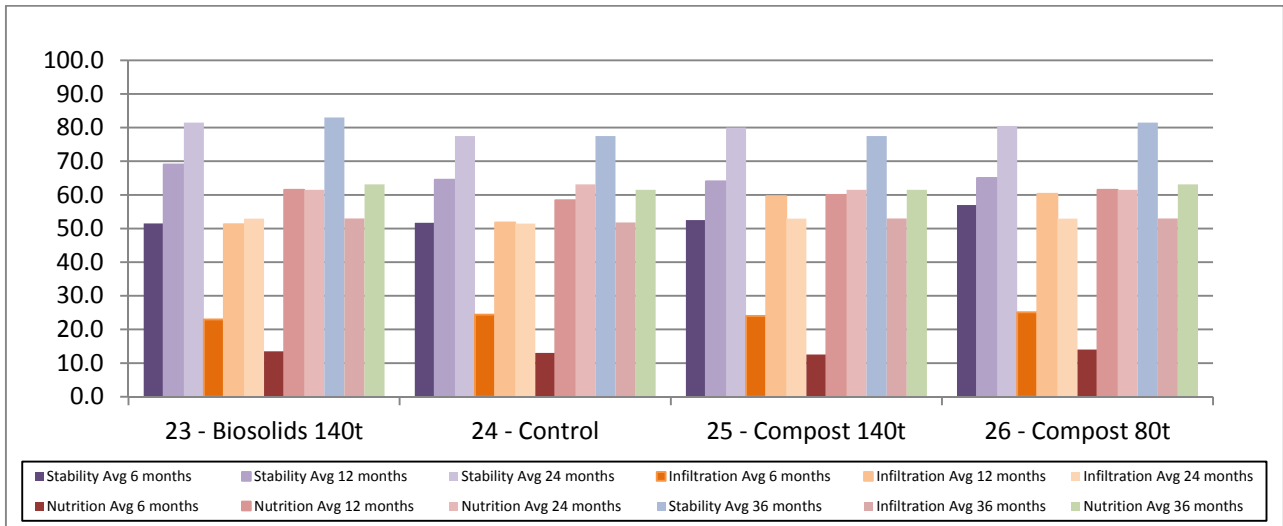
Figure 28 Summary of Rix's Creek 4 ha trial on North Pit Dump.
