Rix's Creek Mine 2018 Annual Review

Rixs Creek North & Rixs Creek South

Name of Operation	Rix's Creek Mine
Name of operator	Bloomfield Collieries Pty Ltd
Development consent / project approval # Rixs Creek North Rixs Creek South	PA 08_0102 DA 49/94
Name of holder of development consent / project approvals	Bloomfield Collieries Pty Ltd
Mining Lease #	CL357, ML1630, ML1648, ML1649, ML1650, ML1651, CL352, ML1432 & ML1725
	Bloomfield Collieries Pty Ltd
Water License #	20WA219698, 20BL172249, 20BL170863, 20BL170864
Name of holder of water license	Bloomfield Collieries Pty Ltd
MOP / RMP start date Rixs Creek North Rixs Creek South	1/12/2018 15/3/2013
MOP / RMP end date Rixs Creek North Rixs Creek South	31/12/2020 15/3/2020
Annual Review start date	1/1/2018
Annual Review end date	31/12/2018
I, Chris Quinn, certify that this audit report is a true and accurate record of the compliance status of Rix's Creek Mine for the period 1/1/2018 – 31/12/2018 and that I am authorised to make this statement on behalf of Bloomfield Collieries Pty Ltd.

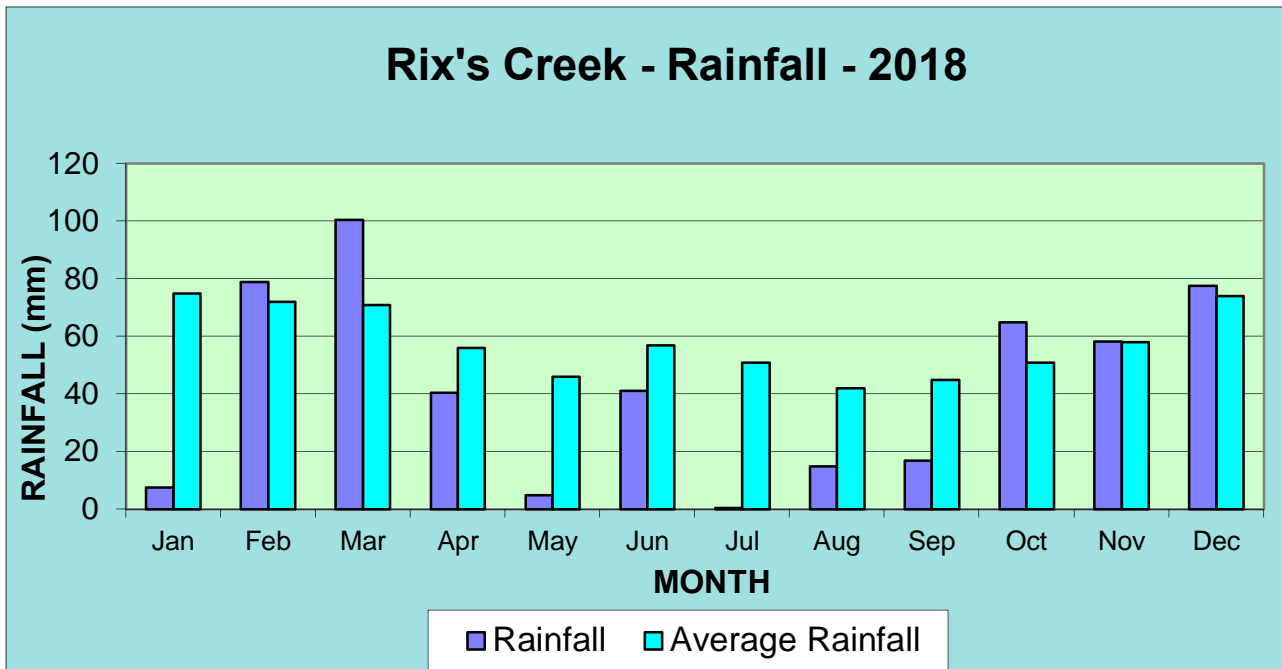
Figure 4 Annual Rainfall 2018

RIX’S CREEK ANNUAL RAINFALL 2018													
Month	January	February	March	April	May	June	July	August	September	October	November	December	TOTAL
Total Rainfall	7.6	79	100.5	40.5	5	41.25	0.5	15	17	64.9	58.25	77.5	507
Average Rainfall	75	72	71	56	46	57	51	42	45	51	58	74	698
Wet days (>0.5 mm rainfall)	4	7	7	7	1	7	1	5	4	7	5	9	64

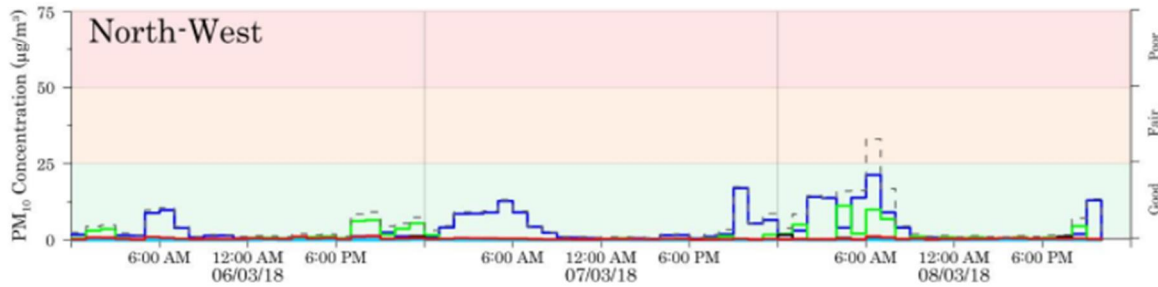
Figure 10 Example of dust forecasting tool to assist operations during 2017

Forecast Date: 6 Mar 2018 - 8 Mar 2018

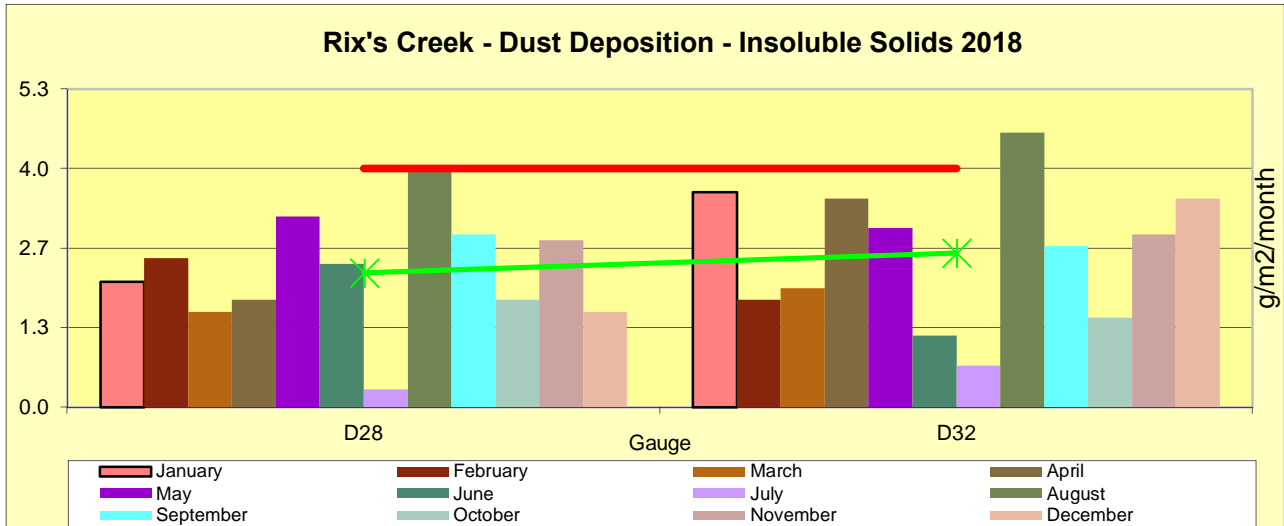
Figure 11 Rix's Creek Insoluble Solids Dust Deposition 2018

Figure 11 displays the individual monthly insoluble solids deposition rates for each gauge and annual average deposition result in g/m²/month. There were no contaminated samples recorded in 2018.

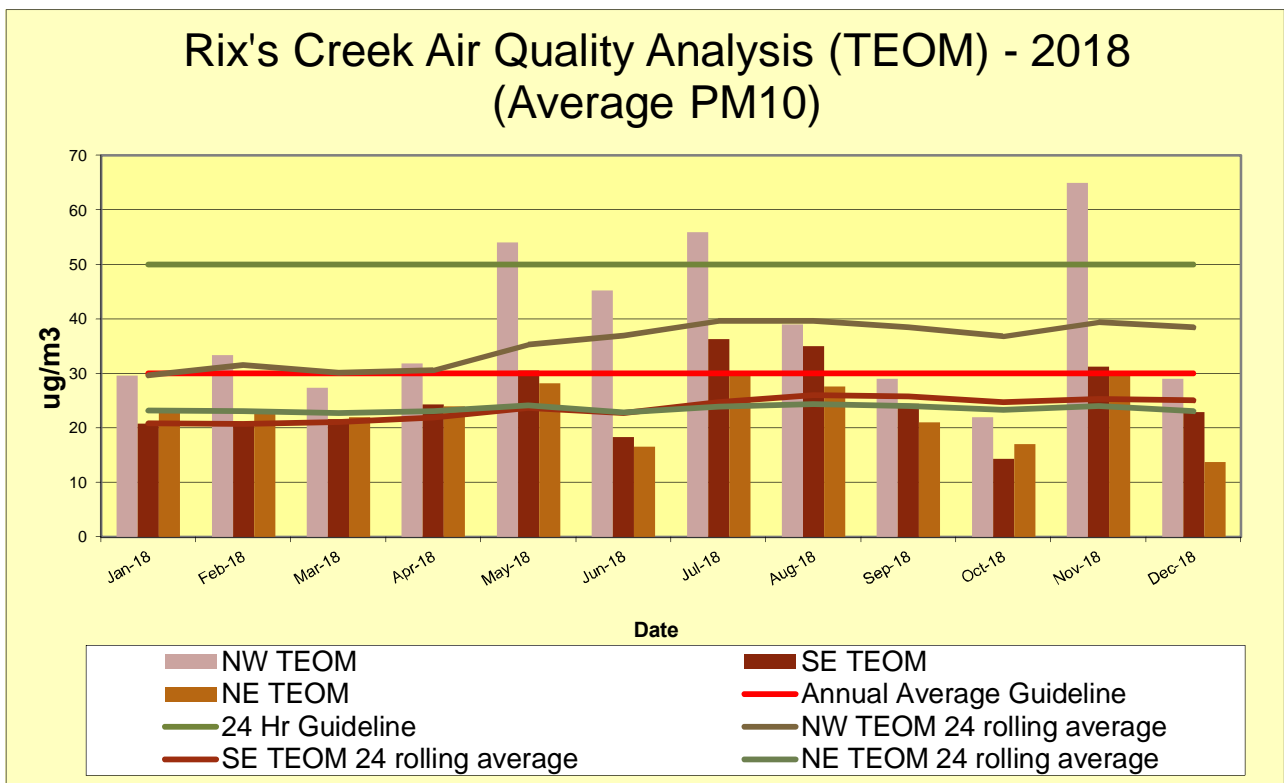
Figure 12 Particulate Matter less than 10 Micron Monthly Average and 12 Month Rolling Averages 2018 - TEOM

The Camberwell Upper Hunter Air Monitoring Network (UHAQMN) monitor recorded an annual average of 31.1 ug/m3 for the 2018 reporting period, an increase from 27.4 ug/m3 recorded for the 2017 reporting period. The Singleton NW Hunter Air Monitoring Network (UHAQMN) monitor recorded an annual average of 26.9 ug/m3 for the 2018 reporting period, an increase from 22.7 ug/m3 recorded for the 2017 reporting period.

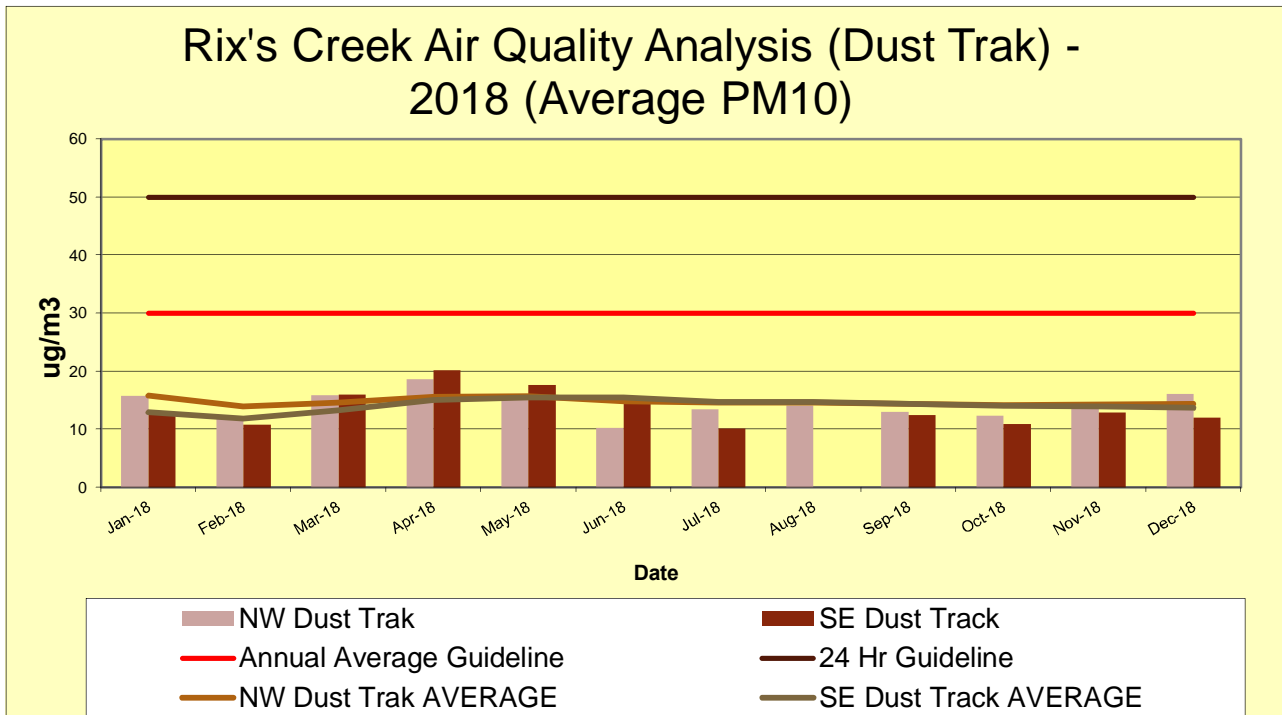
Figure 13 Particulate Matter less than 10 Micron Monthly Average and 12 Month Rolling Averages 2018 – DustTrak

During the 2018 reporting period both Dust Trak RCS NW and Dust Trak RCS SE recorded average monthly results below 50 ug/m3. The annual average for Dust Trak RCS NW in 2018 was 14.3 ug/m3 and Dust Trak RCS SE recorded an annual average result of 13.7 ug/m3.

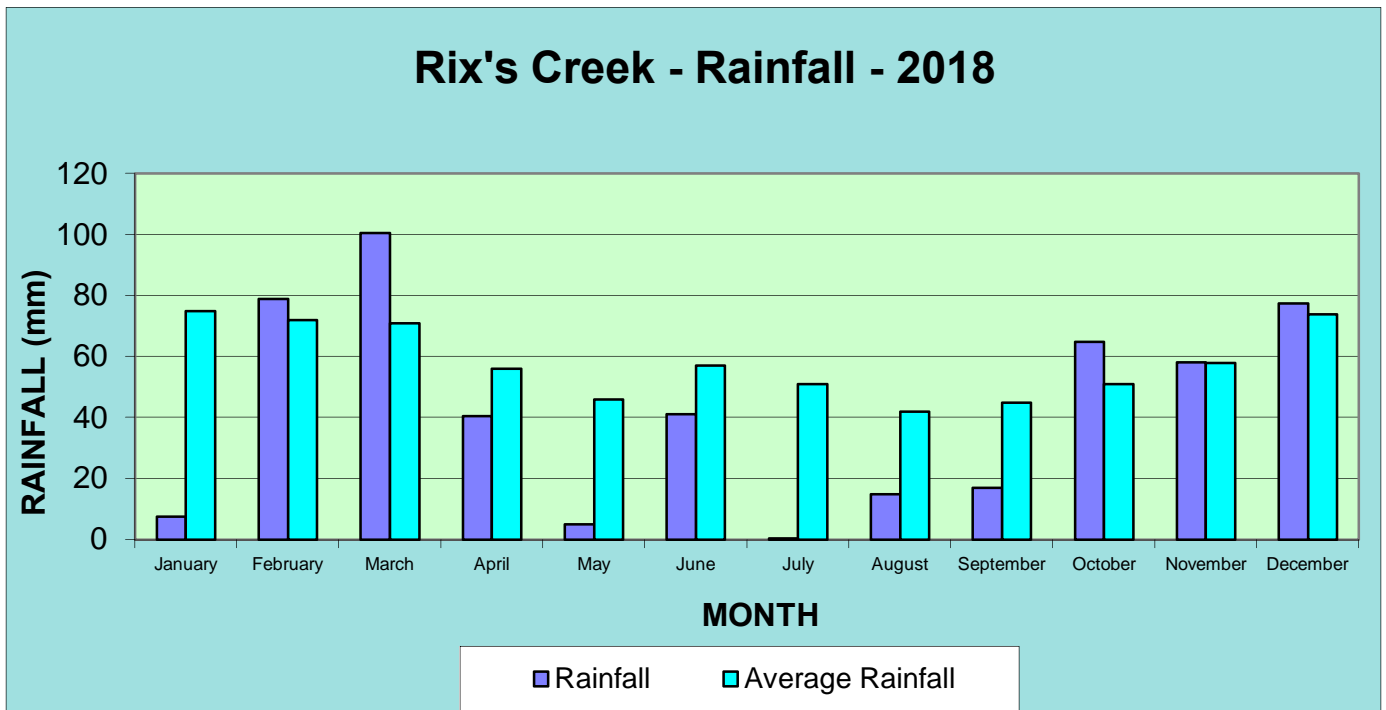
Figure 17 Annual Rainfall at Rix’s Creek 2018

- “ Over the review period, the highest rainfall events at all stations occurred in February and March 2018 which were the result of storm events.
- “ 2018 annual rainfall at Rixs Creek was 507mm, which is significantly lower than the long-term average of 698mm.

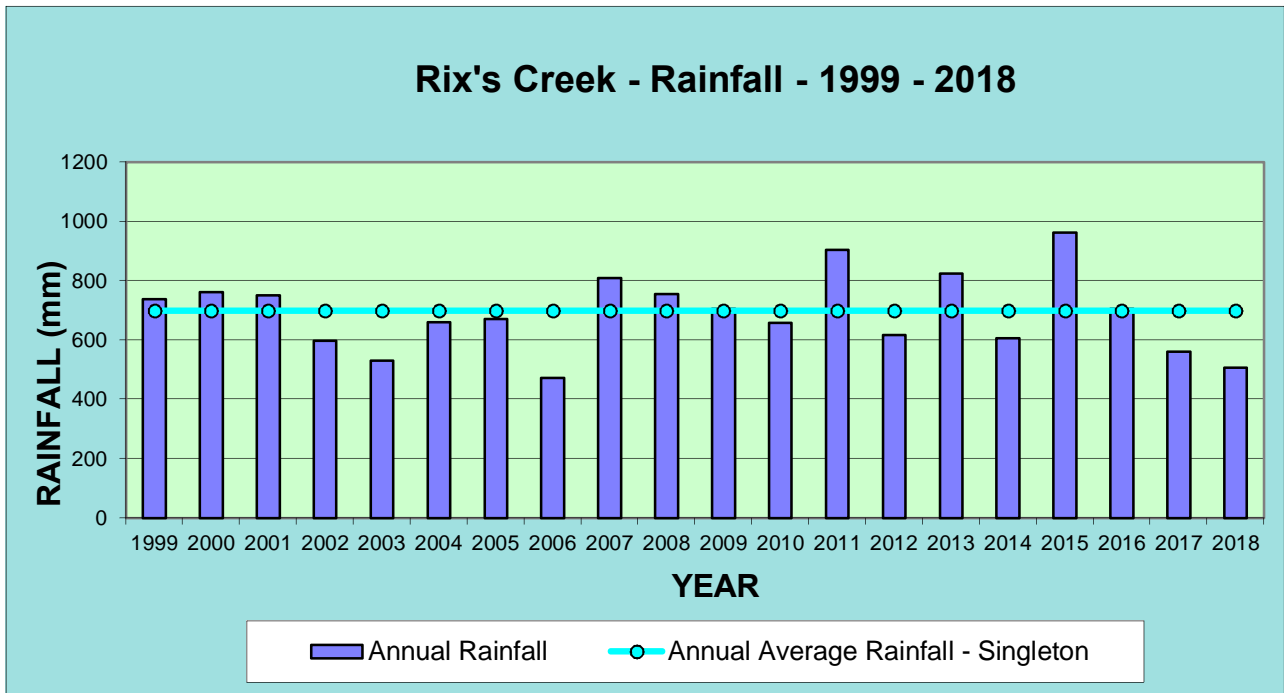
Figure 18 Annual rainfall at Rix’s Creek 1999-2018

Annual rainfall results are plotted for the last 19 years and are presented in Figure 18.
