# Rix's Creek Mine

## 2020 Annual Review

## **ANNUAL REVIEW 2020 – RIX’S CREEK MINE**

Rixs Creek North & Rixs Creek South

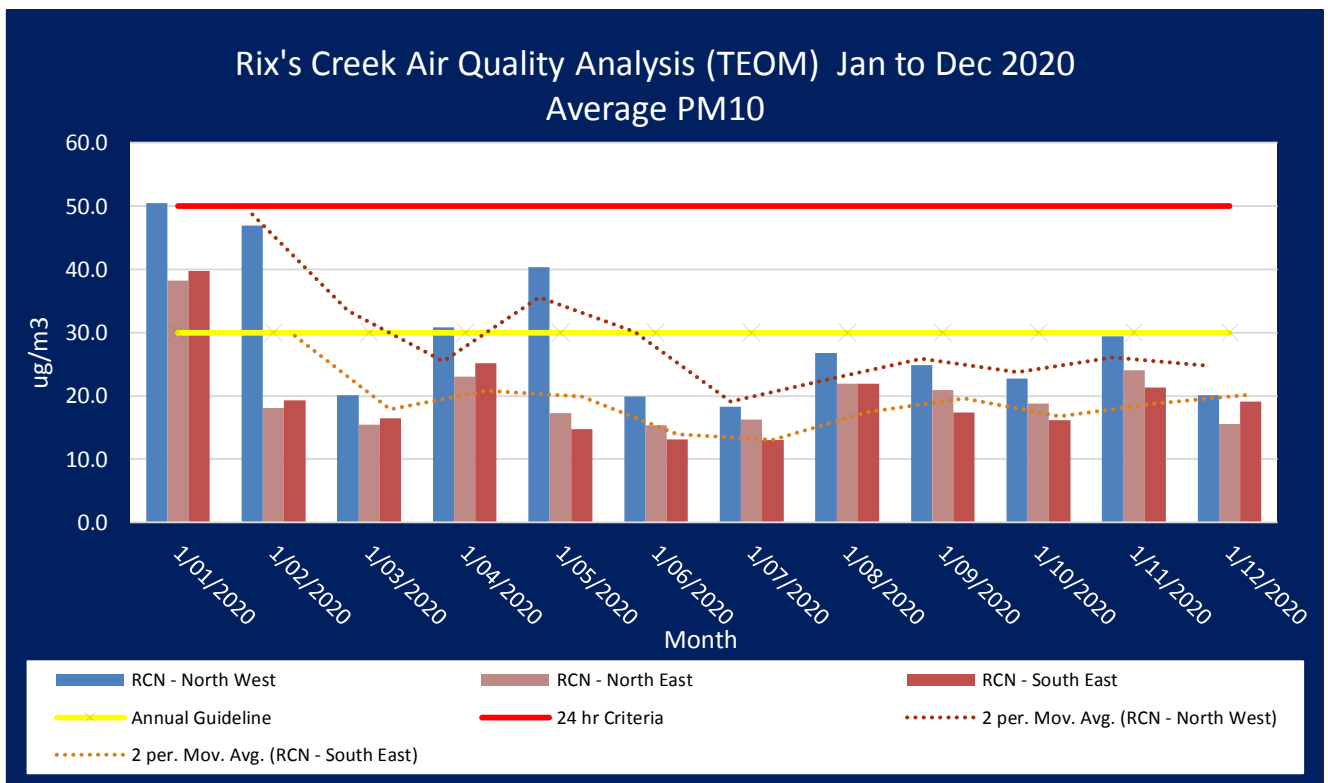
**Figure 12 Particulate Matter less than 10 Micron Monthly Average and 12 Month Rolling Averages 2020 - TEOM**

The Camberwell Upper Hunter Air Monitoring Network (UHAQMN) monitor recorded an annual average of 24.3ug/m3 for the 2020 reporting period, a decrease from 39.9 ug/m3 recorded for the 2019 reporting period. The Singleton NW Hunter Air Monitoring Network (UHAQMN) monitor recorded an annual average of 22.2 ug/m3 for the 2020 reporting period, a decrease from 34.6 ug/m3 recorded for the 2019 reporting period.
