Rix's Creek Mine

2021 Annual Review

Rixs Creek North & Rixs Creek South

Name of Operation	Rix’s Creek Mine
Name of operator	Bloomfield Collieries Pty Ltd
Development consent / project approval # Rixs Creek North Rixs Creek South	PA 08_0102 SSD6300 & DA49/94
Name of holder of development consent / project approvals	Bloomfield Collieries Pty Ltd
Mining Lease #	CL357, ML1630, ML1648, ML1649, ML1650, ML1651, CL352, ML1432, ML1725 & ML 1803
	Bloomfield Collieries Pty Ltd
Water License #	WAL41500, WAL41555, WAL40777, 20BL170864
Name of holder of water license	Bloomfield Collieries Pty Ltd
MOP / RMP start date Rixs Creek Mine	1/12/2019 – 30/11/2022
Annual Review start date	1/1/2021
Annual Review end date	31/12/2021
I, Chris Quinn, certify that this audit report is a true and accurate record of the compliance status of Rix’s Creek Mine for the period 1/1/2021 – 31/12/2021 and that I am authorised to make this statement on behalf of Bloomfield Collieries Pty Ltd.	
Name of authorised reporting officer	Chris Quinn

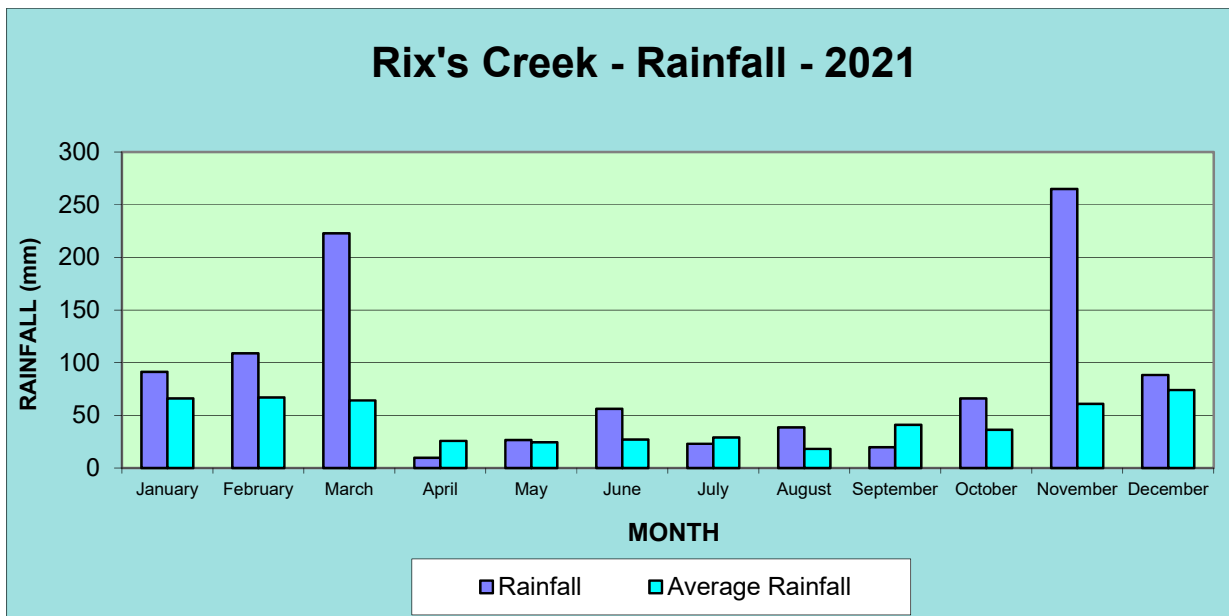
Figure 4 Annual Rainfall 2021

RIX’S CREEK ANNUAL RAINFALL 2021													
Month	January	February	March	April	May	June	July	August	September	October	November	December	TOTAL
Total Rainfall	91.4	109	222.8	9.7	26.6	56.2	23	38.6	19.8	66.0	265	88.4	1,016.5
Average Rainfall	66	67	64.2	25.7	24.5	27	29	18.2	41	36.3	60.9	74	533.8
Wet days (>0.5 mm rainfall)	14	17	17	9	11	10	9	6	9	10	20	12	144

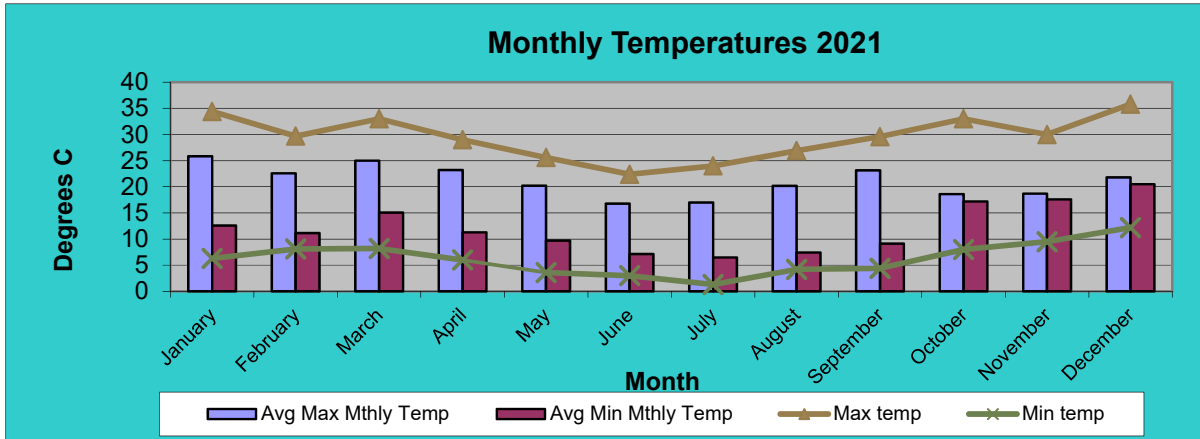
Figure 5 Average Monthly Maximum & Minimum Temperature 2021

The maximum temperature of 35.8°C occurred in December and the minimum temperature of 1.3°C was recorded in July. **Figure 5** shows the monthly average maximum and minimum temperatures for the site as well as the maximum and minimum recorded temperatures.

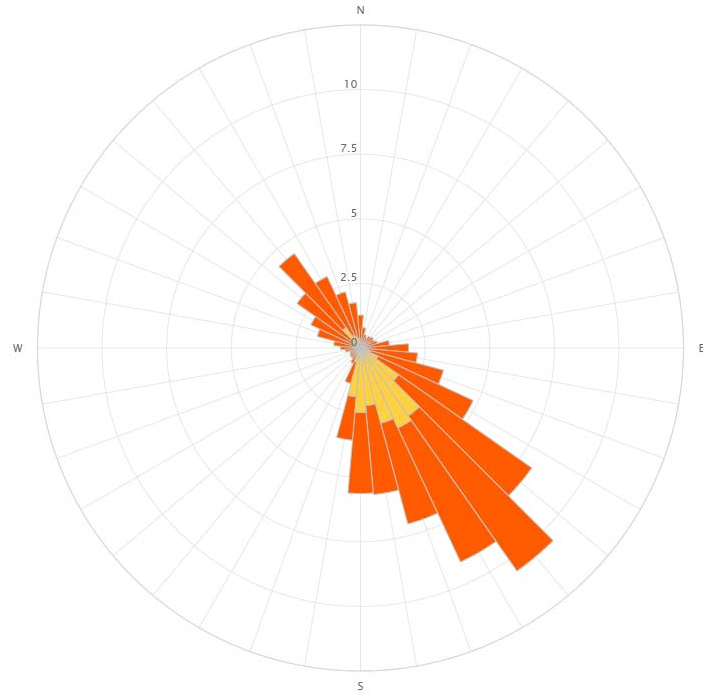
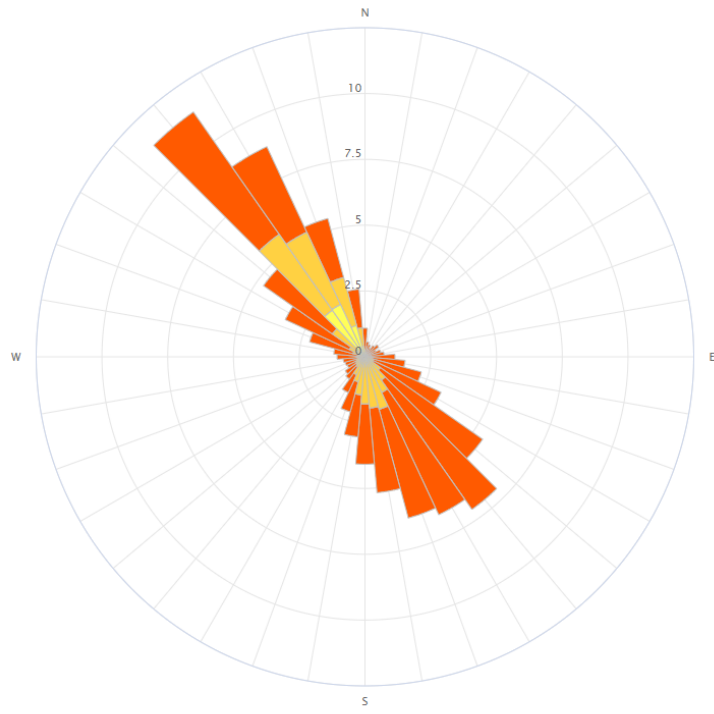
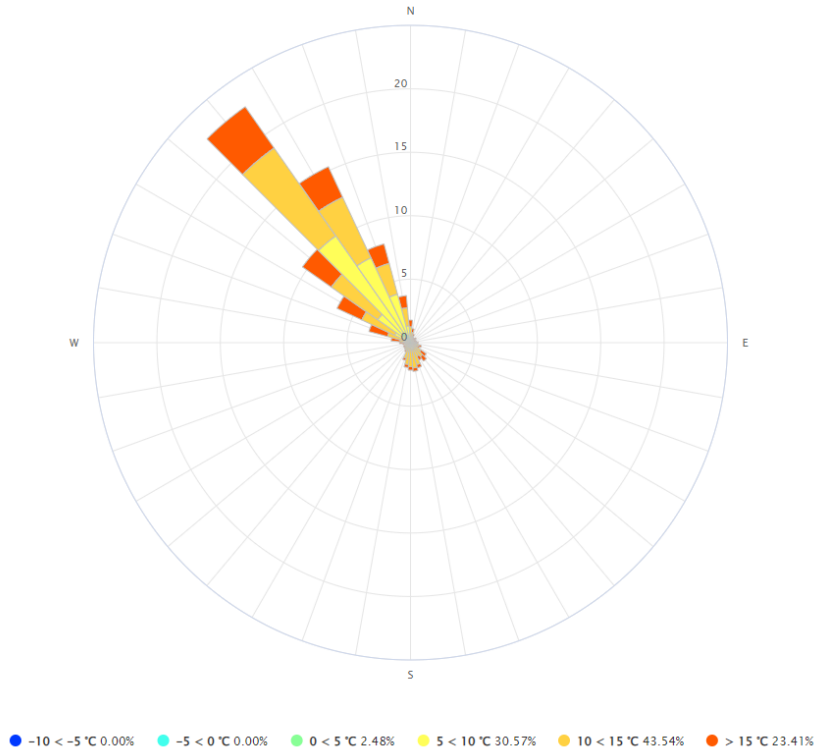
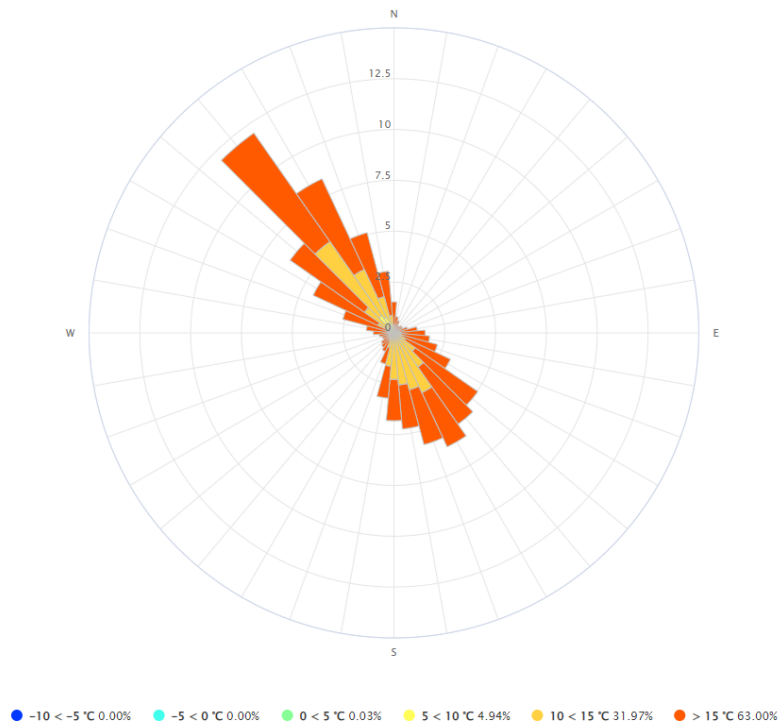
Figure 6 Windrose for Rix’s Creek 2021

● -10 < -5 °C 0.01%
 ● -5 < 0 °C 0.00%
 ● 0 < 5 °C 0.00%
 ● 5 < 10 °C 2.22%
 ● 10 < 15 °C 22.88%
 ● > 15 °C 68.05%

● -10 < -5 °C 0.00%
 ● -5 < 0 °C 0.00%
 ● 0 < 5 °C 0.16%
 ● 5 < 10 °C 7.25%
 ● 10 < 15 °C 27.12%
 ● > 15 °C 65.46%

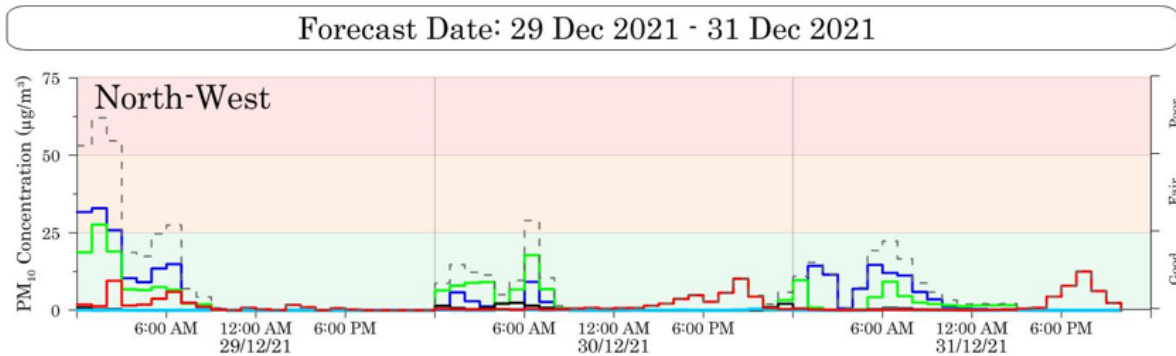
Figure 10 Example of dust forecasting tool to assist operations during 2021

29/12/2021																								
12am 1am 2am 3am 4am 5am 6am 7am 8am 9am 10am 11am												12pm 1pm 2pm 3pm 4pm 5pm 6pm 7pm 8pm 9pm 10pm 11pm												
Wind Speed (m/s)	0.6	1.6	3.1	2.3	3.0	3.4	3.9	4.2	2.6	2.9	2.8	4.4	4.7	3.7	5.6	4.9	6.6	6.5	6.5	5.8	4.5	4.3	3.7	2.3
Wind Direction	SSW	S	S	S	S	S	S	S	S	ENE	E	ESE	ESE	ESE	ESE	ESE	SE	SE	ESE	ESE	ESE	E	E	
Max 1-hour average PM ₁₀ concentration (µg/m ³)																								
North-West	53	62	55	19	17	25	27	7	4	1	0	1	0	0	2	1	0	1	0	0	0	0	0	0

30/12/2021												31/12/2021											
12am 2am 4am 6am 8am 10am						12pm 2pm 4pm 6pm 8pm 10pm						12am 2am 4am 6am 8am				10am 12pm 2pm 4pm 6pm 8pm							
Wind Speed (m/s)	2.1	2.0	1.9	2.0	2.8	3.4	3.9	5.4	7.1	6.6	5.8	3.5	2.2	1.9	1.0	1.8	1.1	0.9	2.6	3.8	5.9	8.7	5.4
Wind Direction	S	SSE	SE	SSE	ESE	E	ESE	ESE	ESE	E	ESE	SE	SSE	S	S	SSE	SE	ESE	SE	ESE	ESE	E	ESE
Max 2-hour average PM ₁₀ concentration (µg/m ³)																							
North-West	12	12	7	20	1	1	1	2	4	4	8	4	13	6	13	19	7	3	2	1	3	10	4

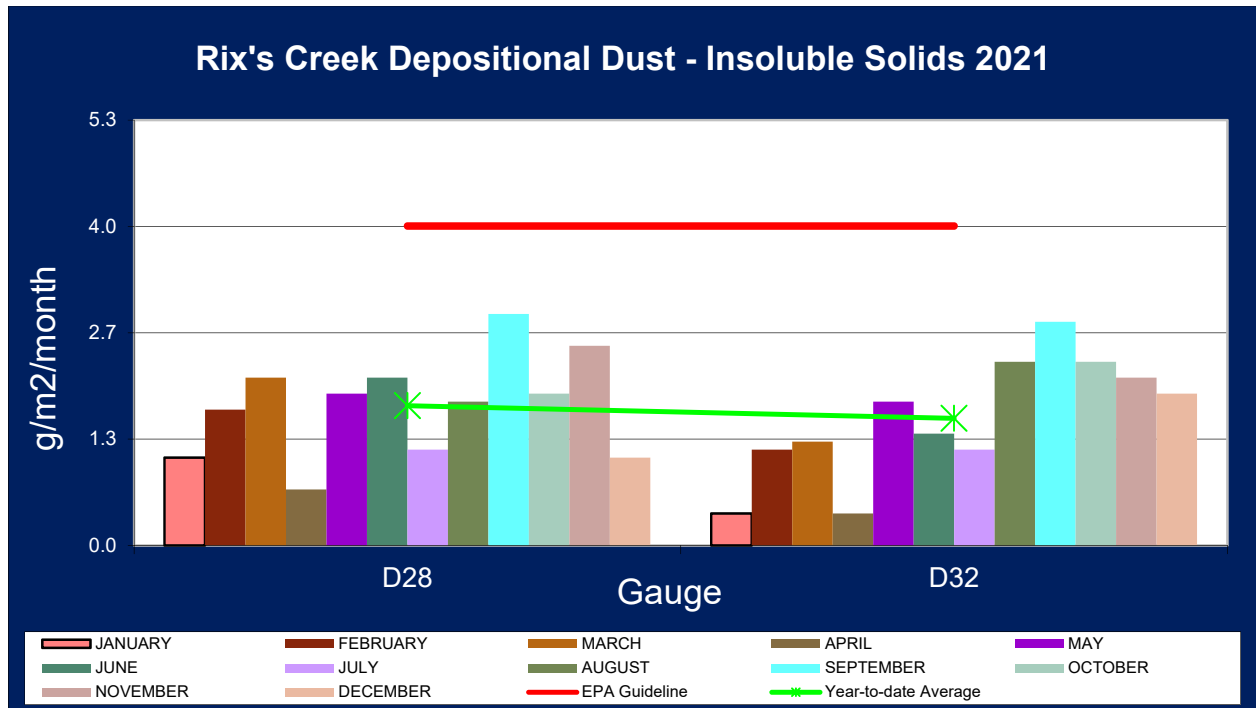
Figure 11 Rix's Creek Insoluble Solids Dust Deposition 2021

During the 2021 reporting period both Dust Depositional gauge DDG28 and DDG32 complied with the Insoluble Solids Dust Deposition assessment criteria of an annual average result of less than 4 gm/m²/month. The 2021 average of DDG28 was 1.8 gm/m²/month while 2021 average of DDG32 was 1.6 gm/m²/month.

In 2021 there were no exceedance of the average result of 4 gm/m²/month for either DDG28 and DDG32. Figure 11 displays the individual monthly insoluble solids deposition rates for each gauge and annual average deposition result in gm/m²/month. There were no contaminated samples recorded in 2021.

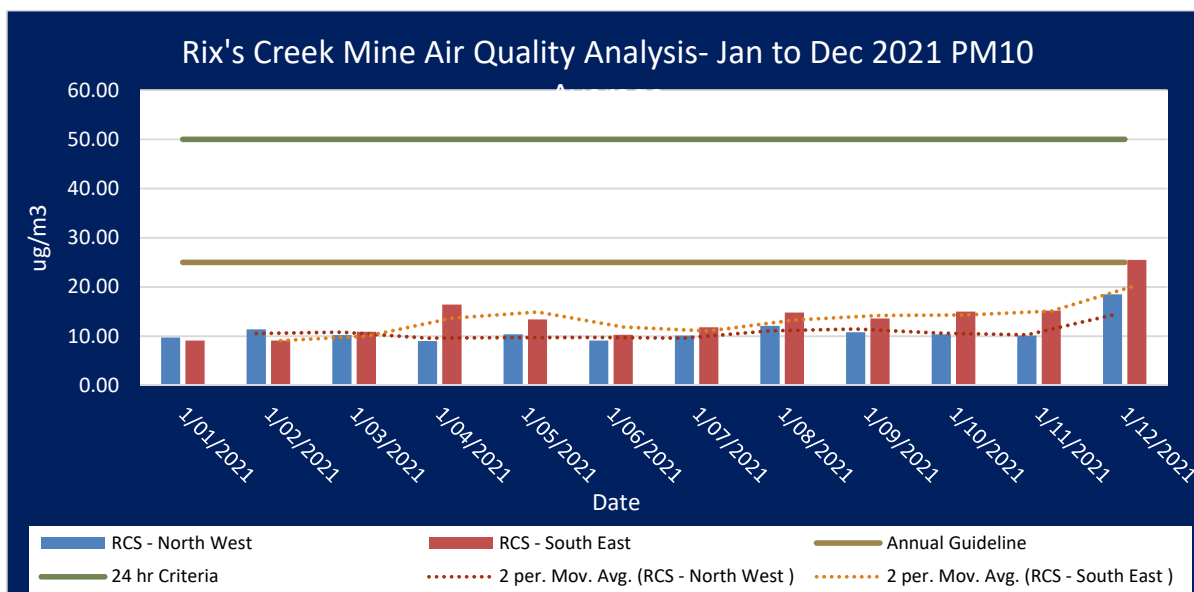
Figure 13 Particulate Matter <10 Micron Monthly and 12 Month Rolling Averages 2021 – DustTrak

The annual average for RCS North West DustTrak in 2021 was 10.56ug/m³ and RCS South East DustTrak recorded an annual average result of 13.53ug/m³. When compared to the modelling predictions for the 2021 privately owned receptors from the 2014 Rix’s Creek Environmental Assessment (EA), ID 173 which is the closest privately owned receptor to the RCS North West DustTrak modelled 39ug/m³ for the 2020 period. ID 140, which is the closest private receptor to the RCS South East DustTrak unit modelled 21ug/m³. Both DustTrakunits were below the 2021 predicted modelling results in the 2014 Rix’s Creek EA.

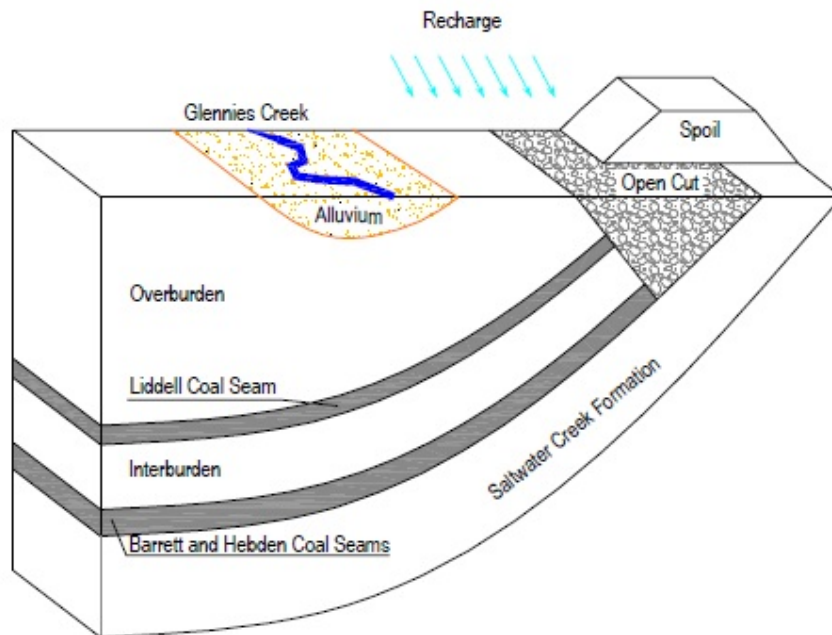
Figure 14 Conceptual Hydrogeological Model of the Rix’s Creek Syncline area

The limbs of the anticline have a relatively shallow dip on the eastern limb with the western limb dipping at a much steeper angle. The syncline axis also plunges from the north and south. The lowest point of the Coal Measures in the synclinal basin is approximately -130mAHD.

Although geologically more complex on the local scale due to the splitting and merging of multiple minor seams, the aquifer system at Rix’s Creek has been simplified and represented by a layer cake style system, with the layer geometry reflecting the synclinal basin structure. Within the layer cake, the major coal seams represent the main aquifers, with the interburden units acting as low permeability aquitards between the aquifers. Within the coal seam aquifers, preferential groundwater flow is along the bedding. Large scale groundwater flow vertically between coal units is impeded by the low permeability interburden units consisting of siltstones, sandstones, tuffs and shales.

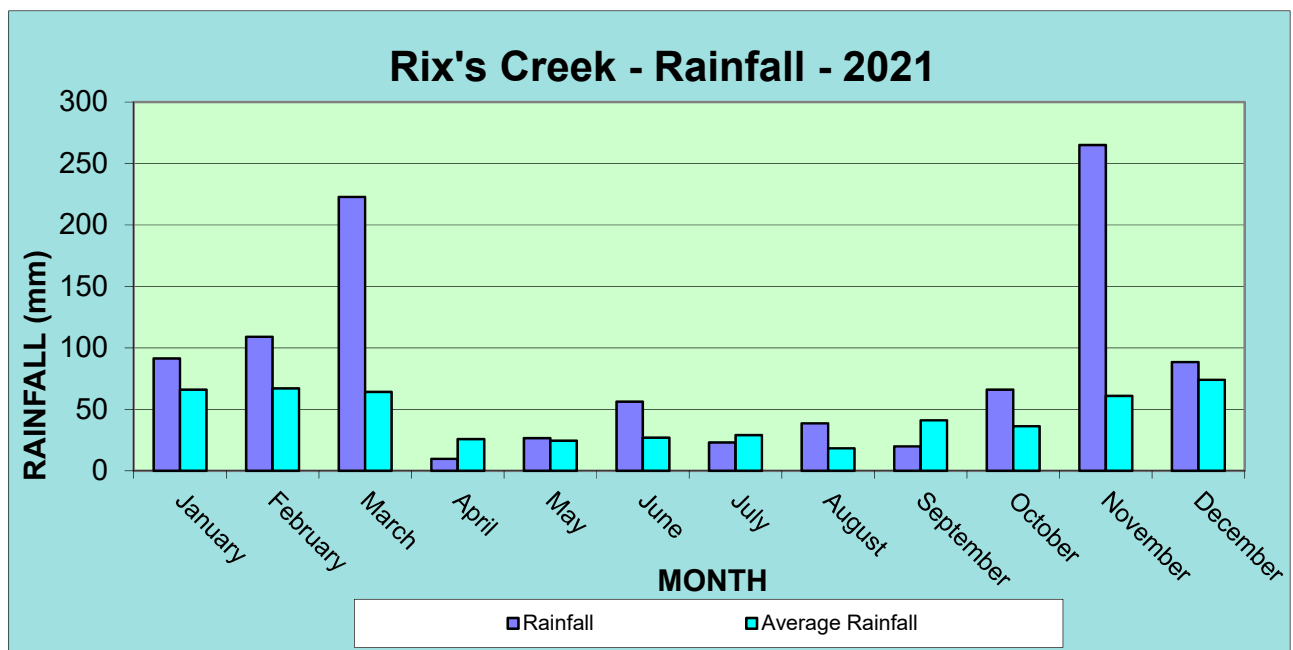
Figure 16 Annual Rainfall at Rix’s Creek 2021

- Over the review period, the only months to that didn’t exceed the monthly average rainfall were April (9.7mm), July (23mm) and September (19.8mm).
- 2021 annual rainfall at Rix’s Creek was 1,016.5mm, which is significantly higher than the long-term average of 640.5mm. March (222.8mm) and November (265mm) were more than 3 times the monthly average.

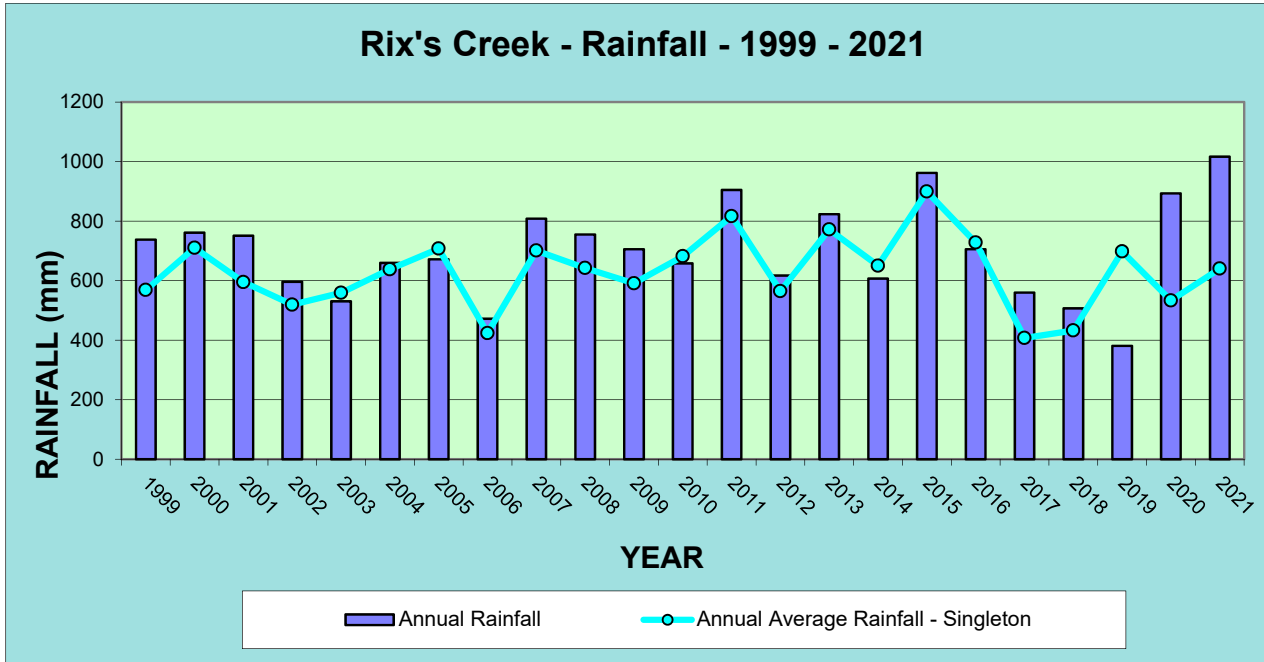
Figure 17 Annual rainfall at Rix’s Creek 1999-2021

Annual rainfall results are plotted for the last 23 year historic rainfall average and are presented in Figure 17.

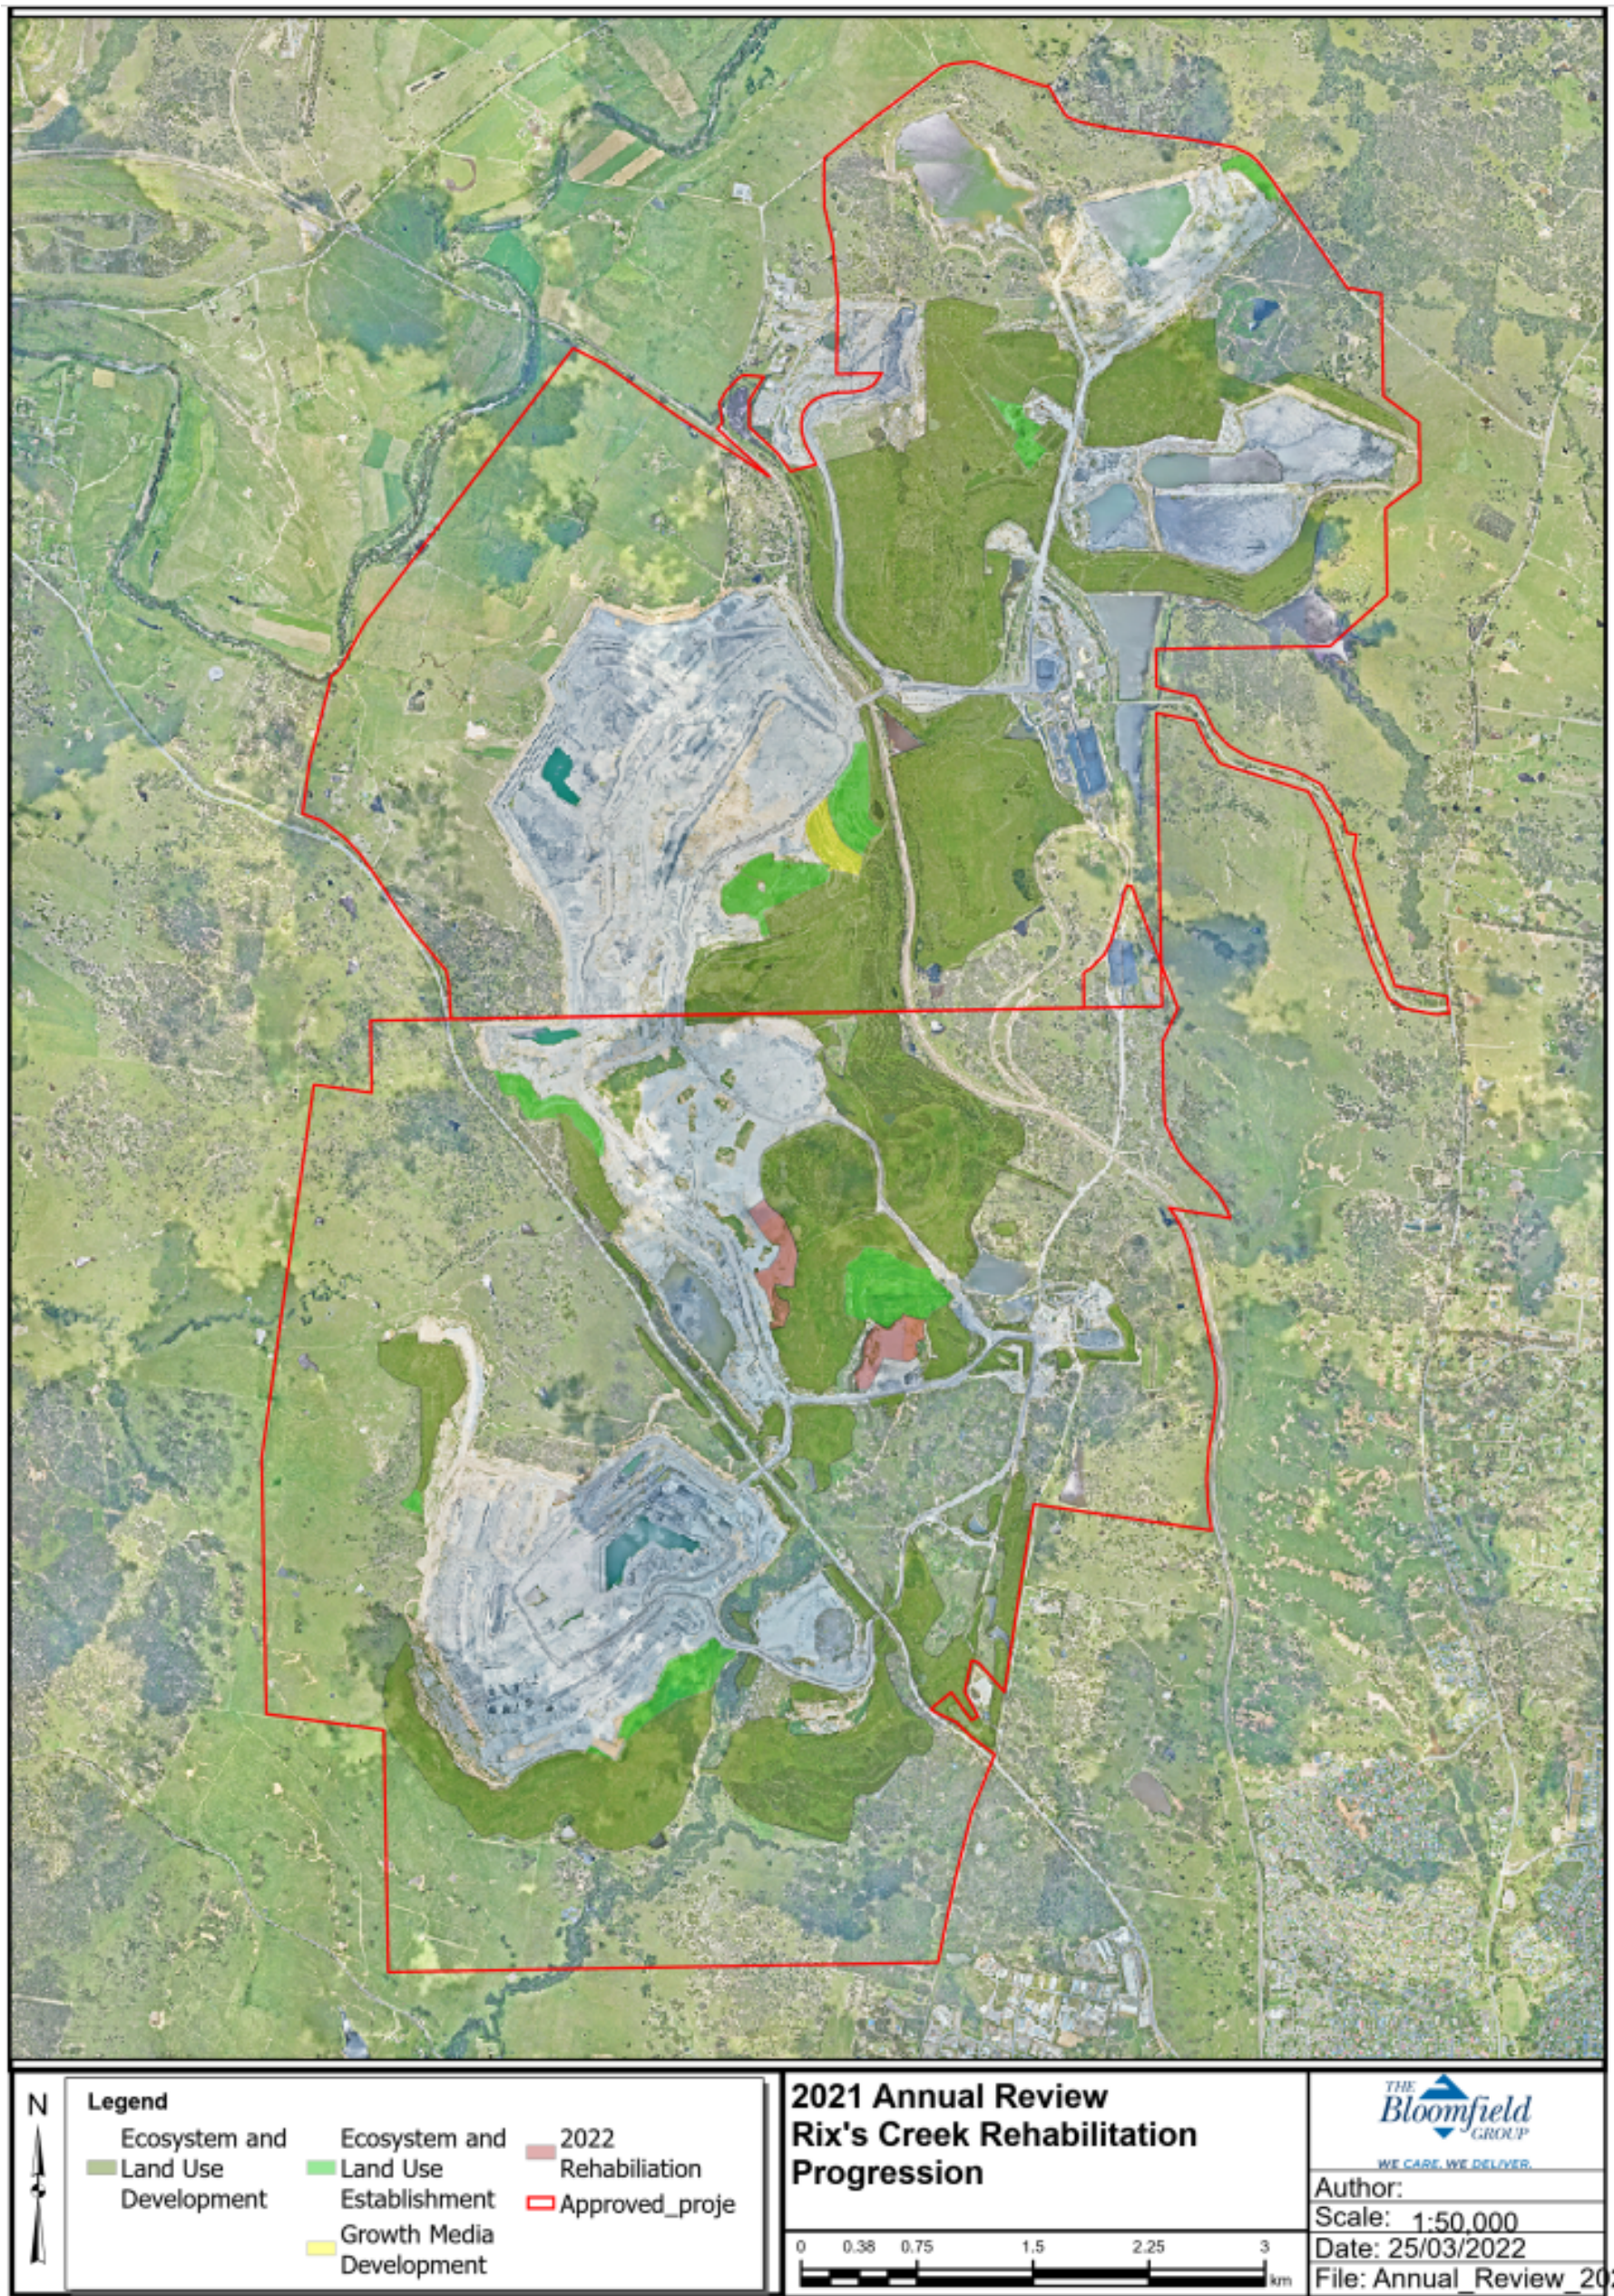
Figure 21 2021 Rix's Creek Mine Rehabilitation

Figure 21 outlines the progression of rehabilitation during the 2021 reporting period. All areas rehabilitated during 2021 across Rix’s Creek Mine were treated with biosolids and gypsum. The application of biosolids greatly enhances revegetation onsite given the poor quality of available topsoil. Biosolids organic properties also aid in water infiltration which leads to an improvement in soil composition and long-term vegetative growth. Figure 21 also shows the areas that were shaped to final landform but were not ameliorated and seeded during the reporting period due to availability issues with covid 19 and rain delays during elevated rainfall in November and December.

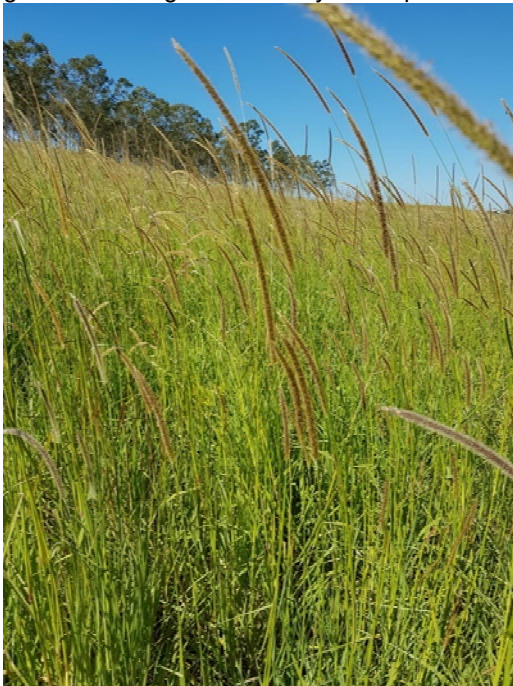
Setaria is a component of the rehabilitation pasture mix that has grown well and produced large volumes of feed.
