# Bloomfield Colliery

Annual Review Report

Year Ending March 2026

# Bloomfield Collieries Pty Ltd

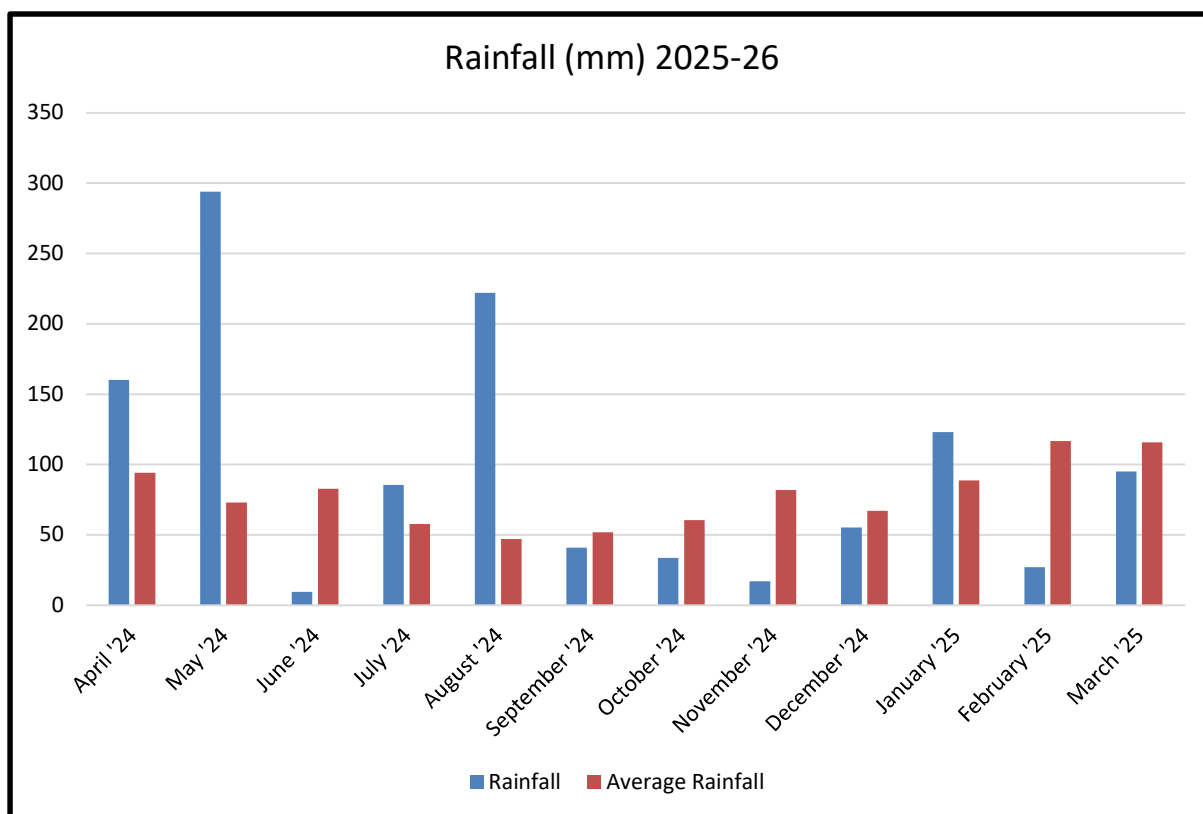
Figure 2: Rainfall YEM 2026

A comparison of monthly recorded rainfall for the YEM 2026 reporting period and annual average data is shown in Figure 2. The total rainfall for the reporting period YEM 2026 was 1164 mm. This was 226 mm above the average of 937 mm.

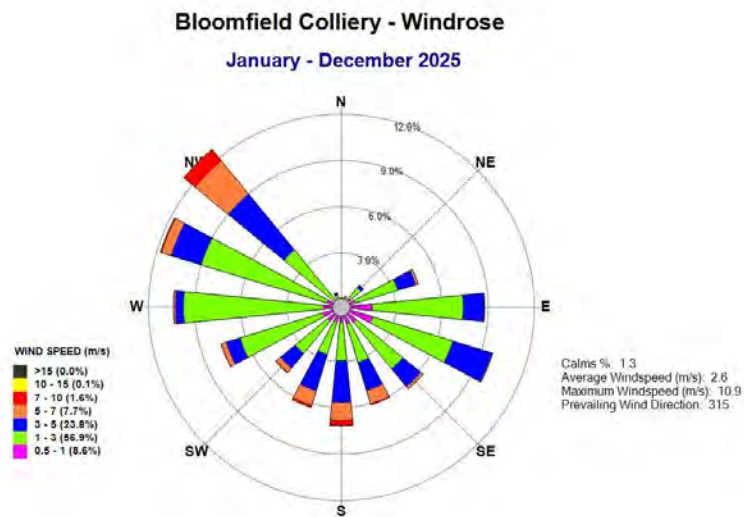
Figure 3: Windrose for Bloomfield Colliery 2025

The results of wind speed and direction monitoring shows a pattern typical in the Hunter Valley. During summer the winds predominate from the south-east and winter the west-northwest. Autumn and spring are transitional seasons with winds distributed between both northwest and south-easterly directions. Figure 3 shows the annual windrose generated for the site for 2025.

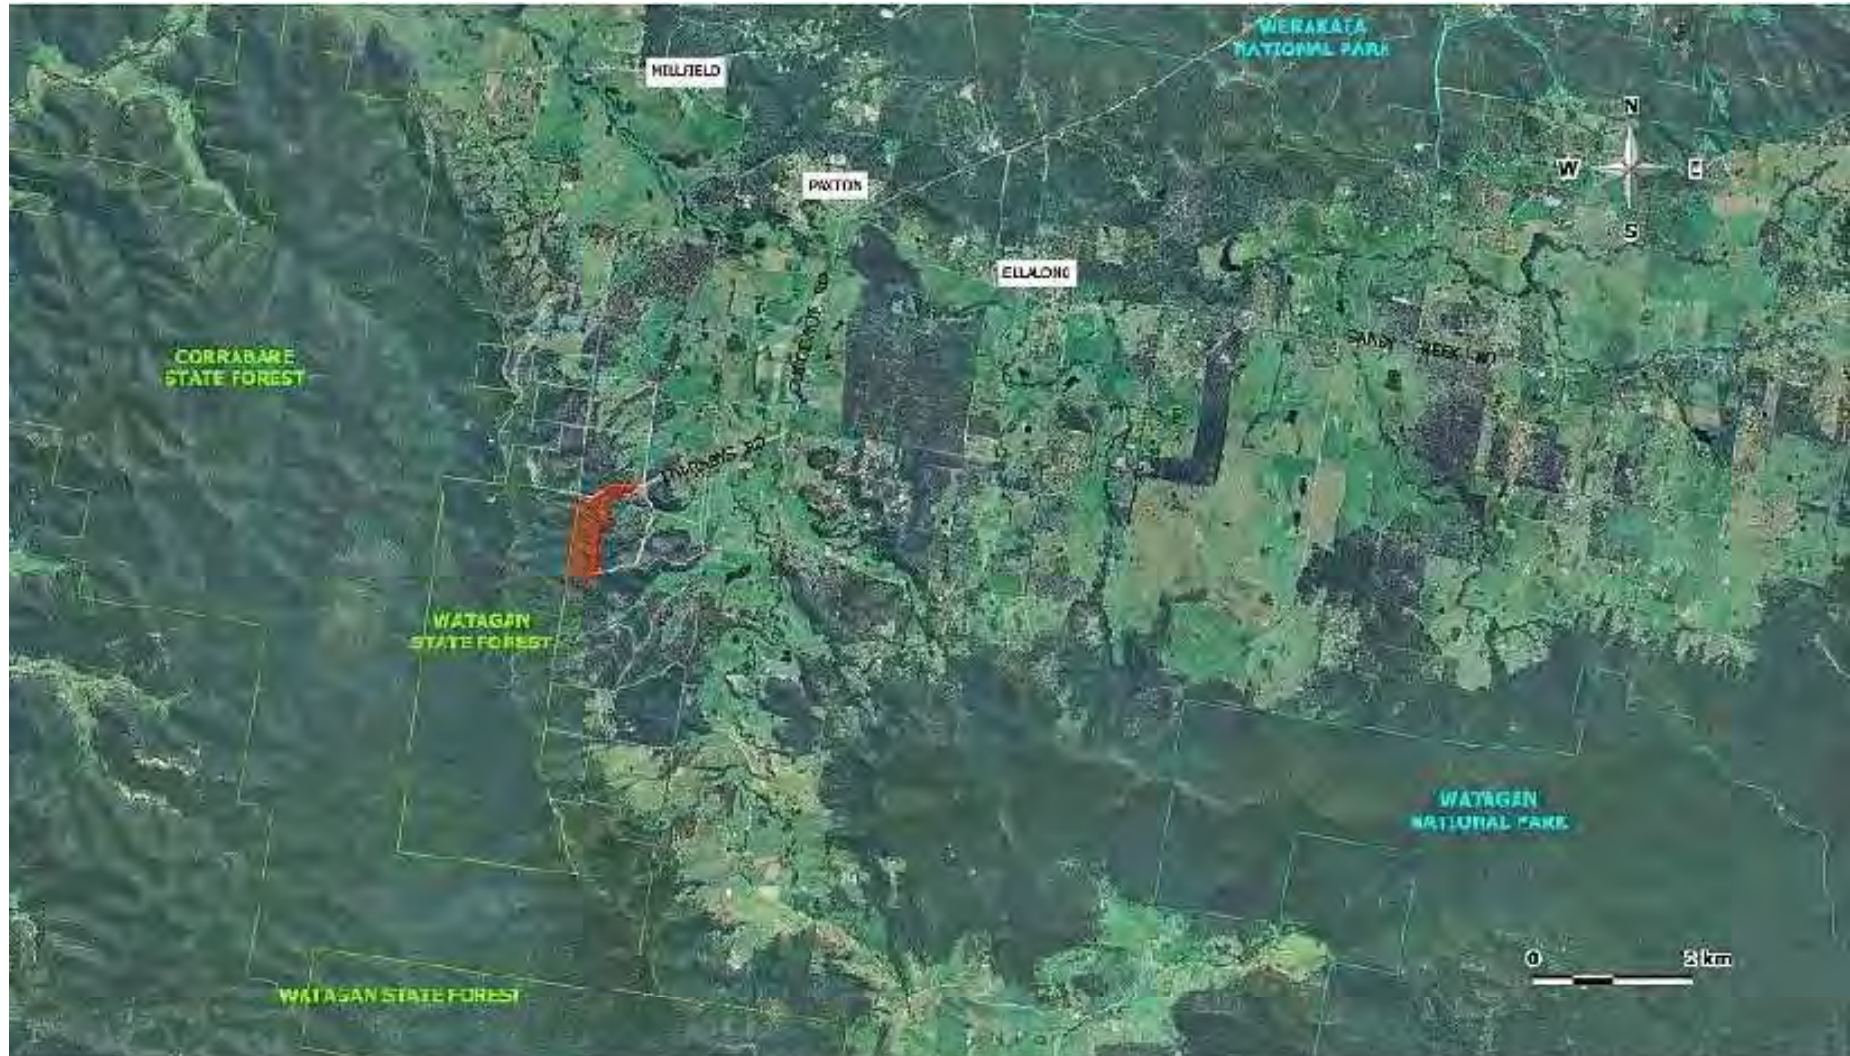
Figure 4: Biodiversity Offset Area

A Biodiversity Offset Management Plan has been prepared and approved by DPHI in accordance with Project Approval requirements for the operation of the mine. A Biodiversity Offset Area has been established to compensate for clearance at the mine. The land was purchased by Bloomfield in December 2011 and consists of 40 Ha of remnant vegetation at Congewai adjacent to the Watagan State Forest. The western boundary abuts a part of Watagan State Forest on the eastern side of the Corrabare Range. Figure 4 shows the location of the Biodiversity Offset Area.

During the reporting period weed spraying for Lantana was carried out on the property. In addition, access track maintenance and fencing repairs were also conducted.

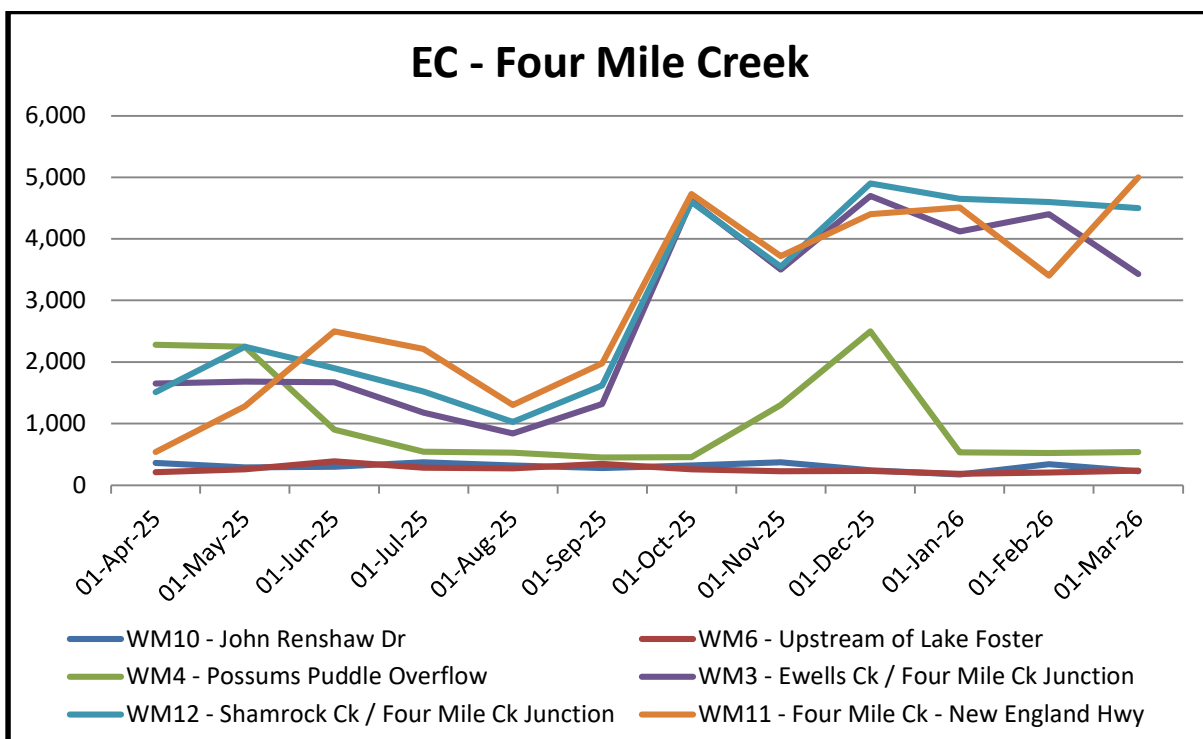
**Figure 5: Four Mile Creek Catchment Electrical Conductivity**

Figure 5 and 6 shows EC and pH results for the Four Mile Creek sites. Figure 5 shows salinity levels are slightly elevated in the lower end of the catchment. Four Mile Creek is ephemeral and the EC level varies due to rainfall and licenced mine discharges. The higher salinity results along Four Mile Creek (Elwells Creek and Shamrock Creek junctions and New England Hwy) reflect concentration of solutes in ponds during low flow periods and from licenced discharges in addition to offsite sources such as historic underground workings.

As outlined later, there were 26 licenced discharges throughout the reporting period. EC levels vary due to rainfall, creek flow volumes and mine discharge and therefore monthly and yearly trends cannot be assessed.

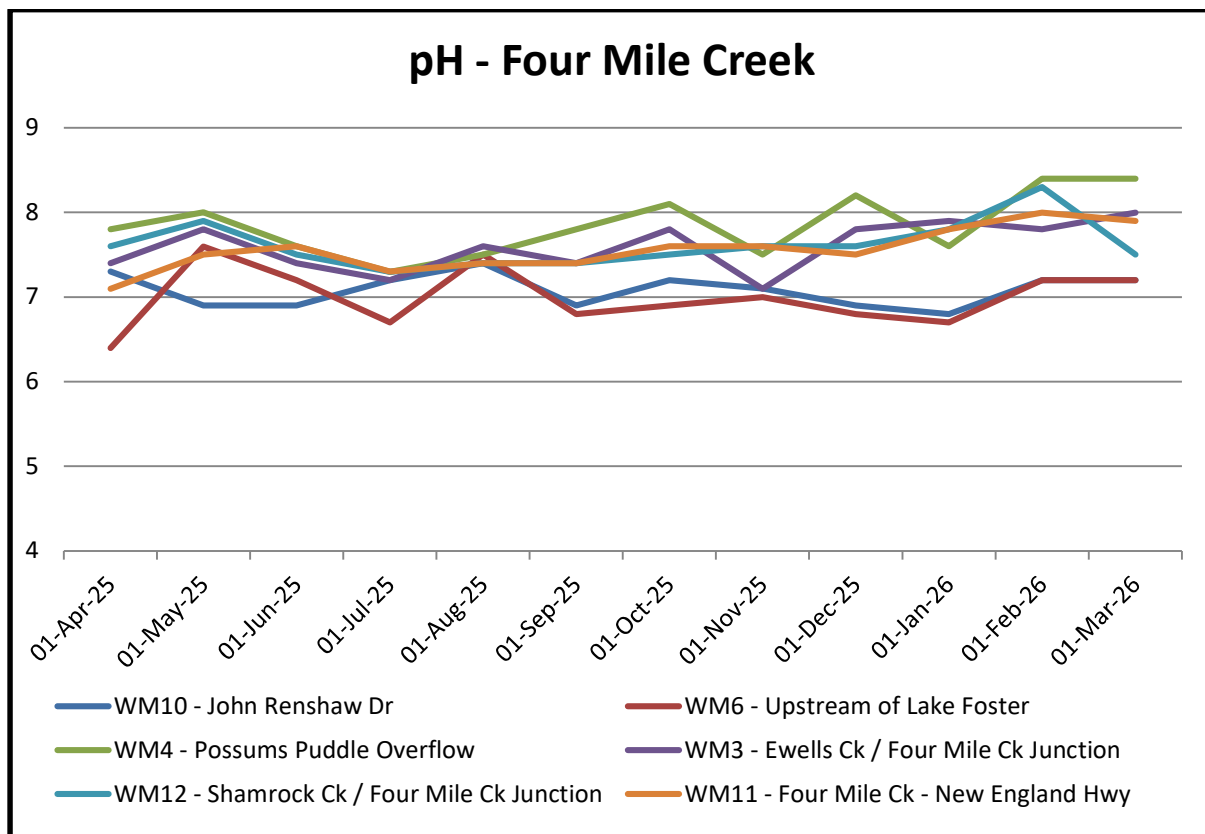
**Figure 6: pH of Four Mile Creek**

Figure 6 shows the pH levels in Four Mile Creek are generally consistent with ANZECC water quality guidelines (pH 6.5-8.5). pH levels vary due to rainfall and mine discharge therefore monthly and yearly trends cannot be assessed.

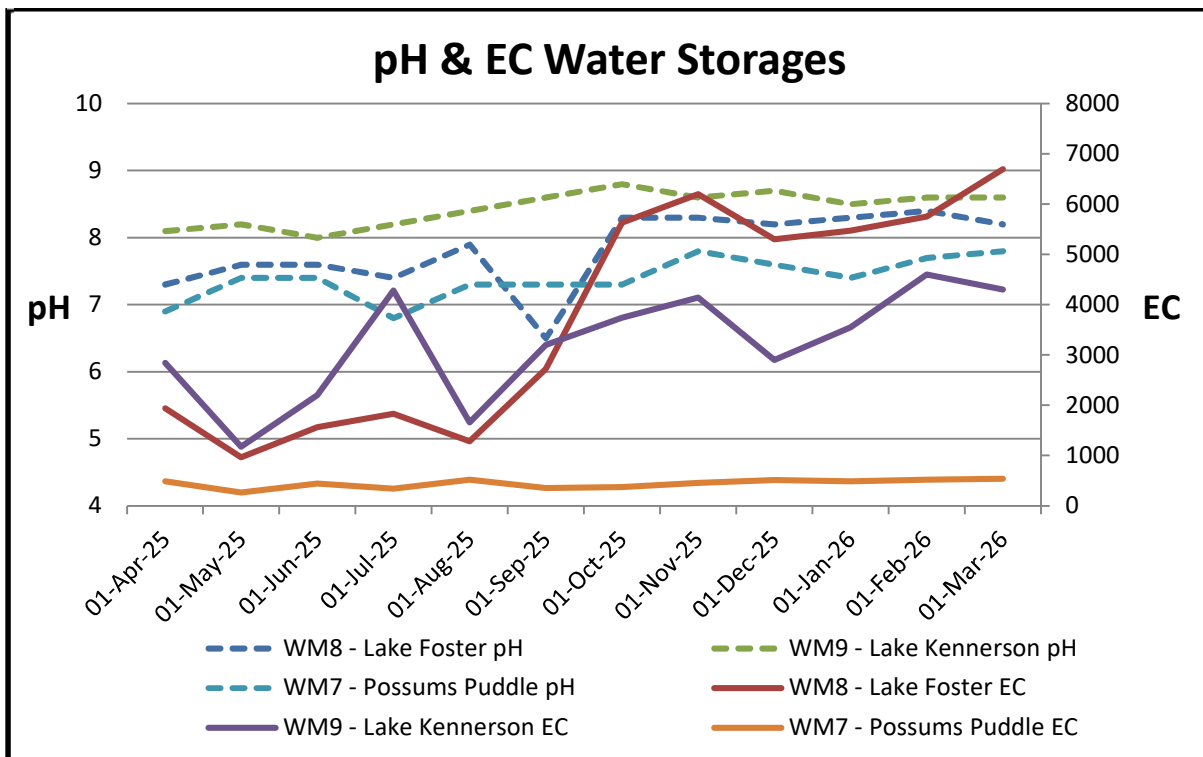
**Figure 7: pH and EC in Site Water Storages**

Figure 7 shows EC and pH results for water storage dams. Water quality within the mine water storage dams (Lake Kennerson and Lake Foster) varies throughout the year depending on rainfall capture in the open cut pits, transfers from Abel Mine, CHPP water usage and frequency of licensed discharge events, which are also rainfall dependent. The freshwater dam (Possums Puddle) remains fairly constant throughout the year as it is separate from mining influences.

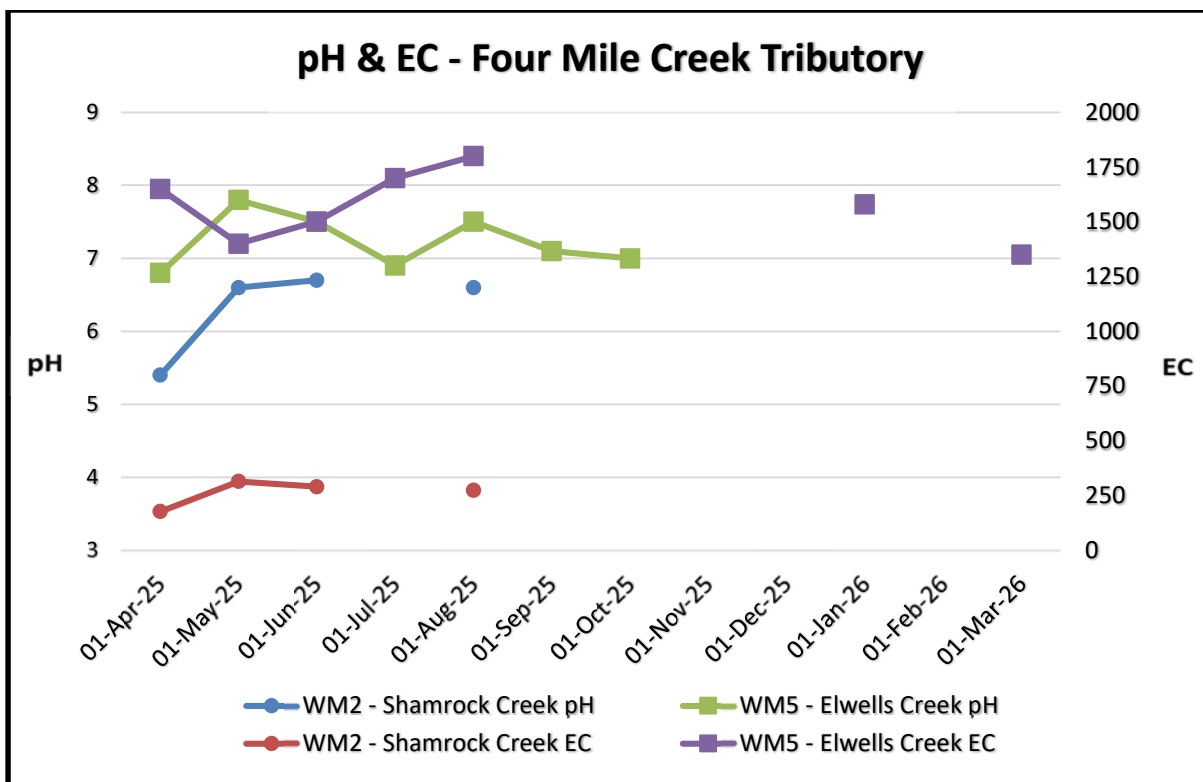
**Figure 8: pH and EC in Four Mile Creek Tributary**

Figure 8 shows the pH and salinity levels in two Four Mile Creek tributaries. These tributaries are ephemeral streams and are often dry or not flowing (evaporating) resulting in gaps in the graphed data.

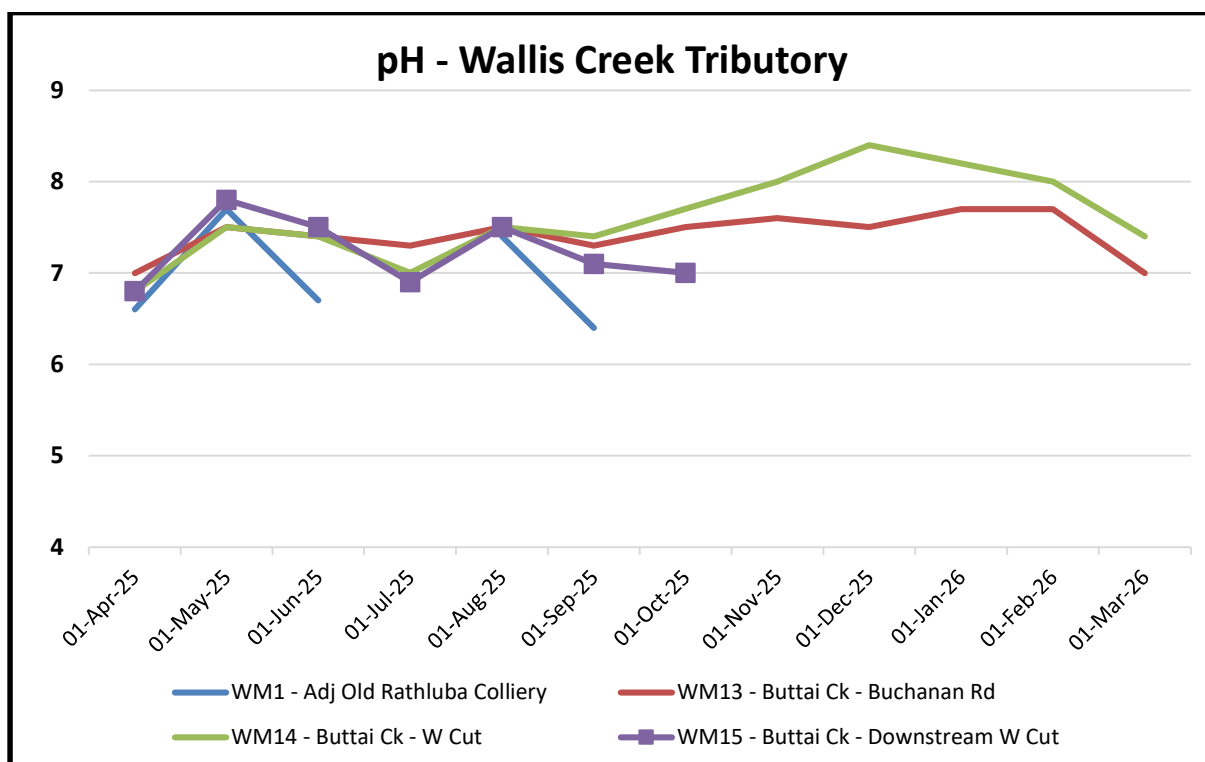
**Figure 9: pH in Wallis Creek Tributary**

Figure 9 shows the pH levels in Wallis Creek tributaries are generally consistent with ANZECC water quality guidelines (pH 6.5-8.5).

Previous results indicate that the surface flow adjacent to the old Rathluba pit top (Plan 1 – Location WM1) has historically been of low pH, regardless of mining impacts. Prior to 2006 pH results were less than 4 however pH levels have been steadily increasing since then. This drainage line carries surface flow from non-mining land and rehabilitated mining land, indicating that other off-site effects may be influencing the water quality in the area. The drainage line is ephemeral and is usually dry or evaporating resulting in gaps in the graphed data.

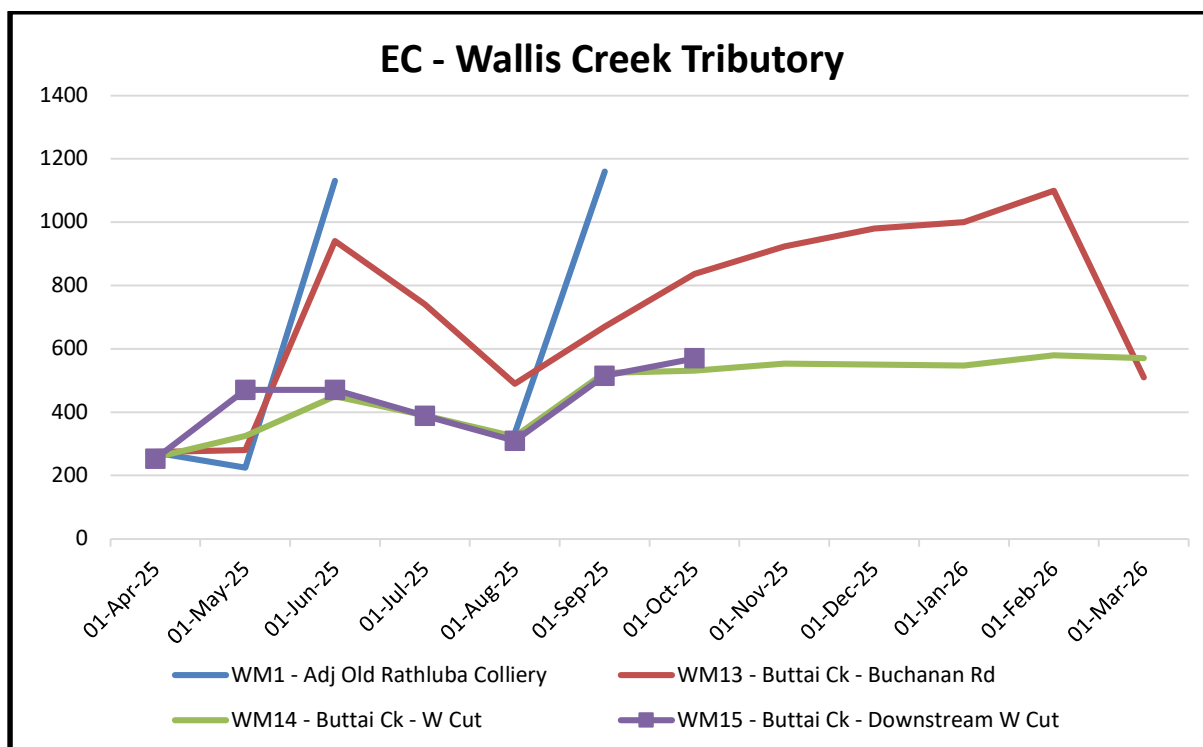
**Figure 10: EC in Wallis Creek Tributary**

Figure 10 shows the EC levels in Wallis Creek tributaries are generally consistent with ANZECC water quality guidelines (EC 125-2200). These tributaries are ephemeral streams and are often dry or not flowing (evaporating) resulting in gaps in the graphed data.

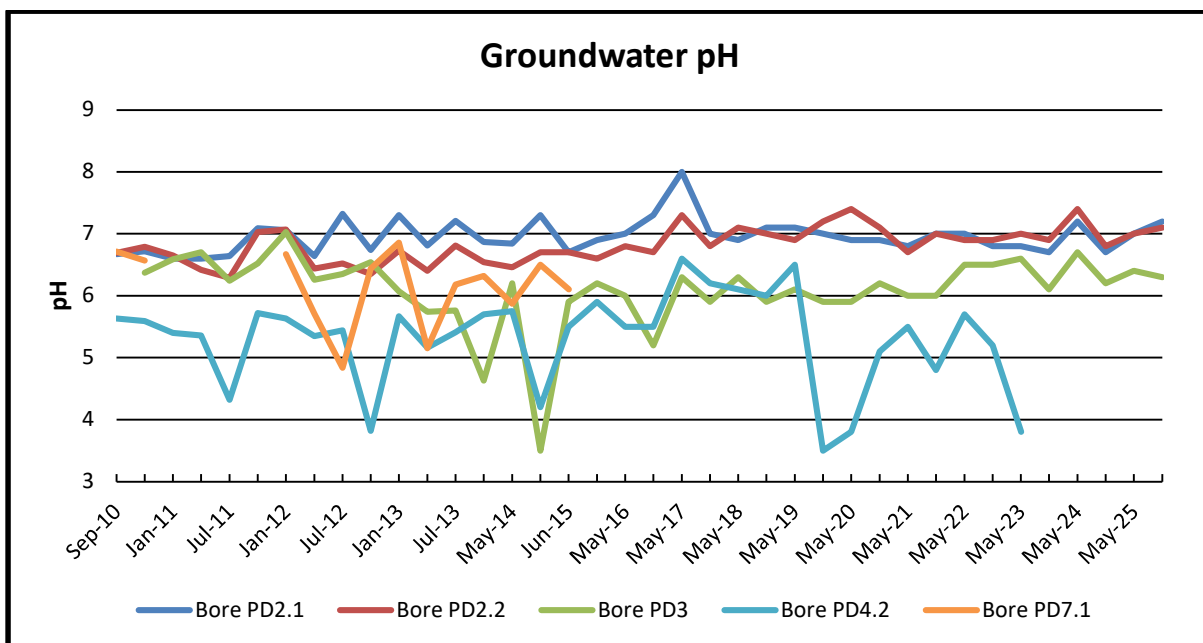
**Figure 11: Groundwater pH**

Groundwater in the vicinity of the Mine Lease is saline and of negligible value for beneficial users. The Groundwater Impact Assessment concludes that no adverse impacts on groundwater supply, quality or any groundwater dependent ecosystems are expected as a result of the Project. Recorded EC and pH levels are relatively stable showing no real trend (Figures 11 & 12).

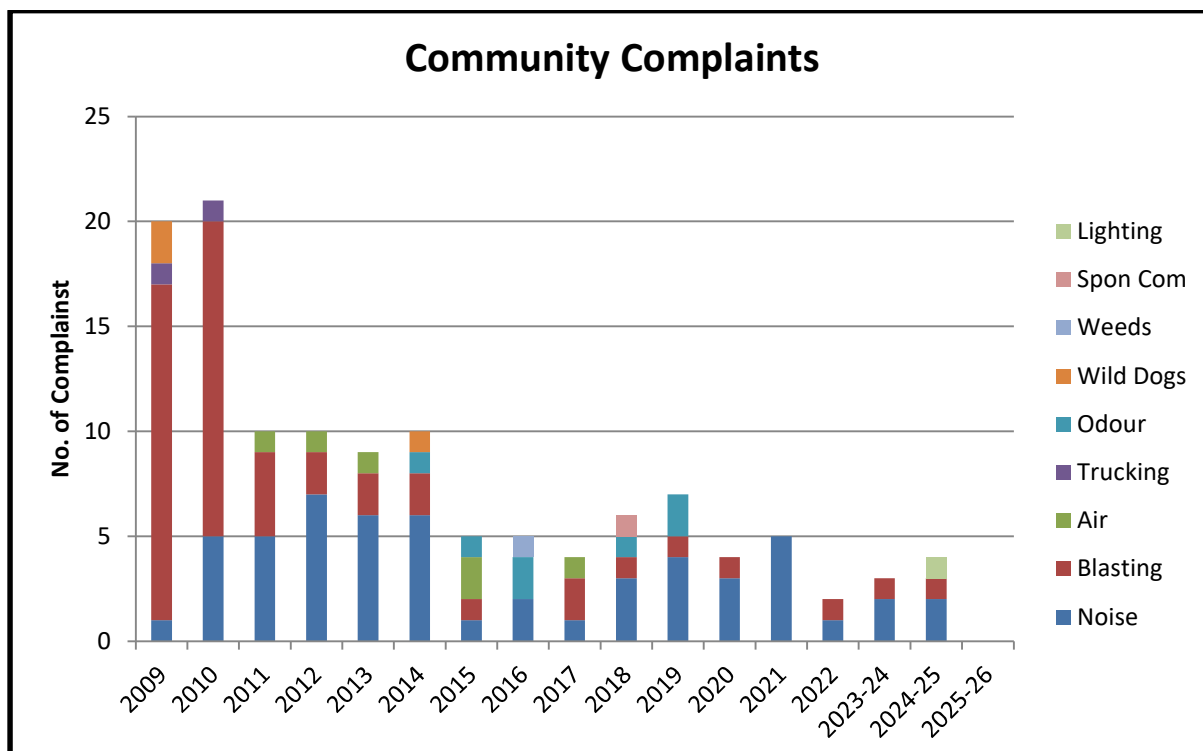
**Figure 13: Community Complaints**

Figure 13 displays a comparison of complaints with previous reporting periods, which demonstrates a decline in the number of complaints received.
