# Bloomfield Colliery

Annual Review Report

Year Ending March 2026

# Bloomfield Collieries Pty Ltd

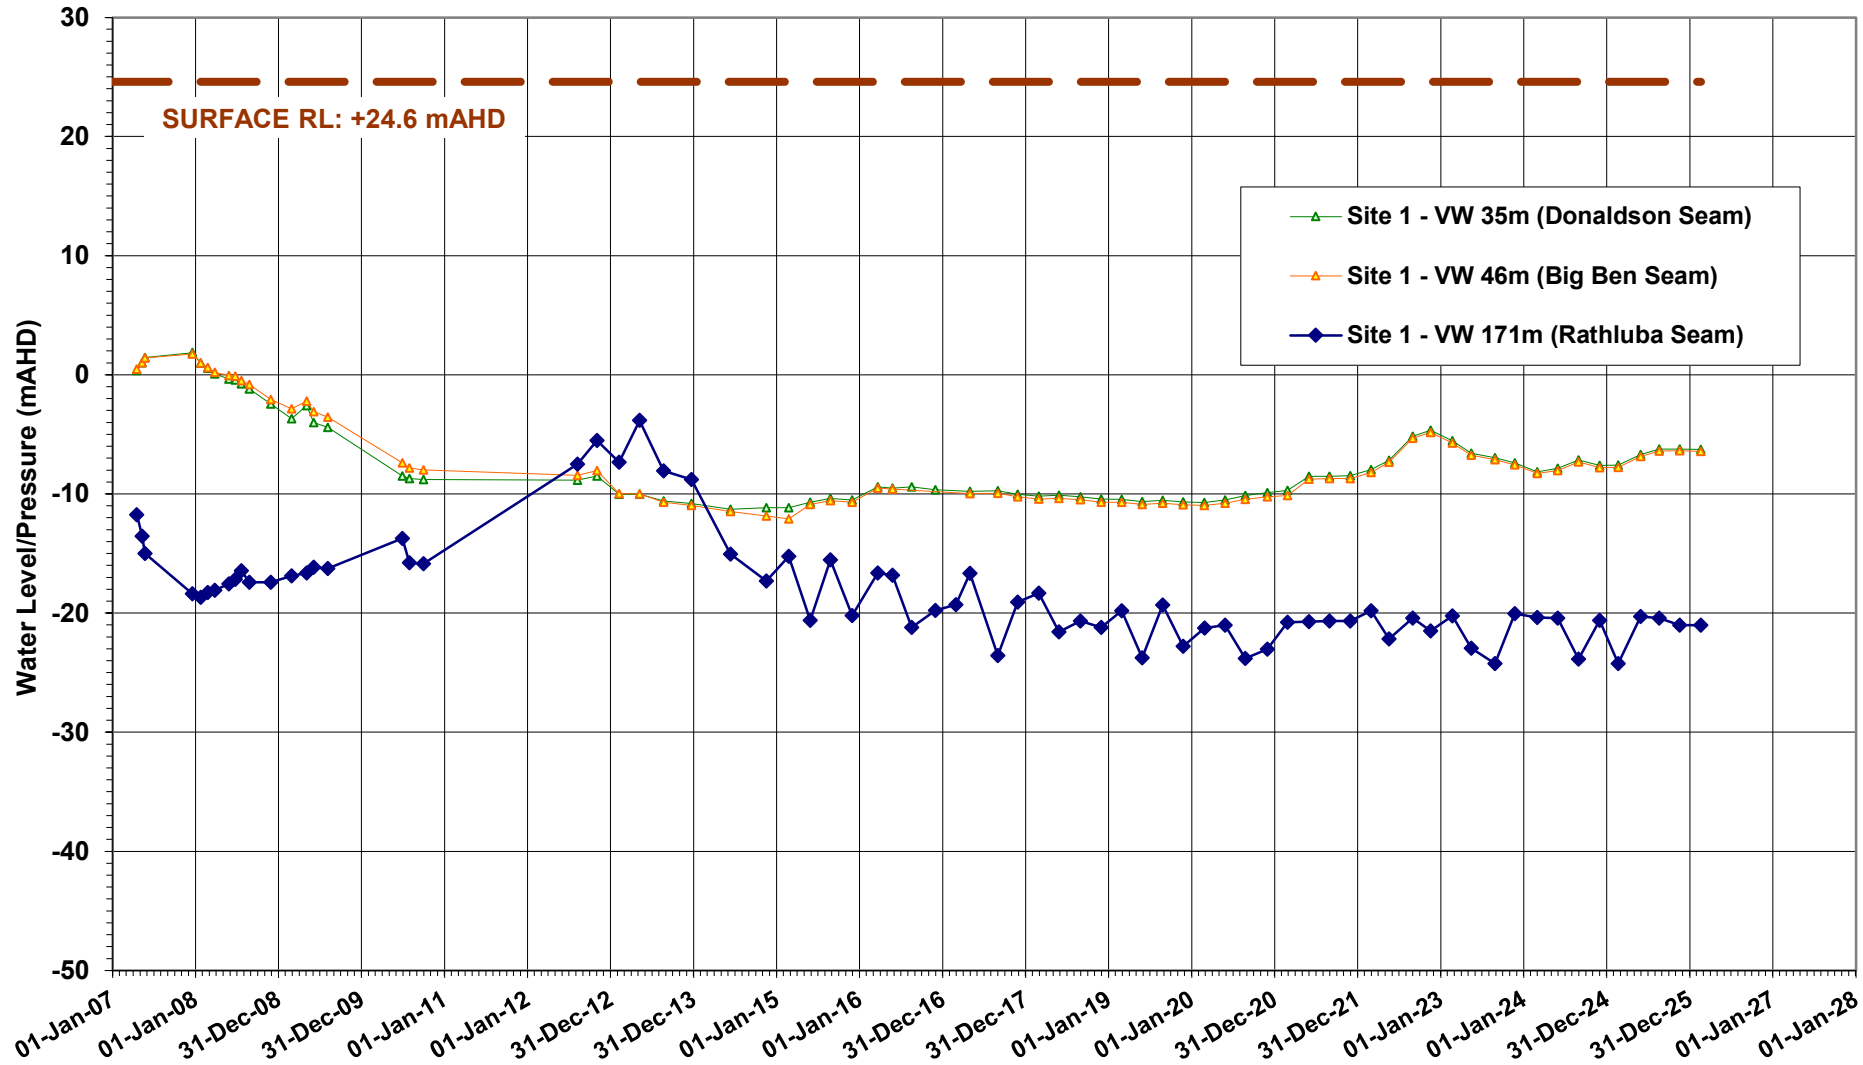
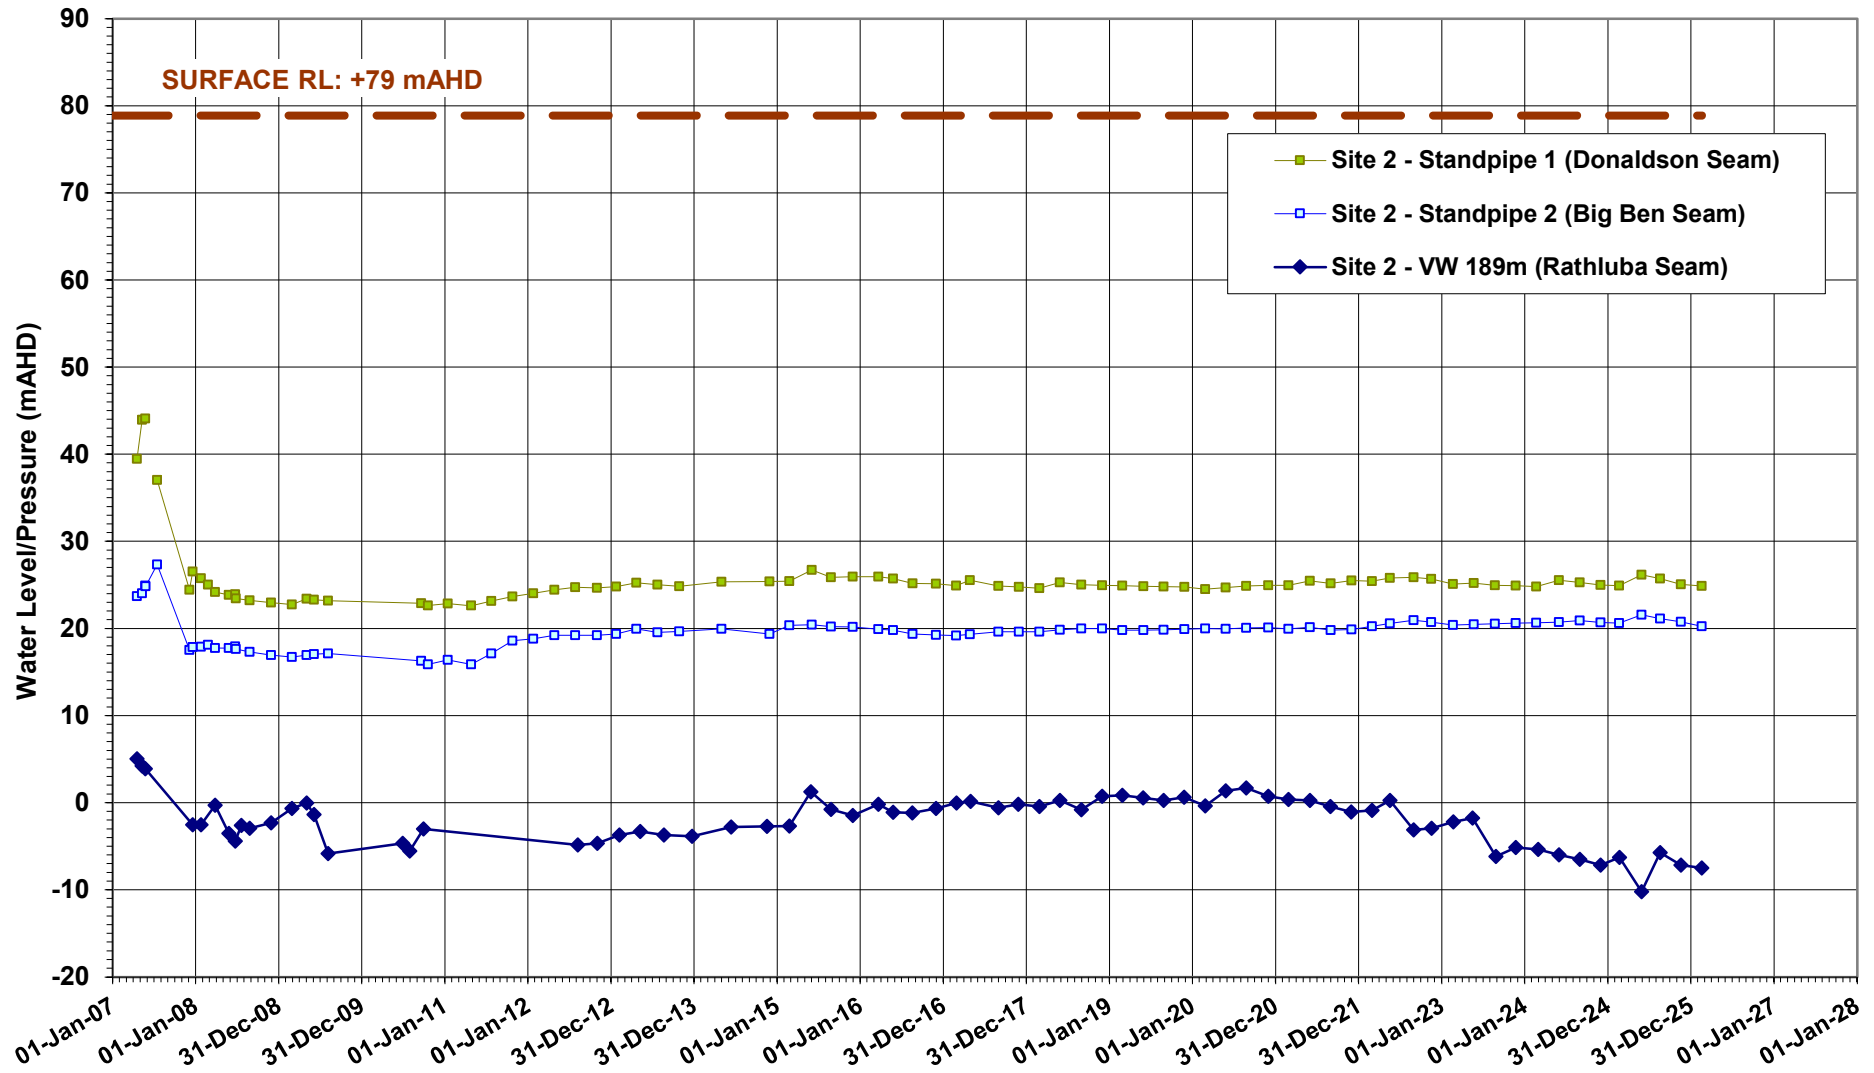
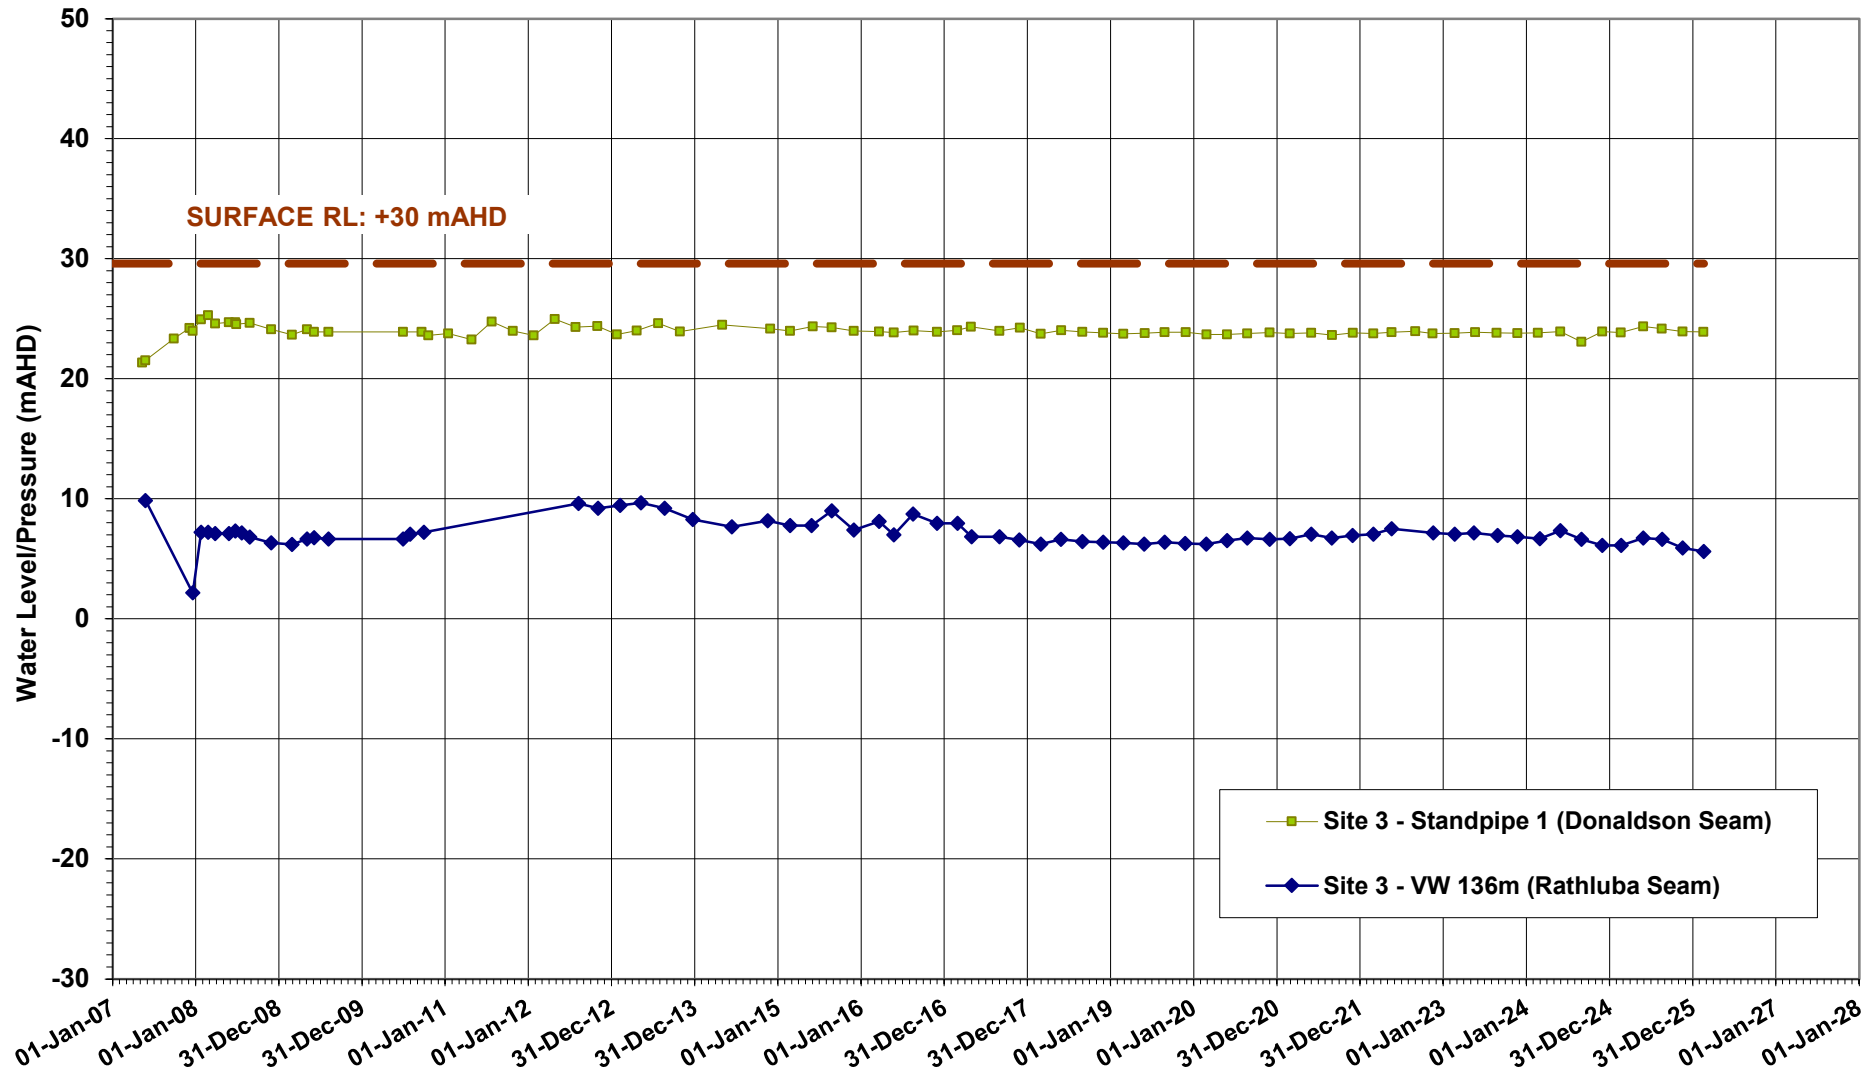
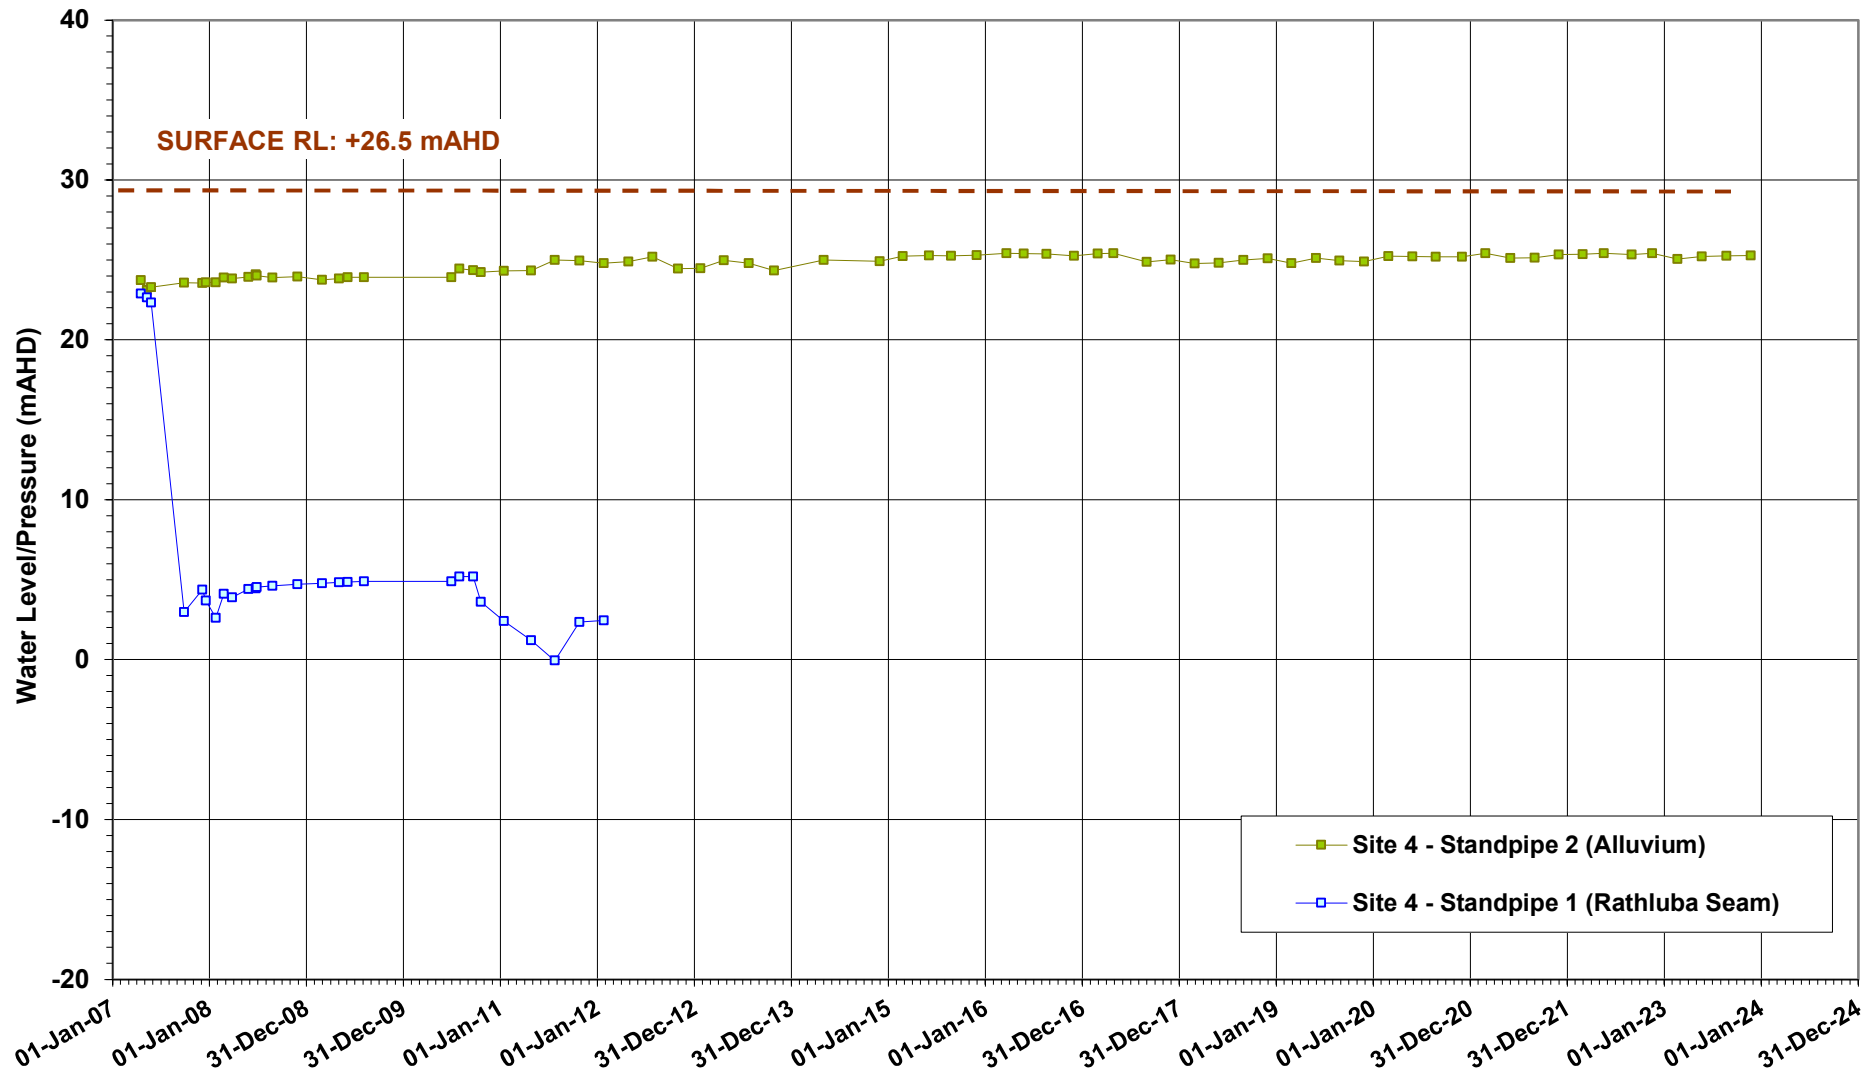
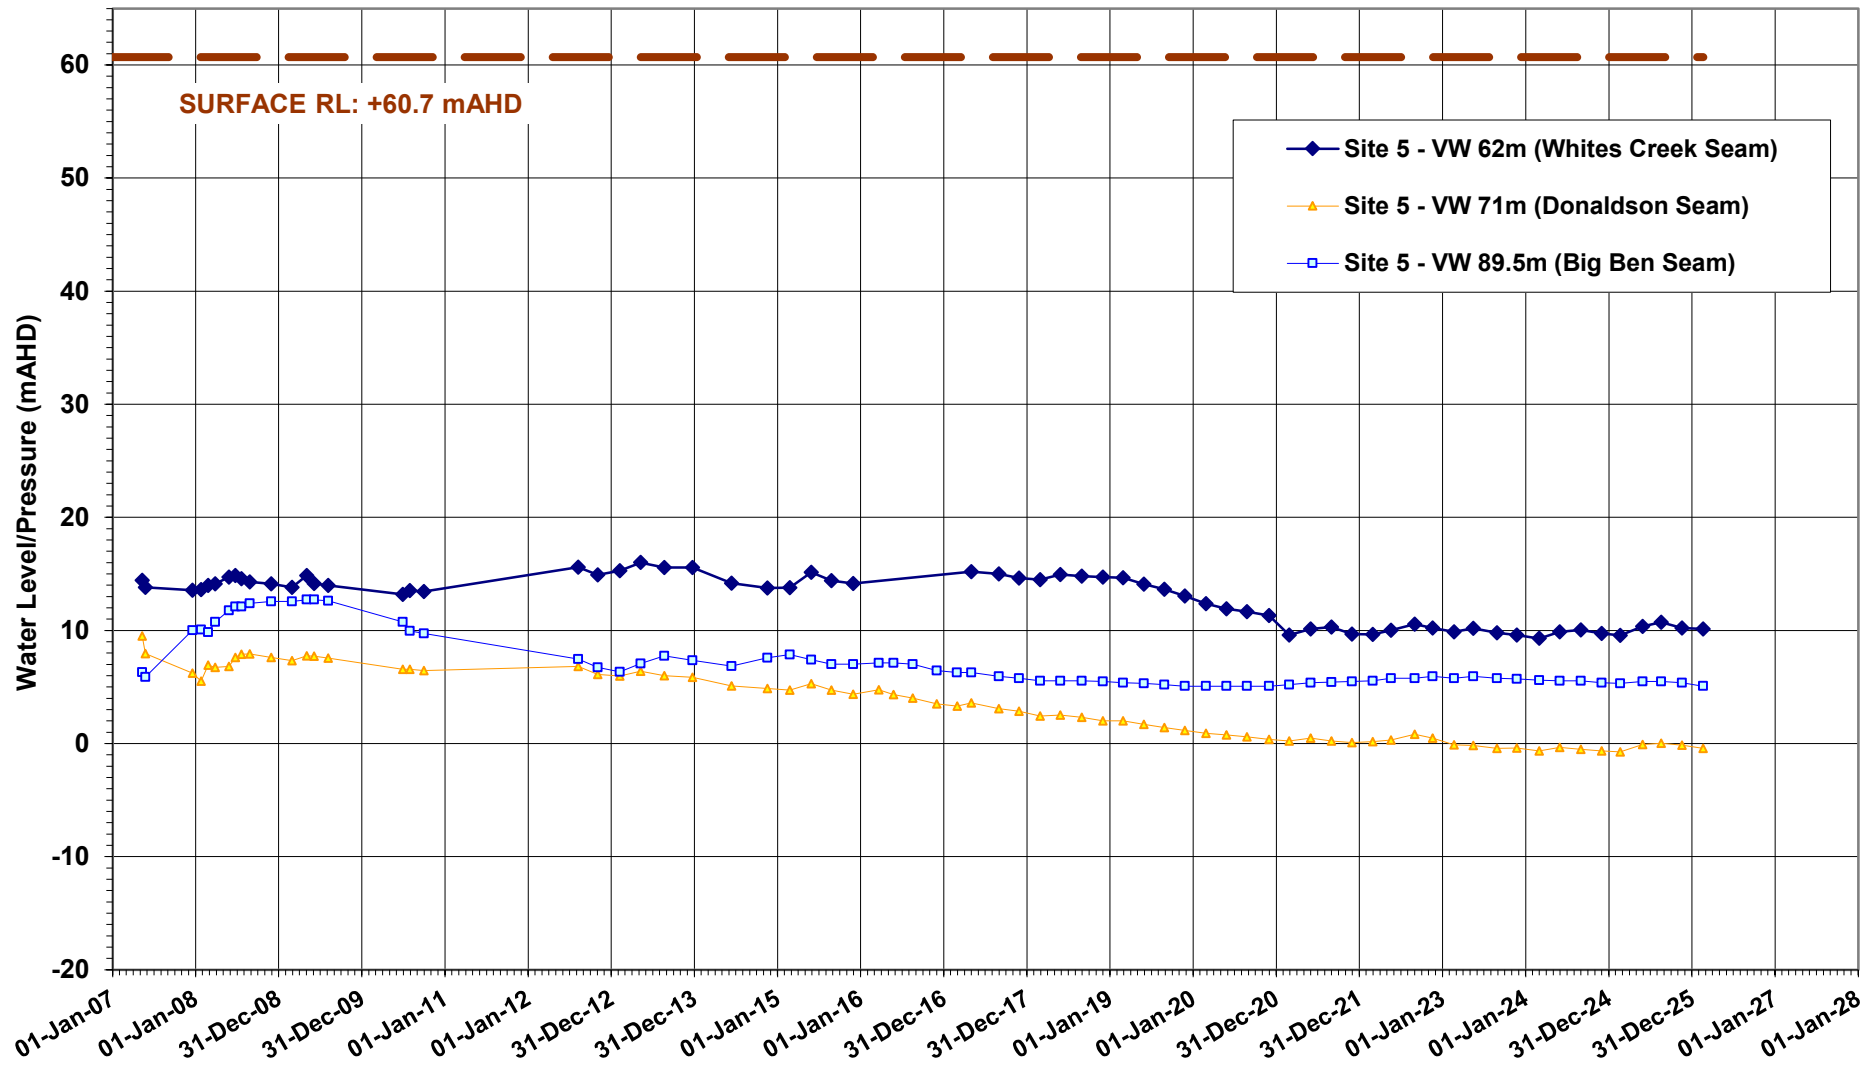
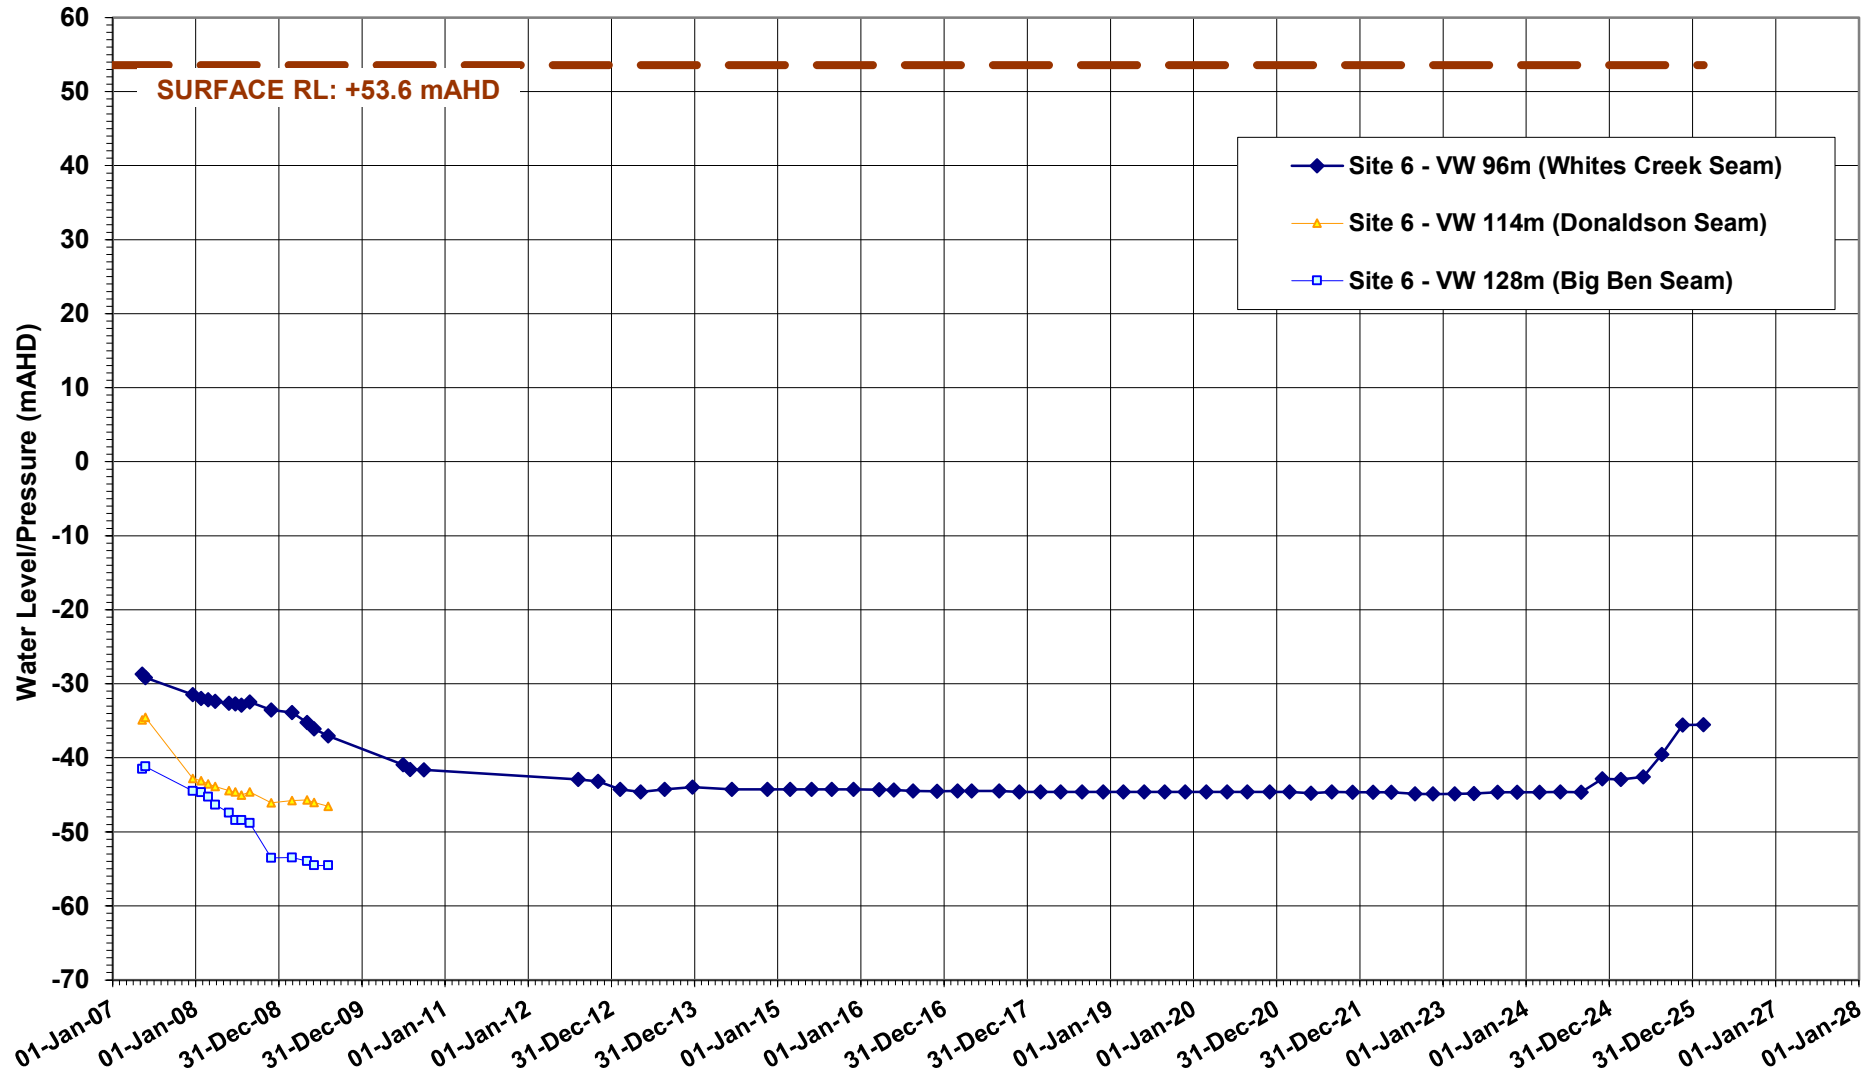
A graphical presentation of the groundwater levels for PD1 to PD8 are provided in Appendix D. Groundwater levels show the accumulated effects of long-term mining. Due to the long period of time mining has occurred on the site (170 years), there is no evidence to suggest what pre-mining groundwater levels might have been.
