Rix's Creek Mine

2021 Annual Review

Rixs Creek North & Rixs Creek South

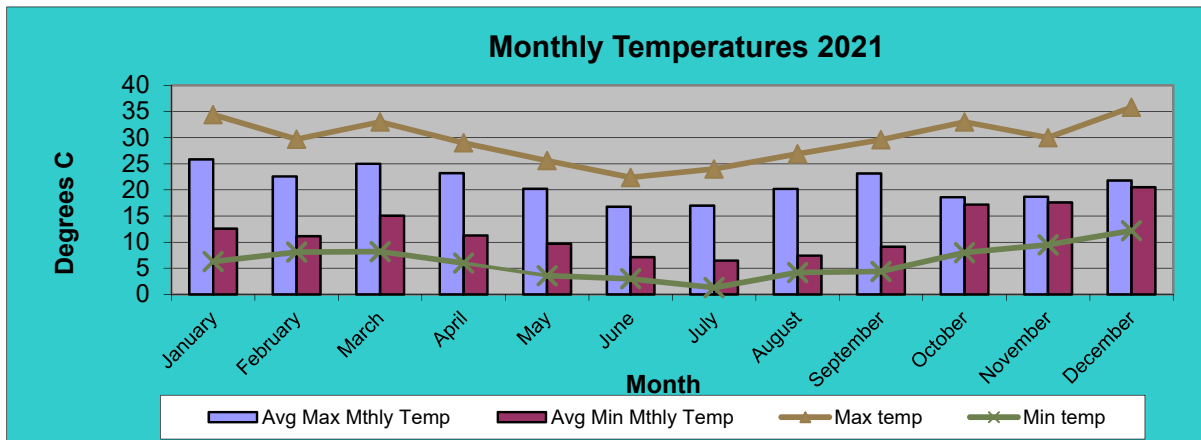
Figure 5 Average Monthly Maximum & Minimum Temperature 2021

The maximum temperature of 35.8°C occurred in December and the minimum temperature of 1.3°C was recorded in July. **Figure 5** shows the monthly average maximum and minimum temperatures for the site as well as the maximum and minimum recorded temperatures.

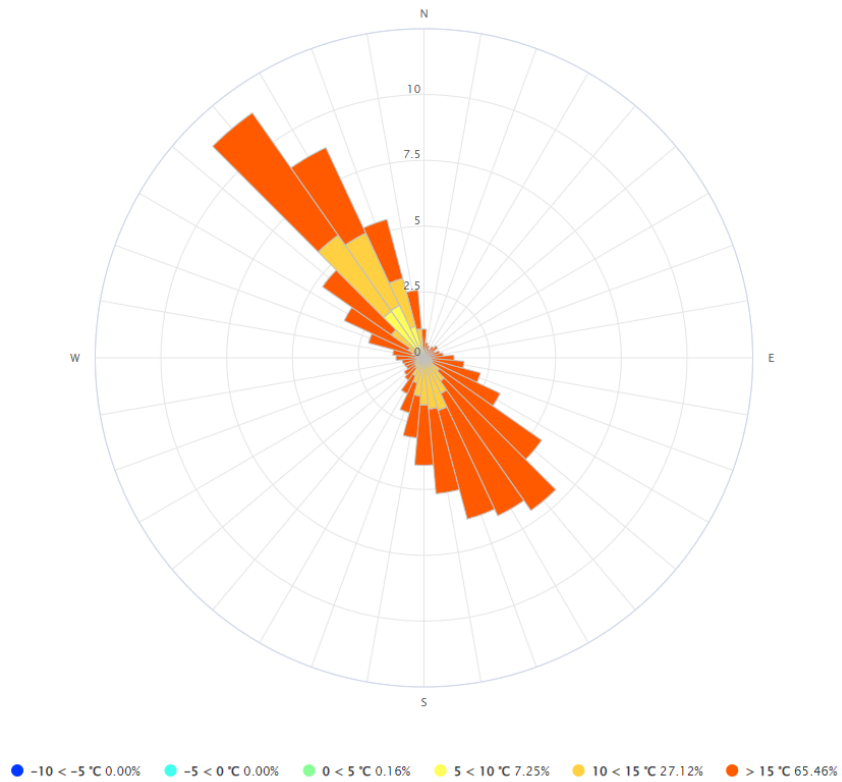
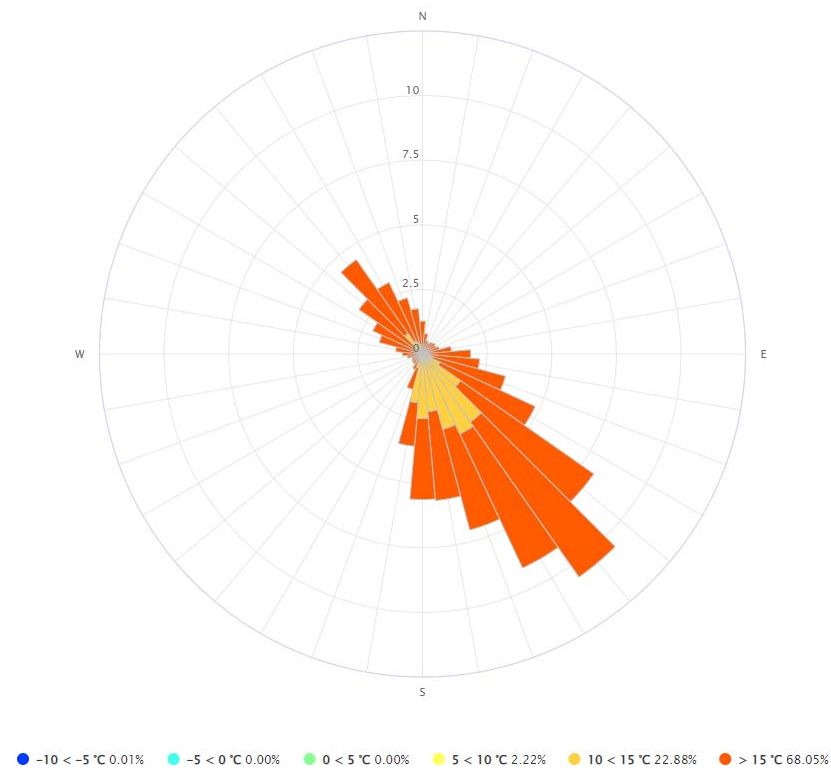
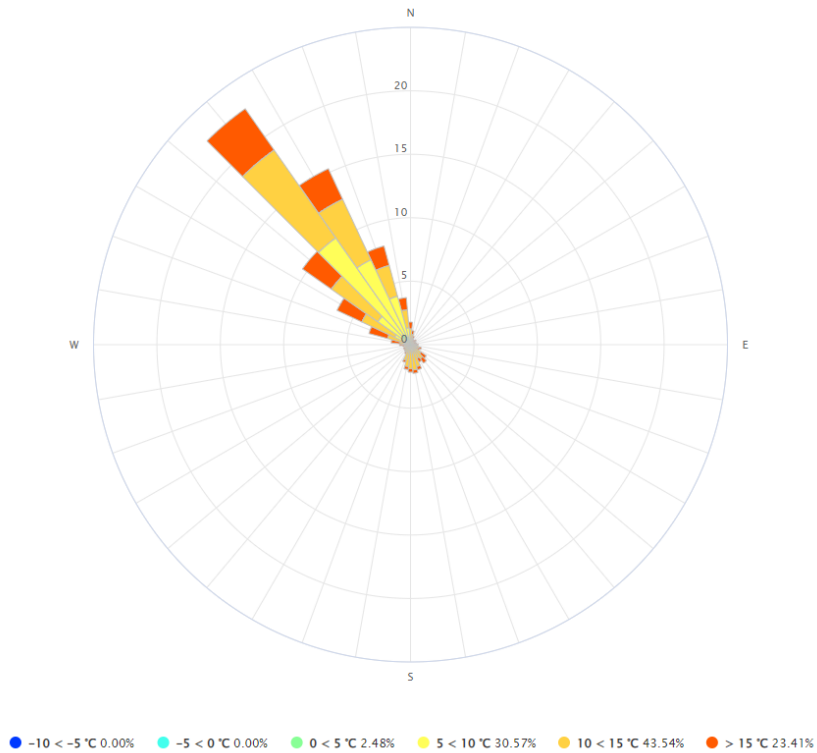
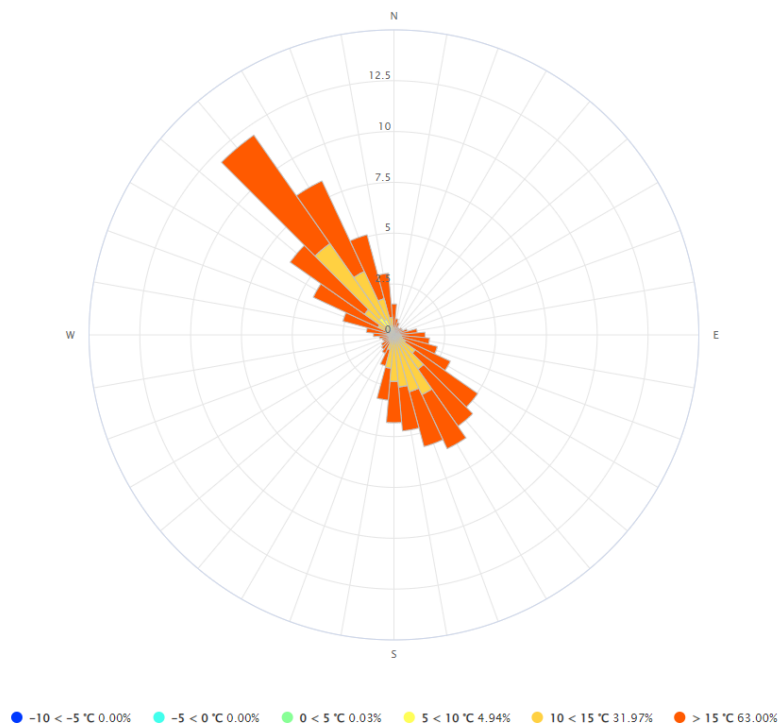
Figure 6 Windrose for Rix's Creek 2021

Figure 6 shows the seasonal wind roses generated for the site on a seasonal basis.

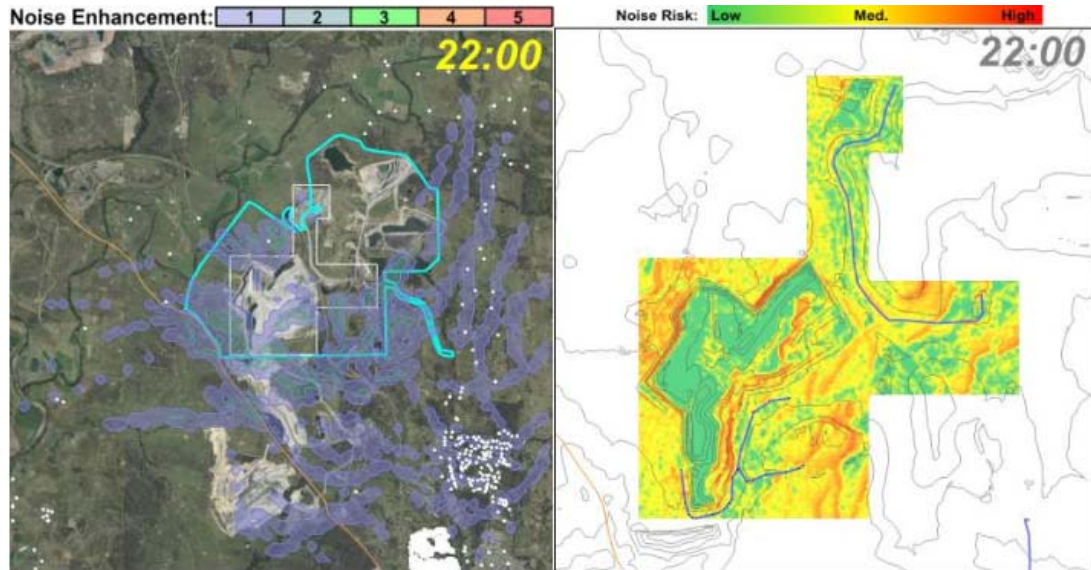
Figure 8 RCS and RCN predictive mine noise forecast models

During the period Rix’s Creek continued work with Todoroski Air Sciences (TAS) to refine the 3-D predictive noise model for the Mine. The meteorological data from the Hunter Valley Meteorological Sounding Group Joint Venture (HVMSGJV), meteorological forecasts for the Rix’s Creek mine site is used to develop half hourly predictions, of noise enhancement conditions, for each twenty four hours of mine production. This model has been validated over a period greater than six years and to date noise enhancement has been identified at offsite locations in accordance with the model’s forecast prediction.

*White dots indicate off-site receptors / residences closest to mining operation.

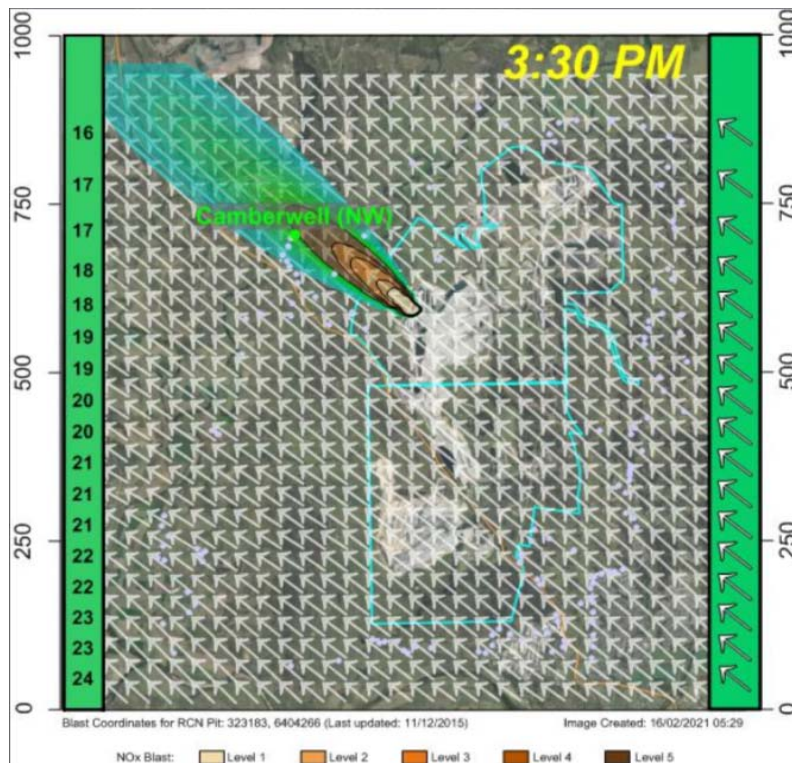
Figure 9 Blast Dust / Fume ‘Plume’ Model.

All blasts are monitored to record air blast overpressure and peak particle velocity at residences most likely to be effected. The modelling of dust and fume associated with blasting commenced during March 2012 and is constantly validated using DustTrak monitors, TEOM dust monitors and gas monitors as required. The monitoring was in conjunction with Rix’s Creek daily EnvMet and NOx emissions predictive modelling. The NOx modelling shows various predicted outcomes and has continued to provide an integral part of Rix’s Blast regime during 22020 and can be seen in Figure 9. The white dots on the model in Figure 8 are the closest residences/receptor’s that can potentially be impacted via blasting.

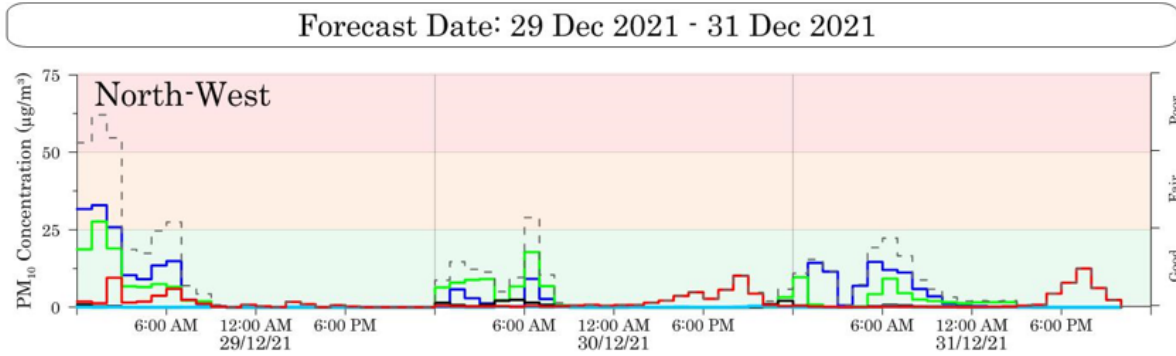
Figure 10 Example of dust forecasting tool to assist operations during 2021

Under adverse weather conditions the overburden removal and dumping operation is modified with dumping occurring either in pit or to areas not exposed to the prevailing winds, alternatively operations may be ceased until conditions are suitable. For blasting, information is used in a model to predict the potential for meteorological reinforcement of overpressure as well as directional travel of dust/fume from a blast. The model shows the likelihood which receptors that may be affected by the blast which in turn can alter the timing of the blast being initiated.

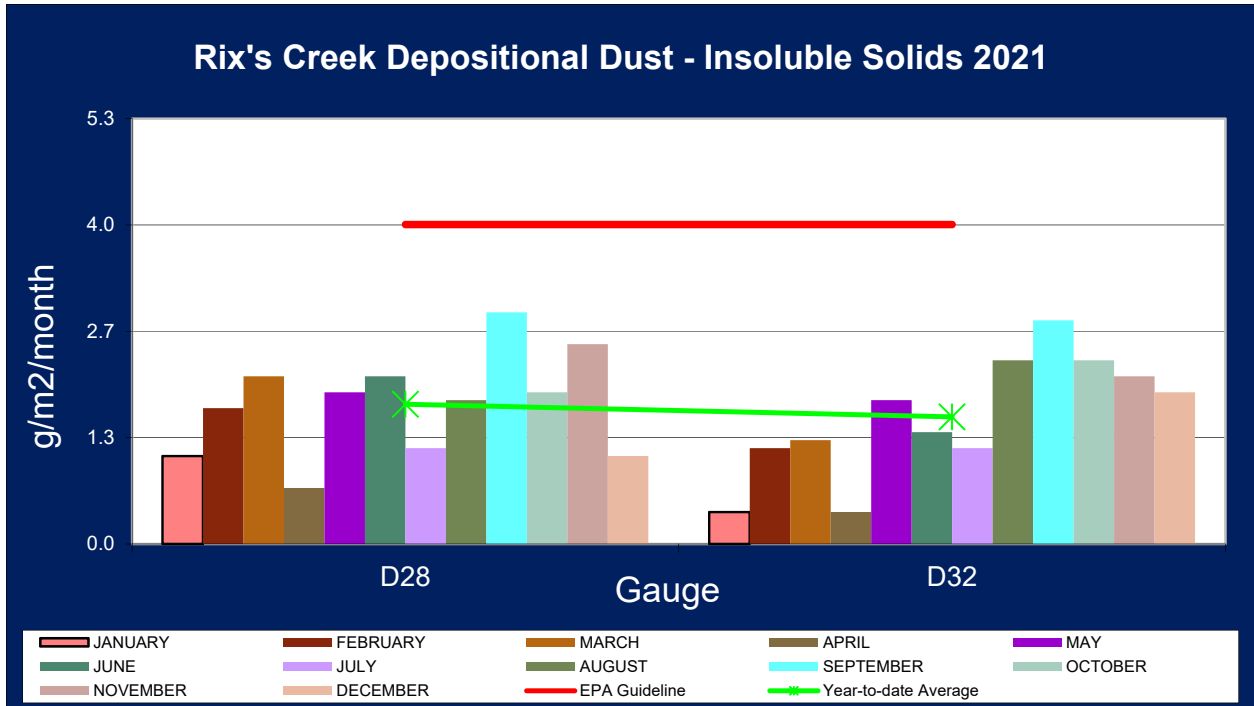
Figure 11 Rix's Creek Insoluble Solids Dust Deposition 2021

In 2021 there were no exceedance of the average result of 4 g/m²/month for either DDG28 and DDG32. Figure 11 displays the individual monthly insoluble solids deposition rates for each gauge and annual average deposition result in g/m²/month. There were no contaminated samples recorded in 2021.

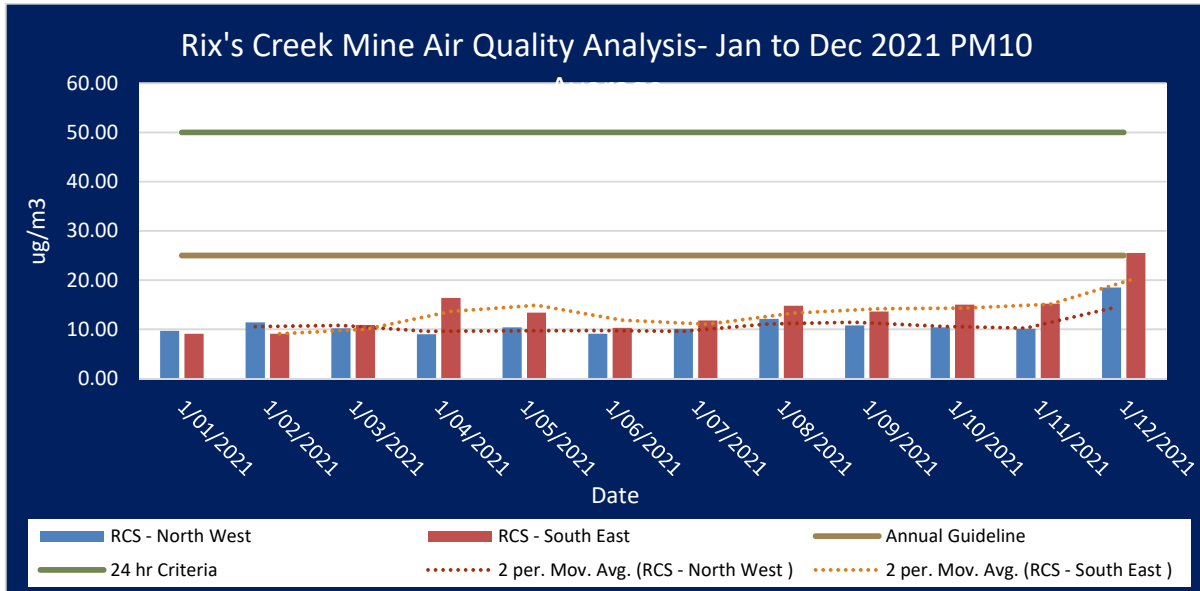
Figure 13 Particulate Matter <10 Micron Monthly and 12 Month Rolling Averages 2021 – DustTrak

The annual average for RCS North West DustTrak in 2021 was 10.56ug/m³ and RCS South East DustTrak recorded an annual average result of 13.53ug/m³. When compared to the modelling predictions for the 2021 privately owned receptors from the 2014 Rix’s Creek Environmental Assessment (EA), ID 173 which is the closest privately owned receptor to the RCS North West DustTrak modelled 39ug/m³ for the 2020 period. ID 140, which is the closest private receptor to the RCS South East DustTrak unit modelled 21ug/m³. Both DustTrak units were below the 2021 predicted modelling results in the 2014 Rix’s Creek EA.

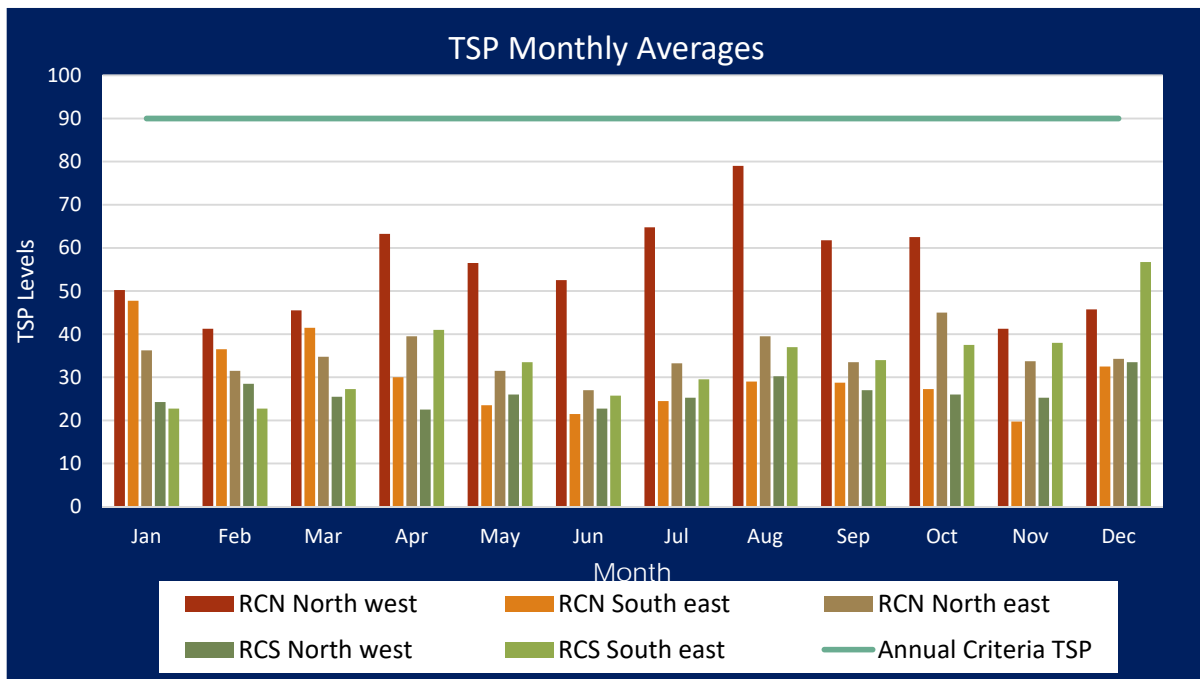
Figure 14 Total Suspended Particulate Monthly Averages for 2021

Total Suspended Particulate matter refers to the total dust particles that are suspended in the air and nominally defined with an upper size range of 30 micrometres (μm). TSP levels are inferred from the measured PM_{10} data by calculating that the TSP level is 2.5 times the measured PM_{10} level. This inference is derived from measurements in the report 'Particle size distributions in dust from open cut mines in the Hunter Valley' (SPCC, 1986). The results for 2021 have remained below the Annual Criteria of $90\mu\text{g}/\text{m}^3$ at all five monitoring points.

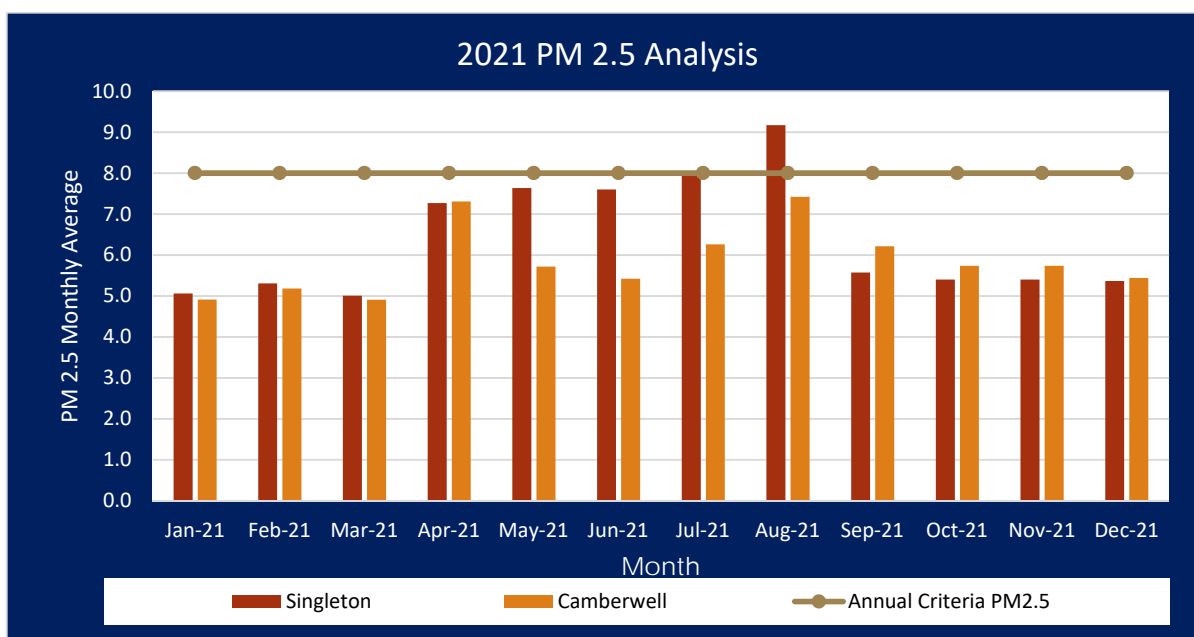
Figure 15 Monthly Particulate Matter 2.5 Analysis for 2021

Particulate Matter 2.5 refers to particulate matter with an aerodynamic diameter less than 2.5µm. PM_{2.5} is a measurement of regional airshed and is reflective of air quality over a larger area than direct source emissions as specific upstream and downstream mine site contributions such as PM₁₀. In accordance with Schedule 3 Condition 27 (d) of the RCN Project Approval data has been sourced from the Upper Hunter Air Quality Monitoring Network (UHAQMN) that was used in Figure 15. August 2021 results were above the annual PM_{2.5} criteria of 8ug/m³. All other months were below the annual criteria level for PM_{2.5}.

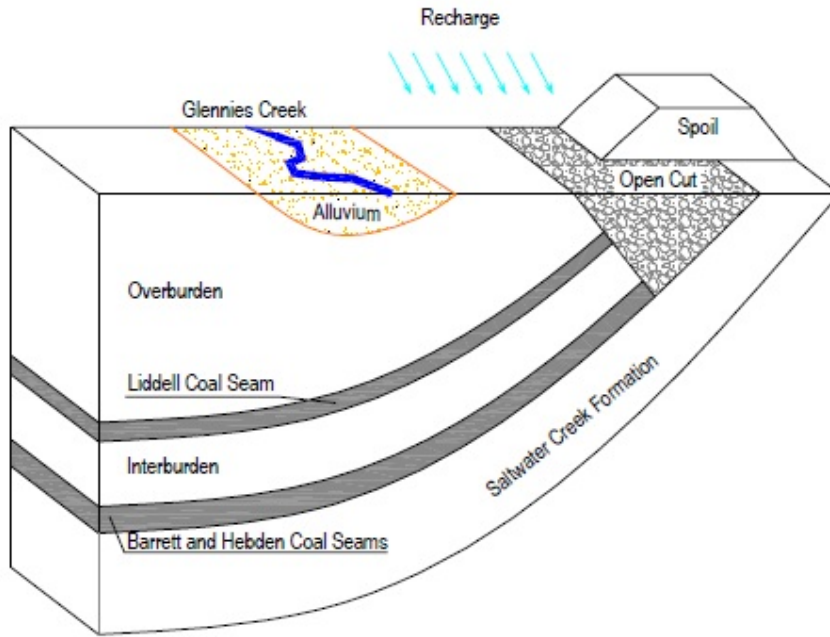
Figure 16 Conceptual Hydrogeological Model of the Rix's Creek Syncline area

Although geologically more complex on the local scale due to the splitting and merging of multiple minor seams, the aquifer system at Rix’s Creek has been simplified and represented by a layer cake style system, with the layer geometry reflecting the synclinal basin structure. Within the layer cake, the major coal seams represent the main aquifers, with the interburden units acting as low permeability aquitards between the aquifers. Within the coal seam aquifers, preferential groundwater flow is along the bedding. Large scale groundwater flow vertically between coal units is impeded by the low permeability interburden units consisting of siltstones, sandstones, tuffs and shales.

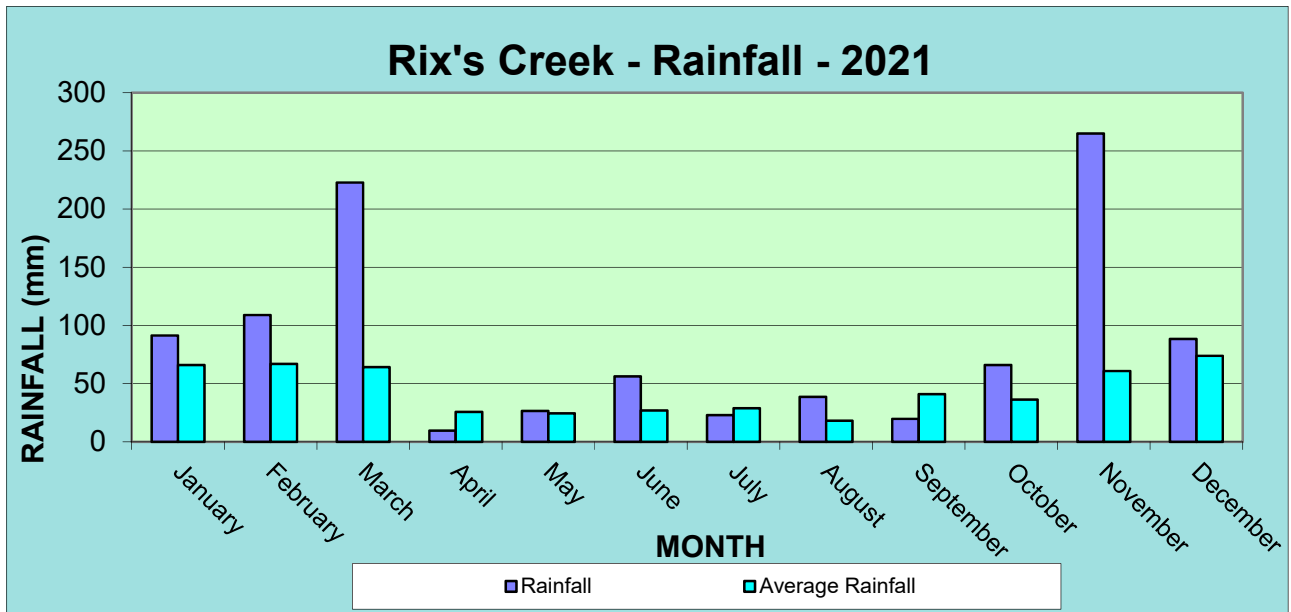
Figure 18 Annual Rainfall at Rix’s Creek 2021

- Over the review period, the only months to that didn’t exceed the monthly average rainfall were April (9.7mm), July (23mm) and September (19.8mm).
- 2021 annual rainfall at Rix’s Creek was 1,016.5mm, which is significantly higher than the long-term average of 640.5mm. March (222.8mm) and November (265mm) were more than 3 times the monthly average.

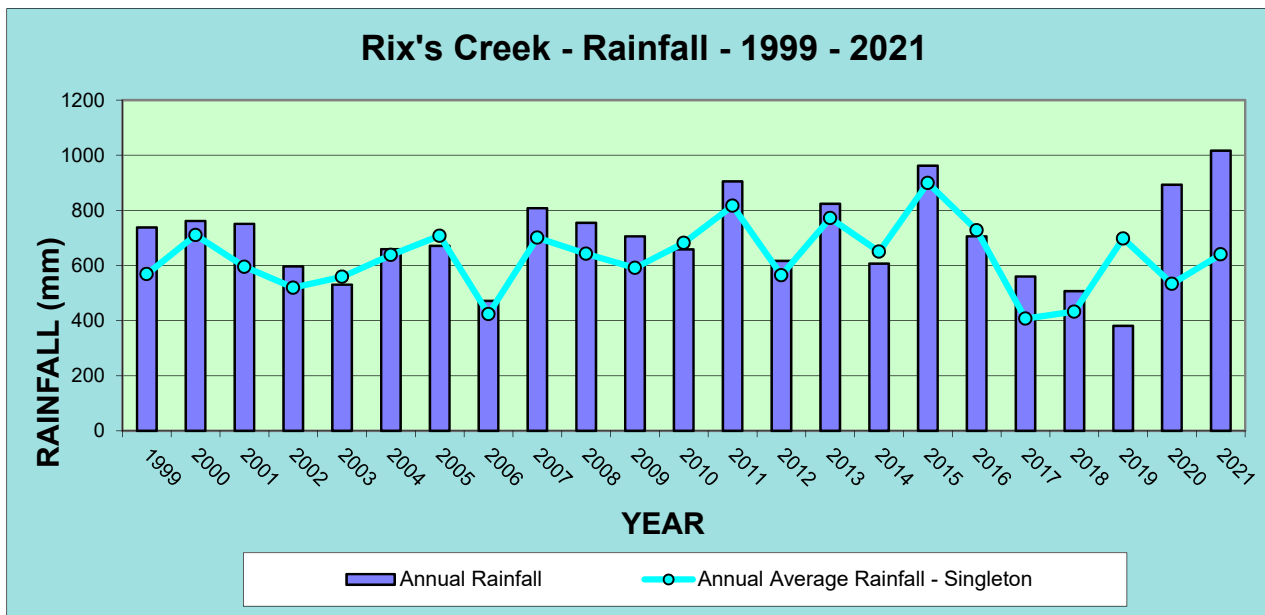
Figure 19 Annual rainfall at Rix’s Creek 1999-2021

Annual rainfall results are plotted for the last 23 year historic rainfall average and are presented in Figure 19.

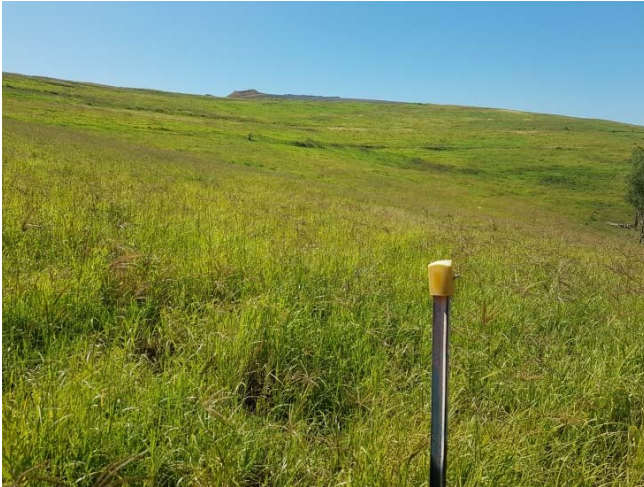
The high growth rates of the tropical pasture species sown on the rehabilitated land has resulted in high ground cover levels, productive cattle feed and a stable pasture base.

Good ground cover levels have been maintained in the rehabilitated pastures, remaining above 80% on average over all recordings. This has reduced the erosion risk considerably despite the heavy rainfall events experienced.
