# **BLOOMFIELD COLLIERY**

## **Annual Environmental Management Report 2012**

# Bloomfield Collieries Pty Ltd

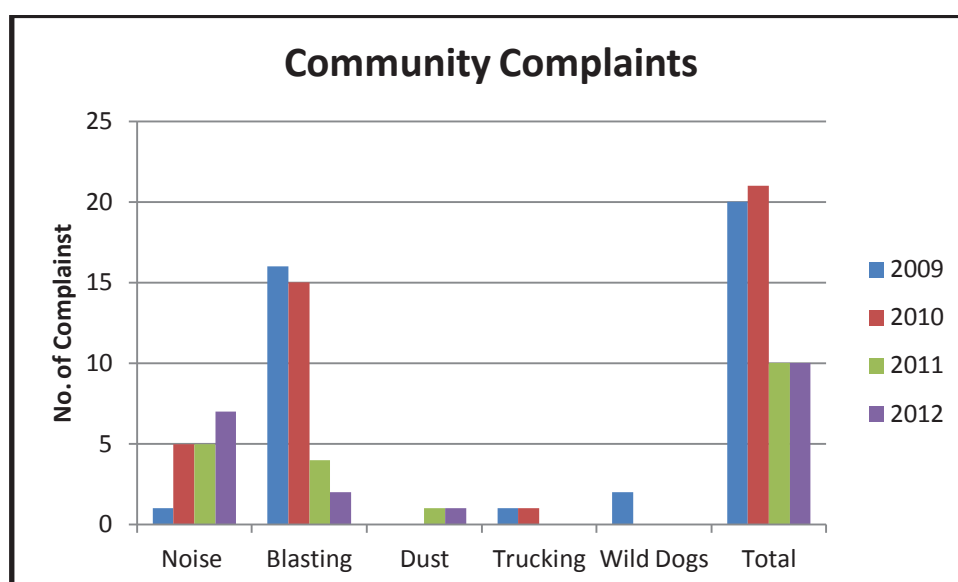
**Figure 10: Community Complaints**

Figure 10 displays a comparison of complaints with previous reporting periods, which demonstrates a decline in the number of complaints received.
