BLOOMFIELD COLLIERY

Annual Environmental Management Report 2014

Bloomfield Collieries Pty Ltd

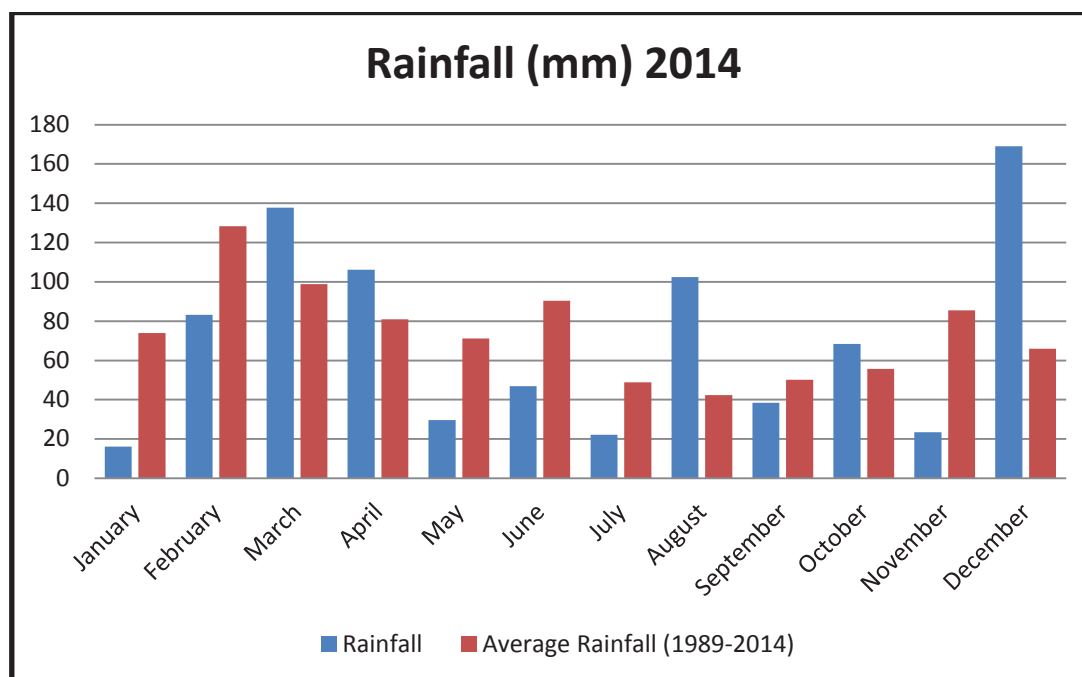
Figure 1: Rainfall

A comparison of monthly recorded rainfall for the 2014 reporting period and annual average data is shown in Figure 1. The total rainfall for the twelve month period was 844 mm. This was 48mm below the annual average of 892 mm.

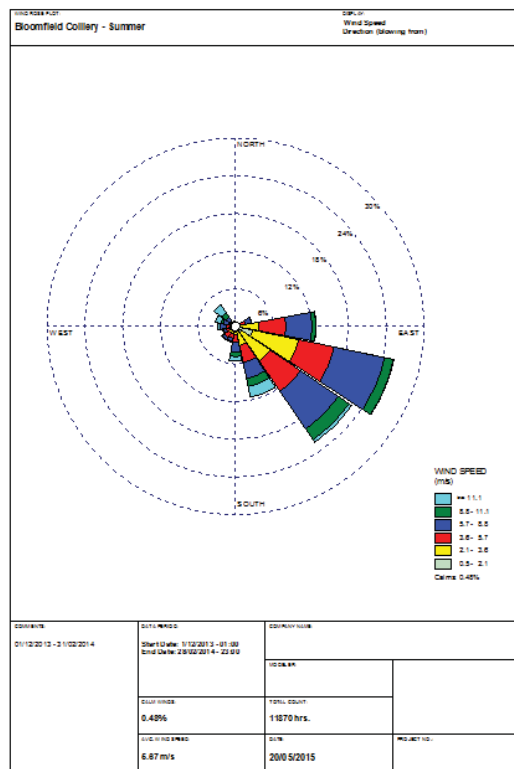
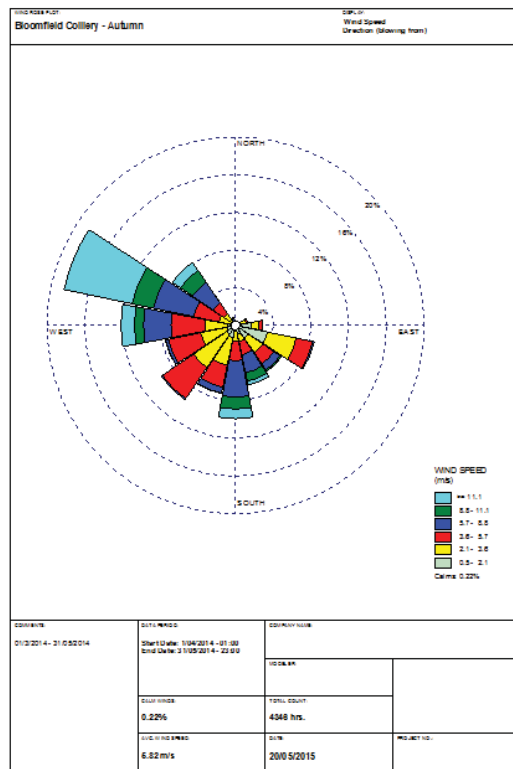
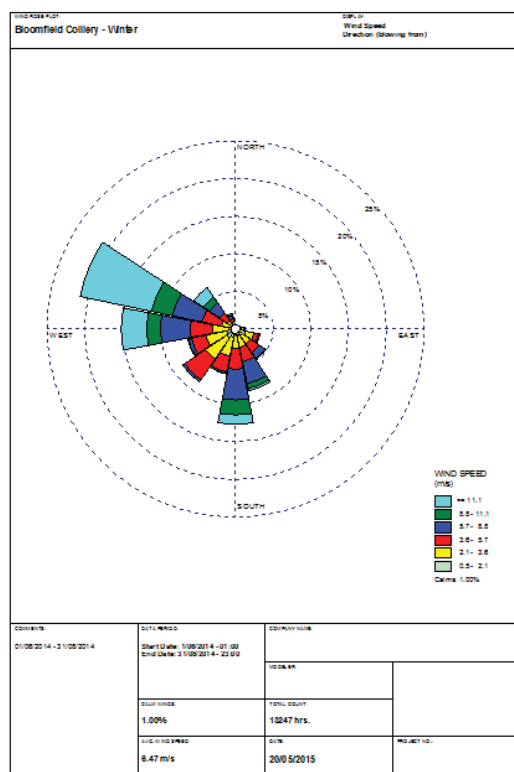
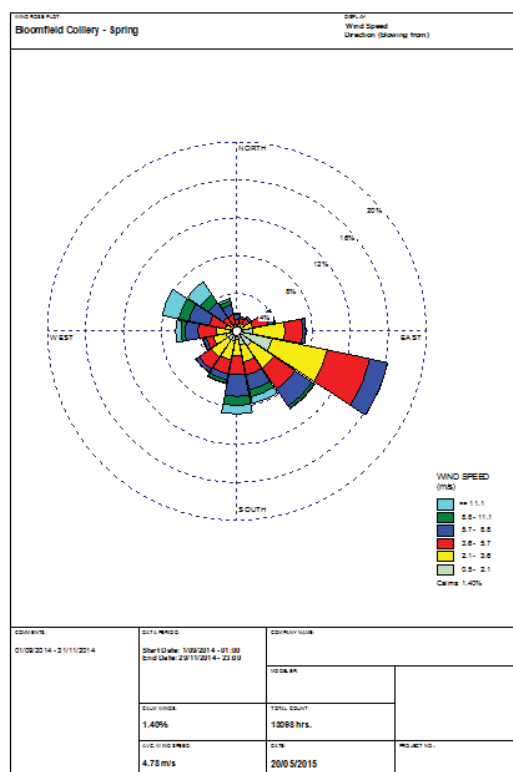
Figure 2: Windroses for Bloomfield 2014

The results of wind speed and direction monitoring shows a pattern typical in the Hunter Valley. During summer the winds predominate from the south east and winter the west-northwest. Autumn and spring are transitional seasons with winds distributed between both northwest and south-easterly directions. Figure 2 shows the seasonal windroses generated for the site on a seasonal basis.

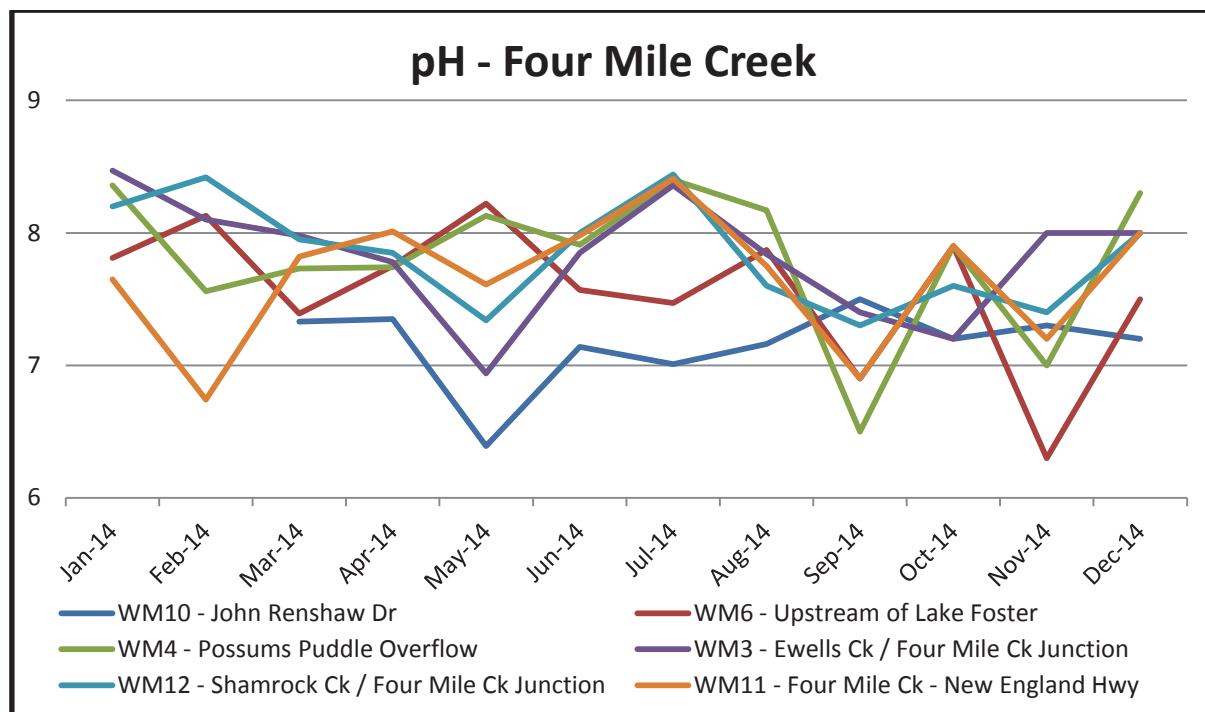
Figure 4: pH of Four Mile Creek

Figure 4 shows the pH levels in Four Mile Creek are generally consistent with ANZECC water quality guidelines (pH 6.5-8.5). pH levels vary due to rainfall and mine discharge therefore monthly and yearly trends cannot be assessed.

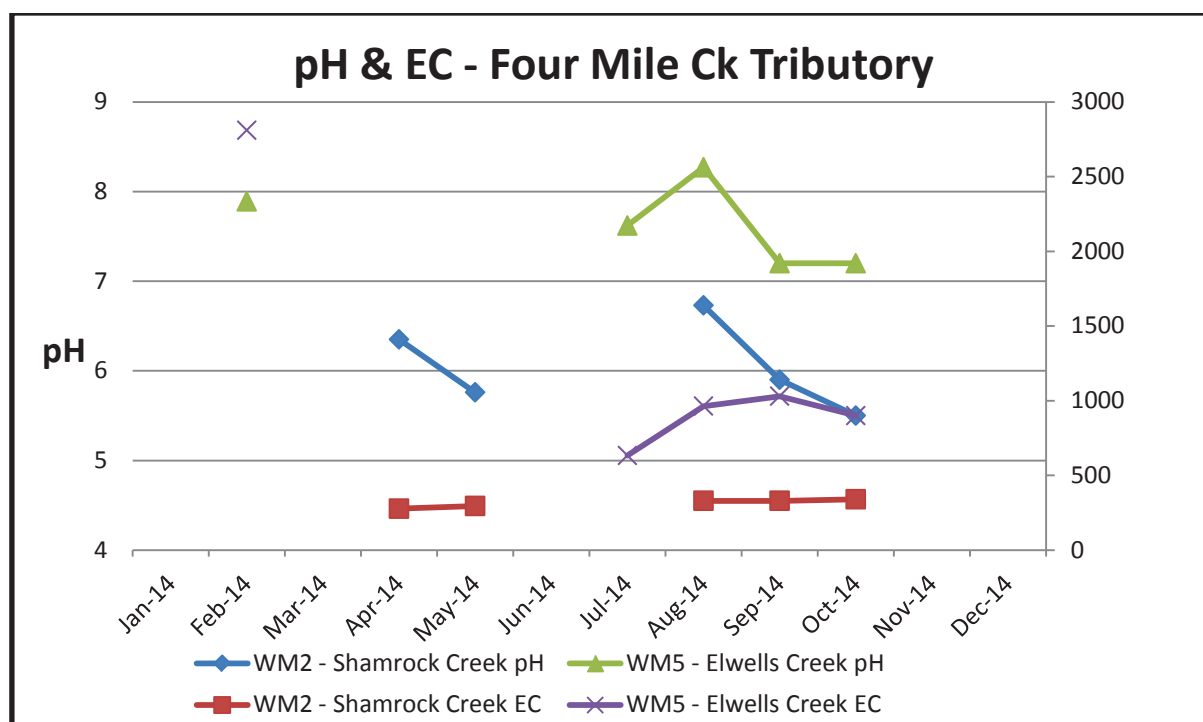
Figure 6: pH & EC in Four Mile Ck Tributary

Figure 6 shows the pH and salinity levels in Four Mile Creek tributaries are generally consistent with ANZECC water quality guidelines (pH 6.5-8.5 & EC 125-2200). These tributaries are ephemeral streams and are often dry. This results in gaps in the graphed data.

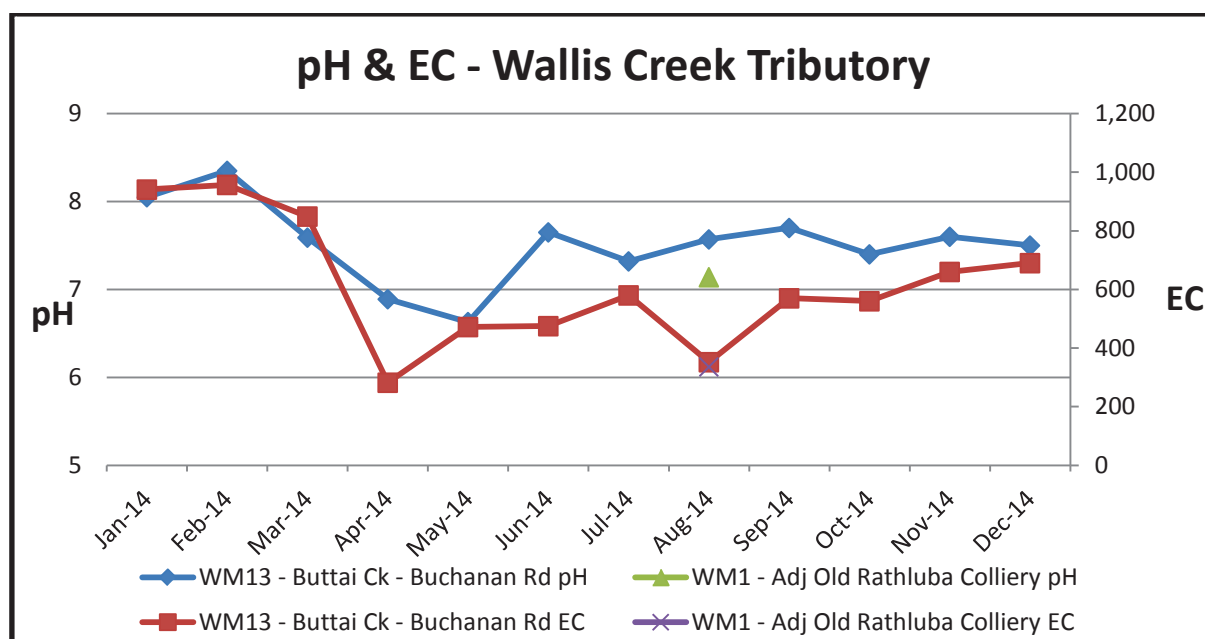
Figure 7: pH & EC in Wallis Ck Tributary

Figure 7 shows the pH and salinity levels in Wallis Creek tributaries are generally consistent with ANZECC water quality guidelines (pH 6.5-8.5 & EC 125-2200).

Previous results indicate that the surface flow adjacent to Rathluba has historically been of low pH, regardless of mining impacts. Prior to 2006 pH results were less than 4 however pH levels have been steadily increasing since then. This drainage line carries surface flow from non-mining land and rehabilitated mining land, indicating that other off-site effects may be influencing the water quality in the area. The drainage line is ephemeral and is usually dry resulting in gaps in the graphed data.

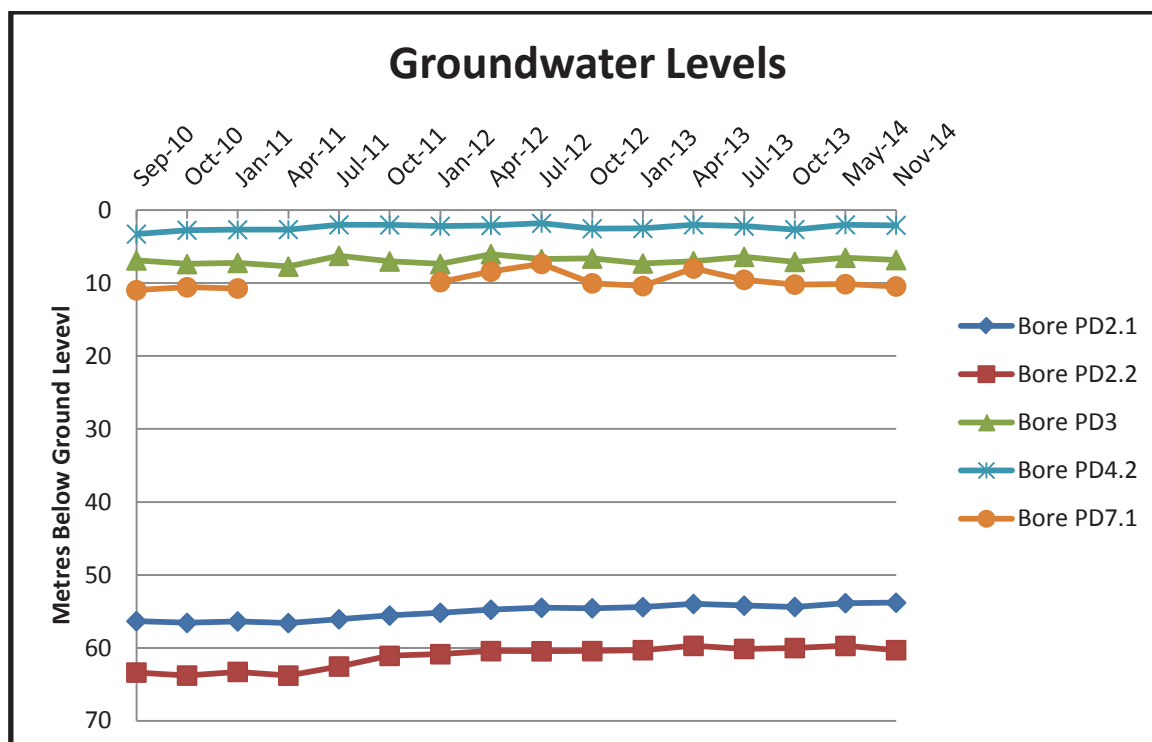
Figure 8: Groundwater Levels

Monitoring was undertaken during the period and the results for 2014 and previous years are summarised in Figures 8 – 10, with the full data set provided in Appendix C. The results are fairly consistent and do not show any real trends. Bore PD7.1 shows variation in EC levels. The S Cut high wall has moved west and is now within a few metres of Bore PD7.1. This may have some bearing on EC levels.

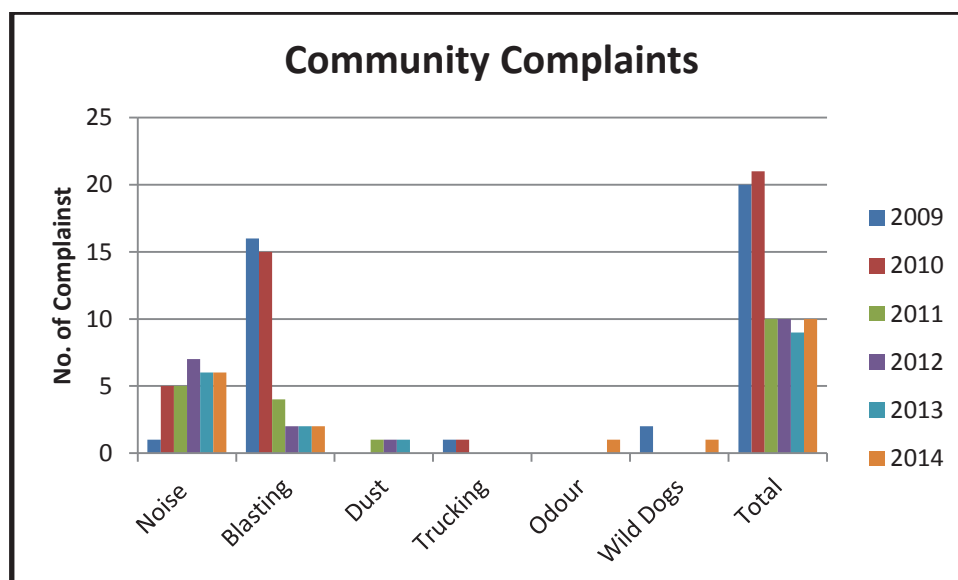
Figure 11: Community Complaints

Figure 11 displays a comparison of complaints with previous reporting periods, which demonstrates a decline in the number of complaints received.

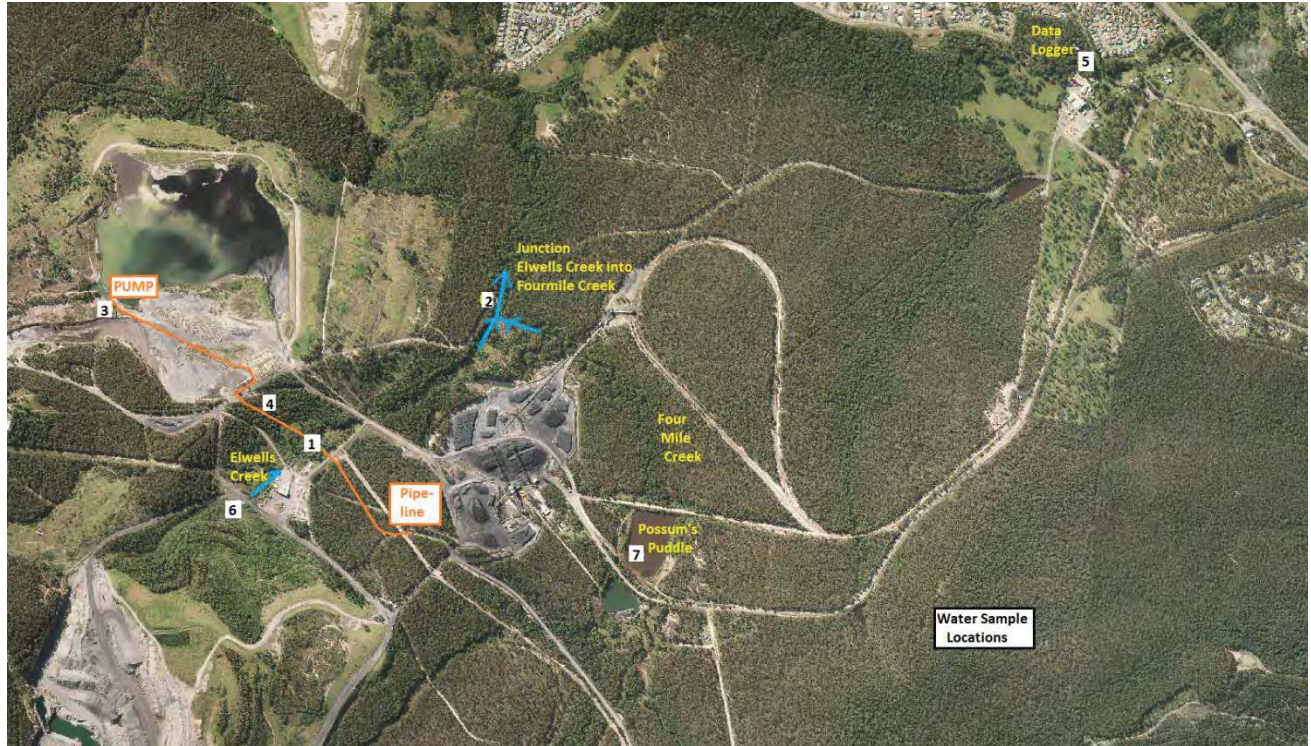
Figure 1: Location Diagram.

Note: Locations shown in Figure 1

- ❑ There was no detectable impact on Four Mile Creek water quality as shown from the logger situated at sample Site 5 in Figure 1 and shown in Graph 1.

- ☐ Four Mile Creek was flushed with clean water from Possum's Puddle Dam located upstream of the release on Four Mile Creek to negate any possible impact of the recycle water leak into the Creek. Field samples taken from Four Mile Creek after flushing on Friday 9th May 2014 are tabulated In Table 2.
- ☐ Possums Puddle Dam is a clean water dam located on Four Mile Creek and is not part of the mine water system.

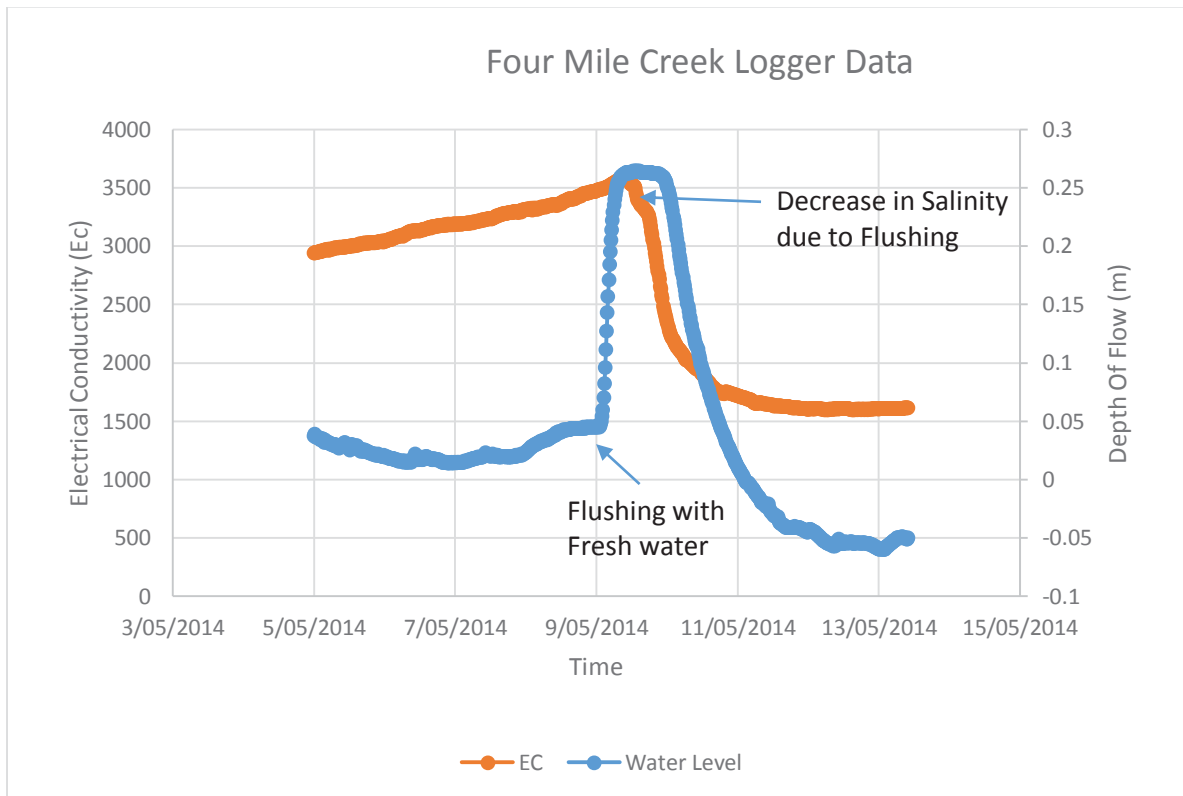
Graph 1 – Four Mile Creek Logger Data

- ❑ Monitoring results indicate the release of recycle water had no detectable impact on water quality in Four Mile Creek. See Graph 1 below.

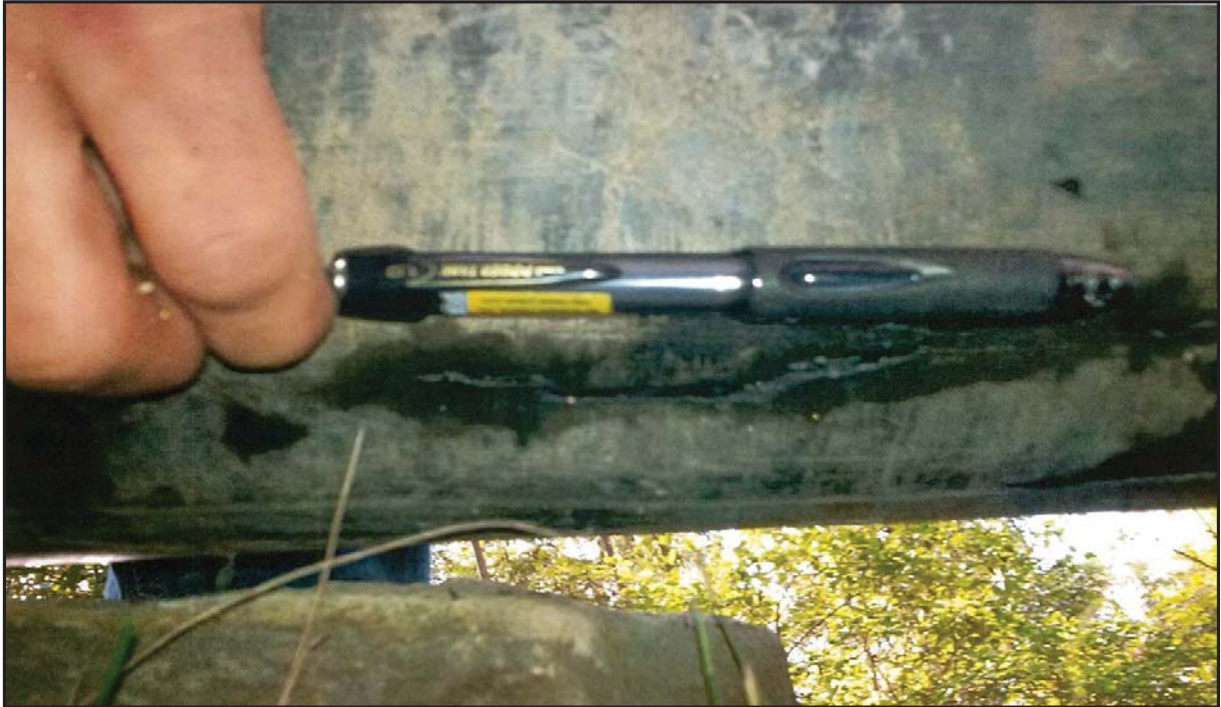
Photograph 1: Split in Pipe.

- ❑ The leak occurred after Tuesday 6th May at 1.30pm as Jeff Dunn was in the same area and did not notice any water running down alongside the pipe.
- ❑ The leak resulted from a split approximately 4 cm in length on the bottom side of the pipe. See Photograph 1.

- ❑ It is unknown how much recycled water discharged. It is estimated the flow from the split was approximately 5 litres per second.
- ❑ The amount of recycle water estimated to have been released from split in pipe is between 450-700 cubic metres. The 700 m³ is a worse case figure calculated back to when Jeff Dunn inspected the area on Tuesday 6th May 2014 when no water was running.

- ☐ The pipe split sometime between 6th May 1.30pm and 7th May 1.45pm, causing a leak of recycled water and a possible discharge into Four Mile Creek.
 - ☐ The pipe was PN8 grade and second hand when installed some years ago.
 - ☐ There was no air valve installed until only five years ago, possibly resulting in the distortion of the pipe when filling and draining weakening the wall.
 - ☐ No evidence that the release water reached or had an impact on water quality in Four Mile Creek from sample results.
 - ☐ As a precaution immediately after discovery of the leak clean water was pumped into Four Mile Creek to flush the creek and negate any possible impact.
 - ☐ Sample results have demonstrated that the recycle water released would have met EPL 396 quality limits had a rainfall event allowed an approved discharge.
-

- ❑ The entire 6 m length of pipe is to be replaced with PM 10 rating poly pipe when repaired.

- ☐ Replace the pipe and the entire remaining PN8 quality pipe with PN10 where practical.
 - ☐ Conduct a review of all pipes and ensure that those with a higher risk ranking have sensors at each end of the pipe with appropriate warning systems installed. Small size of leak may not have been detected by flow monitoring sensors. Also consider if these pipes should be buried in the event of a bush fire.

- ☐ Have the areas around the pipe maintained and sprayed to assist with visibility (if decision is not to bury the pipes as above).
 - ☐ It was noted that the air valve was leaking as well. Move the position of the valve to the opposite side of the road so if there is a leakage it goes into the tailings and doesn't discharge off site.

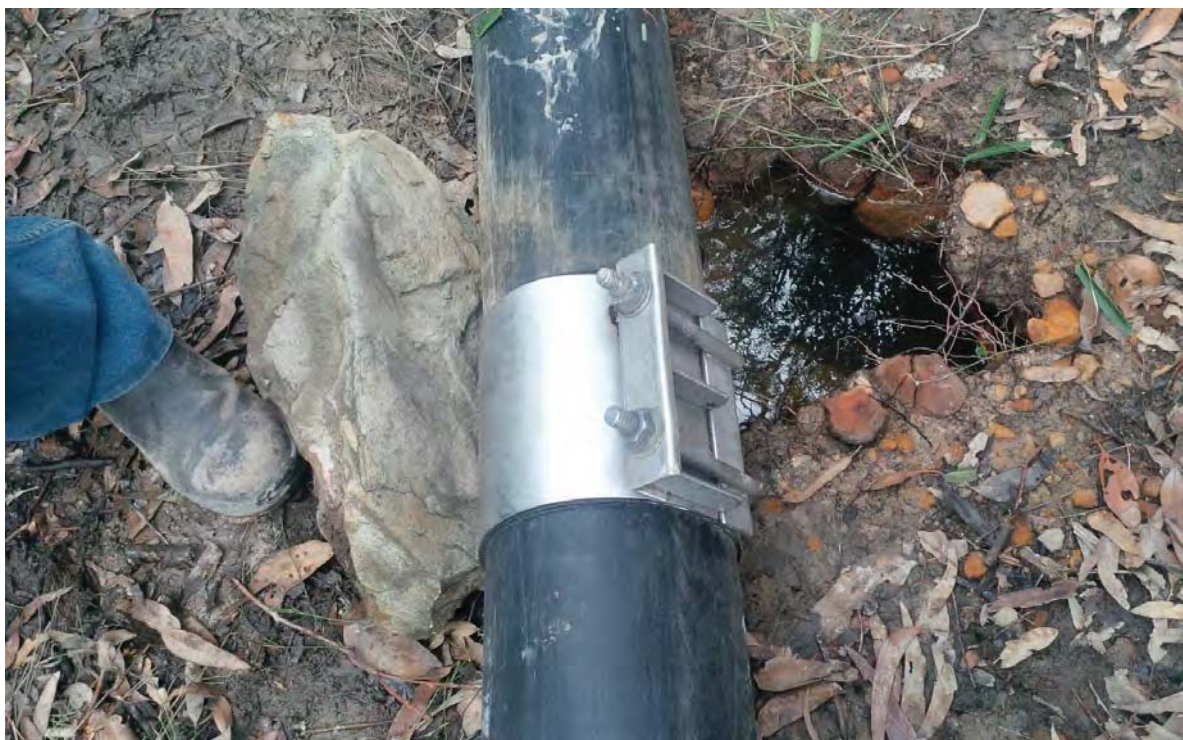
Photograph 2: Previous Repair Clamp & Hole Caused by Leak

- ❑ A previous split in the pipe occurred some 3-4 years earlier adjacent to the current leak. An employee who started the pump on return noticed the spray in the air and immediately shut the pump down and repaired the leak using a metal stainless steel clamp (See Photograph 2). No recycle water reached Elwells Creek.

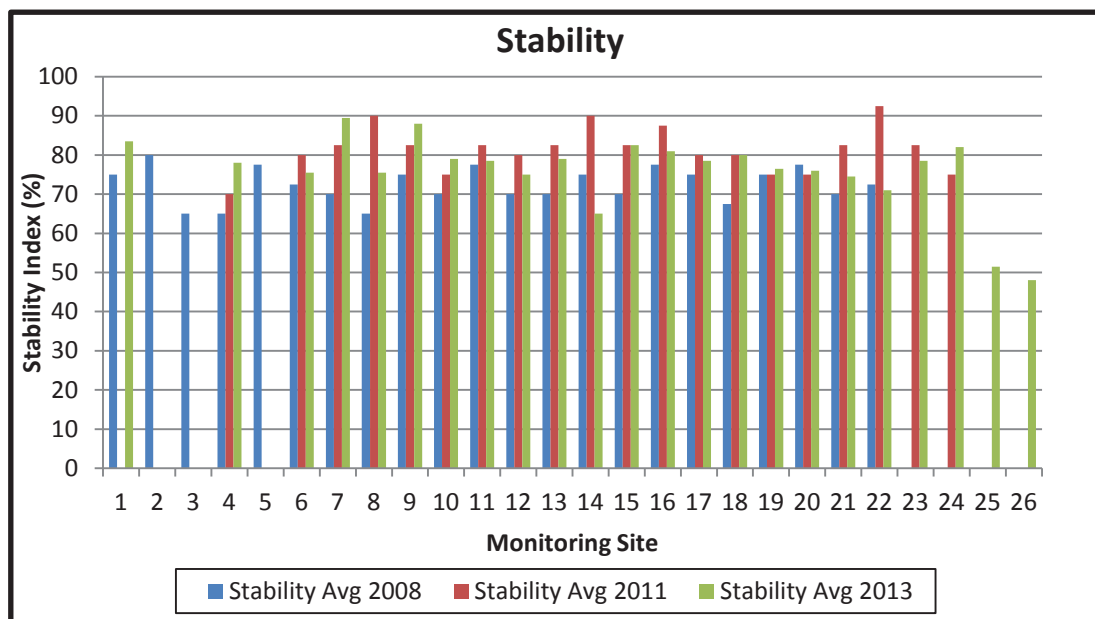
Stability is defined as the ability of the soil to withstand erosive forces, and to reform after disturbance.

The older established sites are fairly consistent and the variation in the stability index can be put down to inconsistent annual rainfall. In 2011 monthly rainfall was above average for

most of the year resulting in many sites having a spike in the stability index when compared with other years. The second half of 2013 was below average rainfall in the lead up to the rehabilitation monitoring.

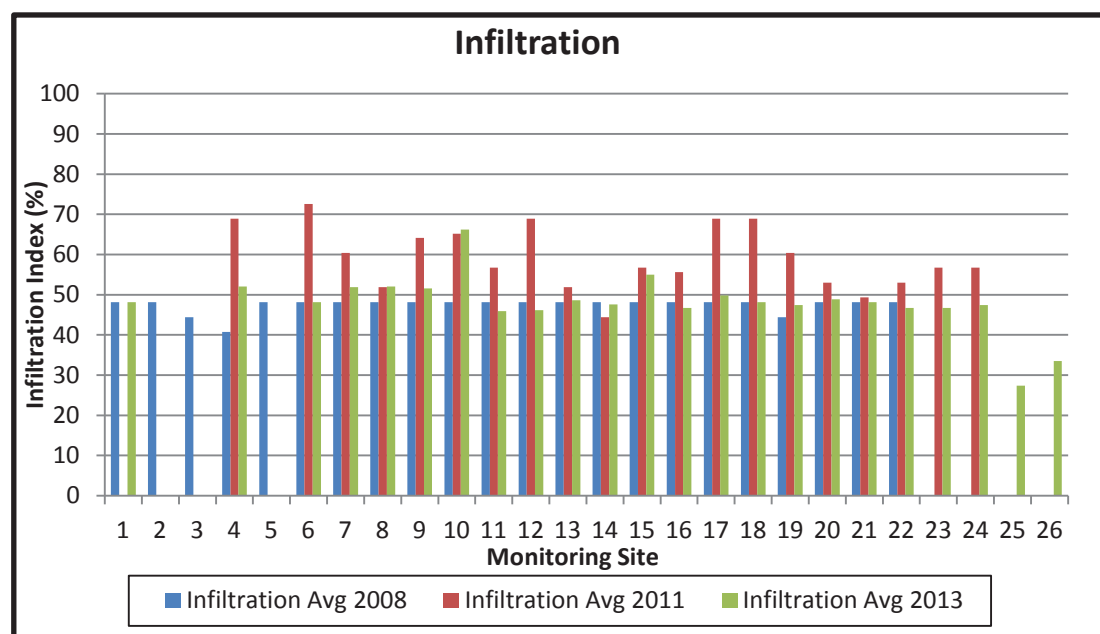
Infiltration is defined as how the soil partitions rainfall into soil-water (water available for plants to use), and runoff water which is lost from the local system, or may also transport materials (soil, nutrients and seed) away.

The index demonstrates the impact of the above average monthly rainfall in 2011 having higher infiltration rates. Alternatively the 2013 results are linked with hard surface-setting (crusting) soils following a dryer than average period.

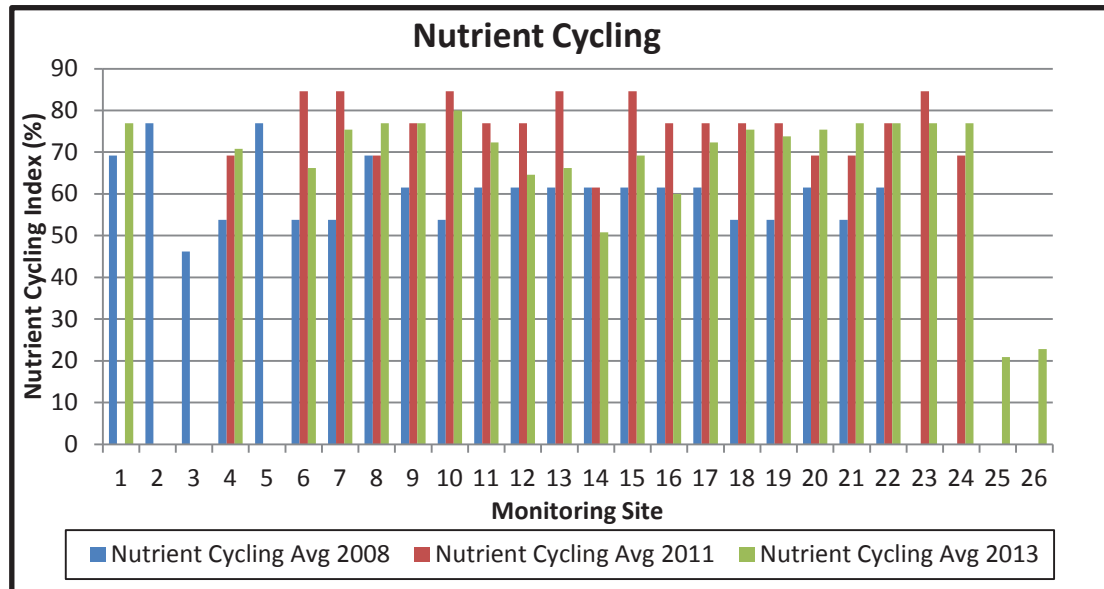
Nutrient cycling is defined as how efficiently organic matter is cycled back into the soil.

For nearly all sites the nutrient cycling index improved between 2008 and 2013, with a spike in 2011 due to the above average monthly rainfall.
