### Bloomfield Open Cut

### MANAGEMENT PLAN

Doc No: EMP001- Historical Heritage Conservation Management Plan

### Heritage Condition Assessment

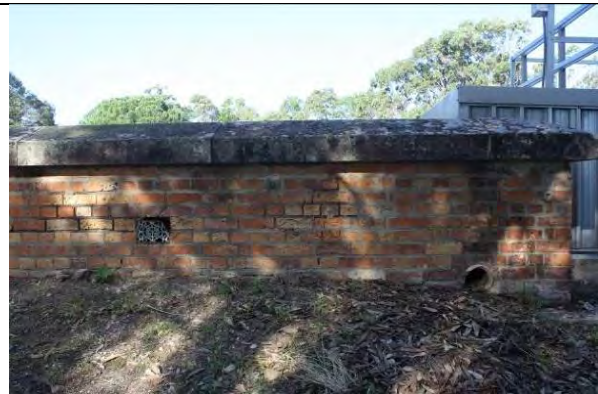
Plate 15

No repointing has been done along the lowest visible course of brickwork. It appears the repointing has only been done to the bricks that were visible above the level of the ground level at that time. A section of the wall at the western end is visible below the level where the terracotta pipes were located. The mortar around these bricks has thinned and errored out on the façade wall (Plate 15).

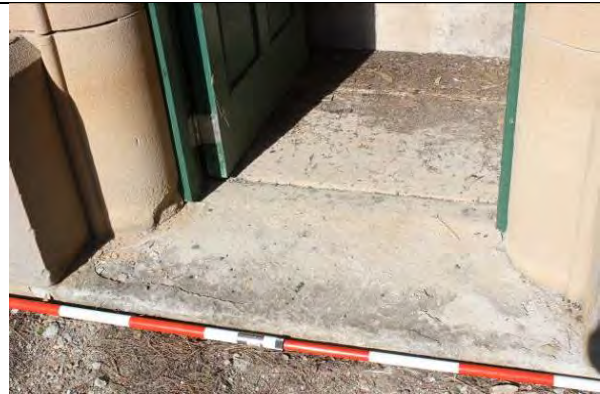
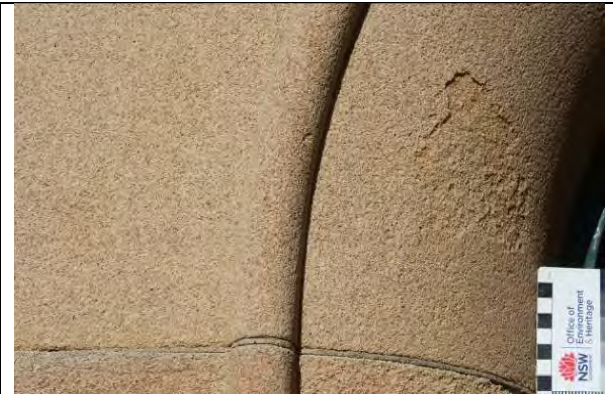
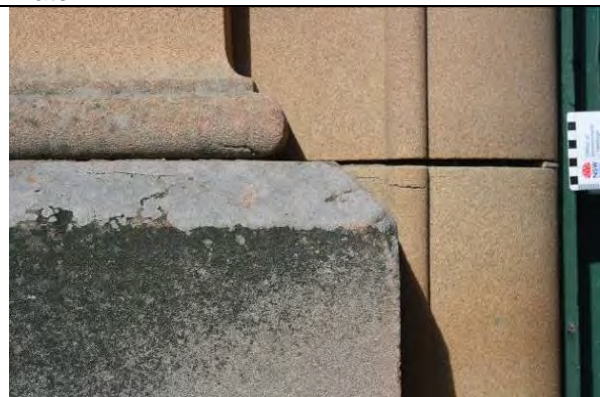
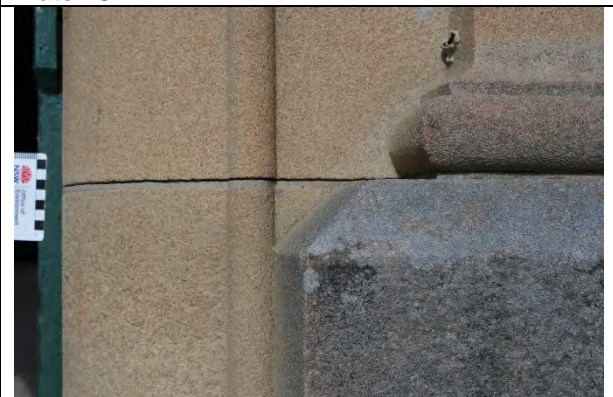
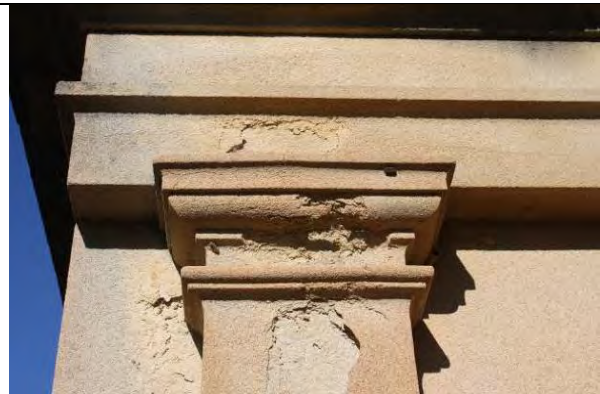
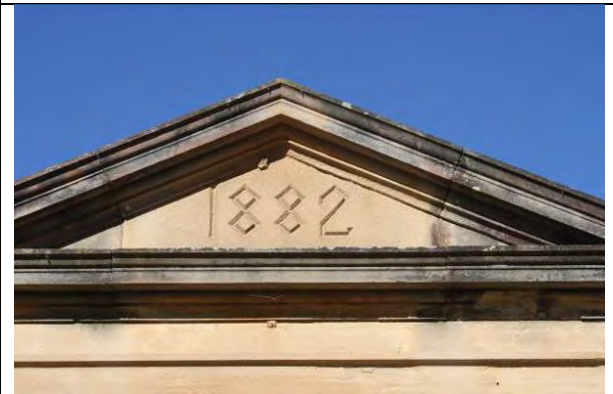
The sandstone portico consists of a decorative sandstone façade set onto the front of a small brick entry structure with an arched brick roof. There is a round window at the back of the portico, overlooking the reservoir, the glass of which has been replaced with a rusting steel grille. Entrance to the portico is gained through an arched panelled timber door, which is painted green. The portico has a cement peaked roof that is unflushed. There is exfoliation of the skin of the sandstone on both columns and around the door within the arched sandstone entrance. Some of the sandstone blocks have started to separate around the doorway, and within the top section around the date (Plates 17 to 22).

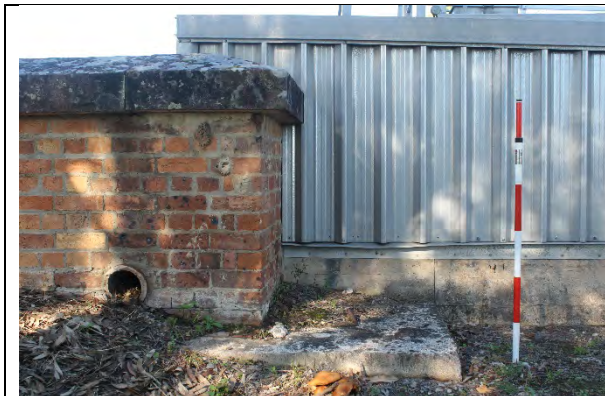
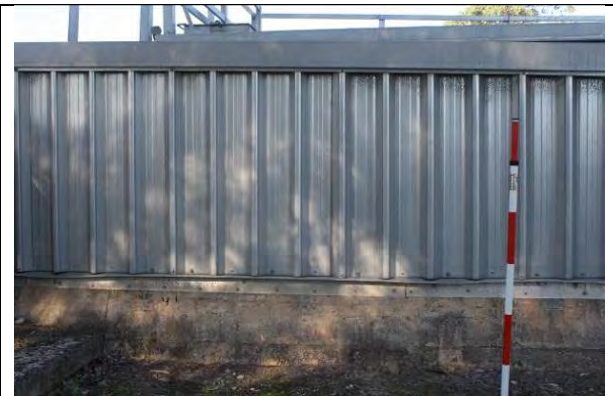
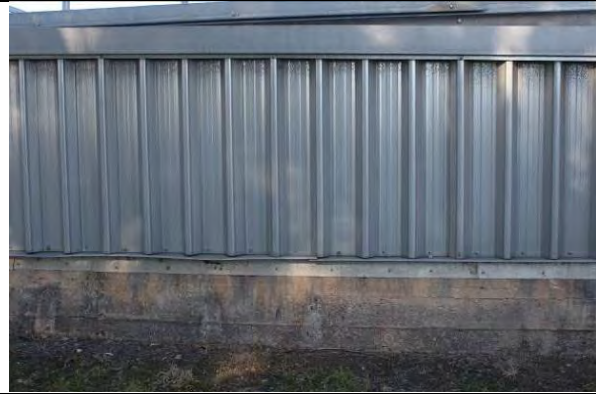
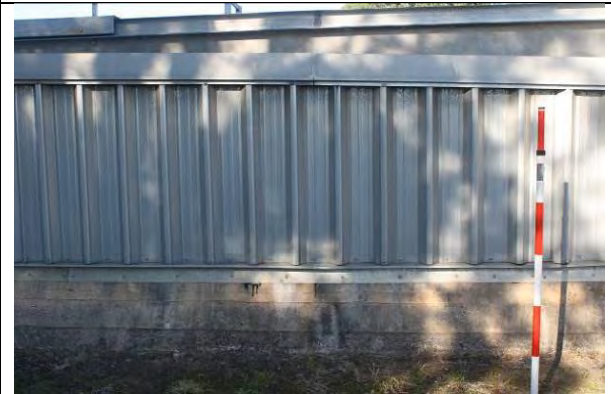
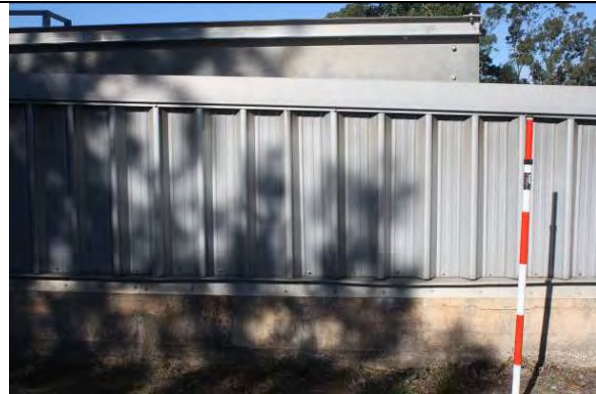
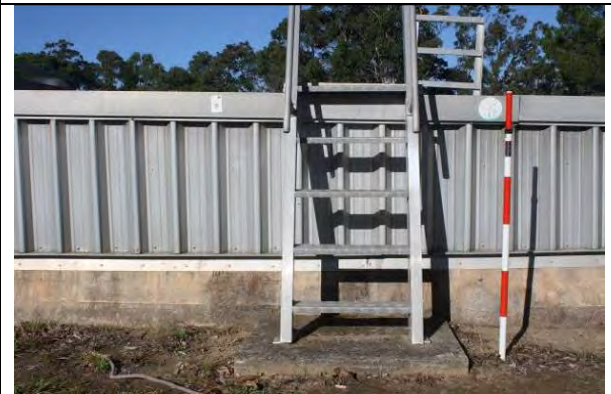
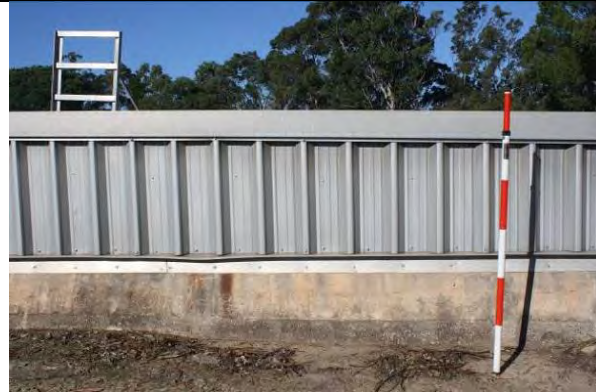
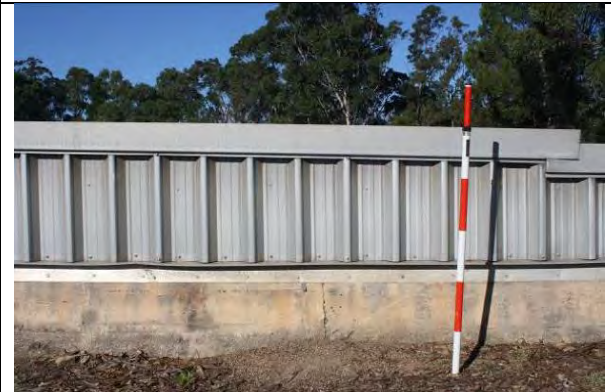
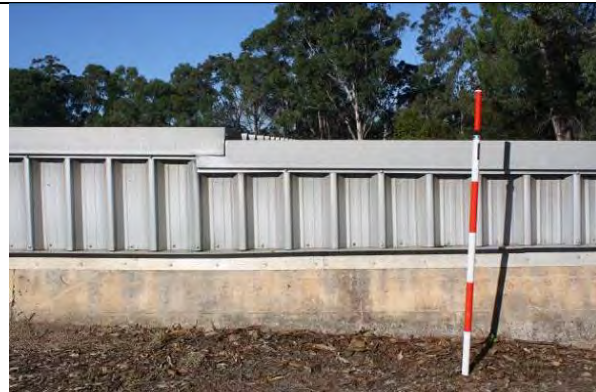
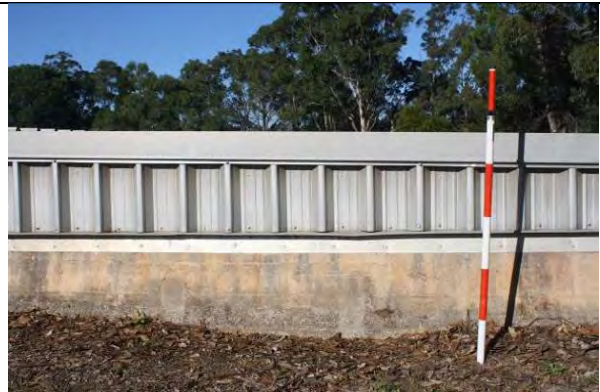
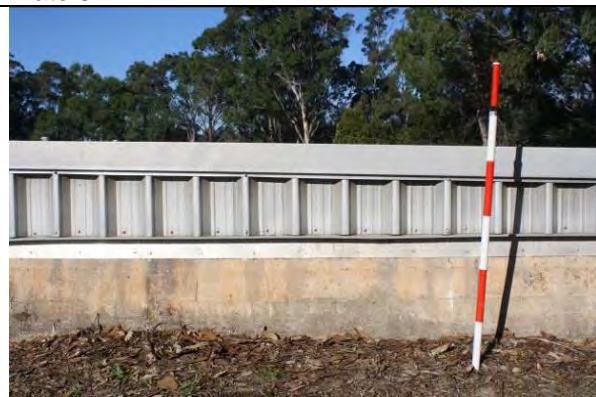
Reservoir No 2 abuts and joins to Reservoir No 1. The steel sheeting and flashing that connects the two is set back from the façade of the Reservoir No 1, and has been cut around and over the top of the brick and sandstone work present on the western wall of Reservoir No 1. The lower concrete wall of Reservoir No 2 is only visible for approximately 0.4 metres above the current ground level around the reservoir. The roof of Reservoir No 2 is higher than that of Reservoir No 1, which slopes from the east where it meets with Reservoir No 1 down towards the western corner of Reservoir No 2. The roofing section consists of a steel flashing immediately on top the concrete wall, with a steel profile panel wall forming the façade to the roof. The steel associated with Reservoir No 2 is all new and is all considered to be in good condition (Plates 23 to 36).

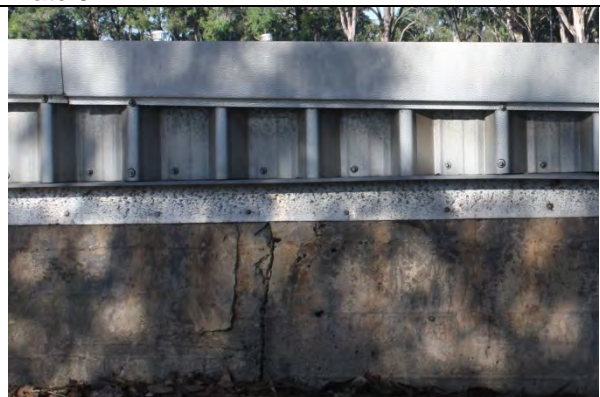
Plate 33

The concrete walls appear to have been cast *in situ*, with the timber formwork impression and casting joint still present in the concrete, with the wall raking inward. The concrete wall is in good condition. There is one casting joint present approximately five metres in from the western corner that has cracking and some exfoliation of the outer skin of the concrete (Plate 34).

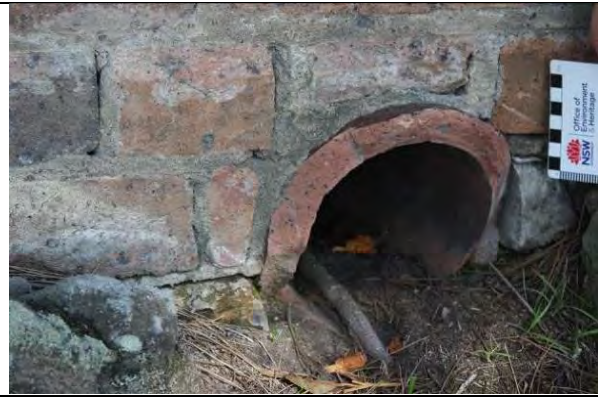
Plate 37

At the base of the visible façade are seven terracotta pipes that are evenly spread along the wall. These penetrate through the brick wall and take water off of the roof of Reservoir No 1. Each of the terracotta pipes are in working and good condition. The ends of the pipes have been cracked and fractured (Plates 37 to 43).

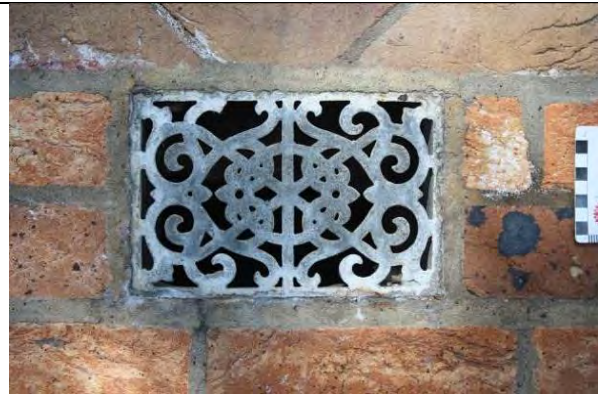
Plate 44

Almost the whole of the northern façade brickwork has been repointed. This has included around the six grills present in the brickwork. The tops of the decorative grills are located four courses below the capping stone. The brickwork immediately above the cast iron grills were cut on an angle when the wall was constructed to fit the grills, but more recent repointing work has covered over some of the bricks and attempted to recreate the detail in the original cut brickwork (Plates 44 to 48).

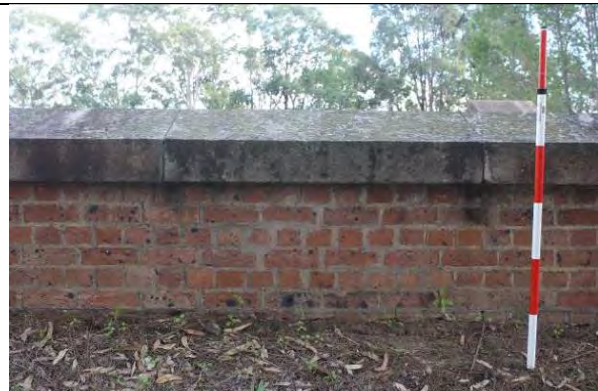
Plate 53

The brickwork along the eastern façade of Reservoir No 1 is generally in good condition. There is evidence of some patches of repointing that have occurred to the mortar joints (Plates 53, 54, 55, 59 and 69). Also, at the southern end of the brick façade, there has been some major repatching between the top of the brickwork where it meets with the underside of the sandstone capping (Plate 72).

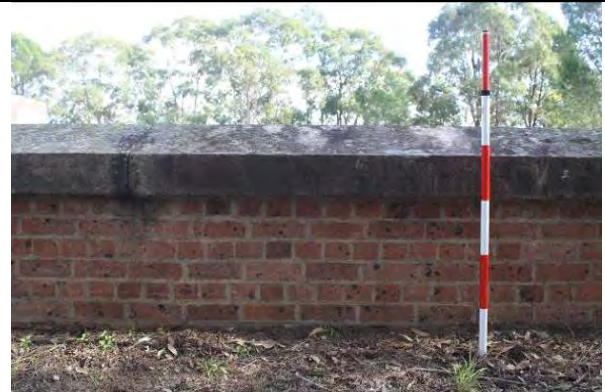
Plate 56

There is evidence on the brickwork of water damage occurring. These generally line up with the joints between the sandstone capping blocks, where they have separated slightly and allowed water to channel between them and onto the brickwork (Plates 56, 58 – 61, 63 – 64 and 67 – 72). This does not appear to have caused any damage to the bricks, only to have discoloured the outer skin. There is also a section of mould growing at the southern end of the brickwork, where the brickwork of Reservoir No 1 meets with Reservoir No 2.

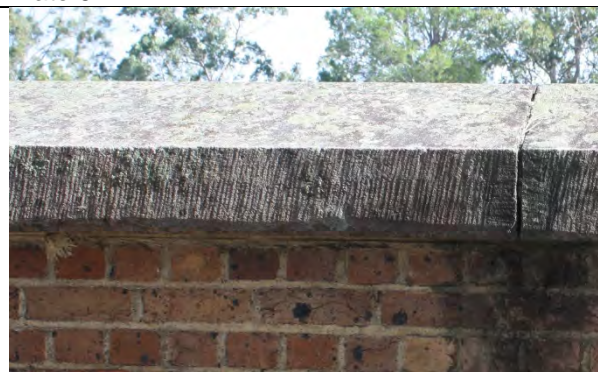
The sandstone capping stones are also considered to be in good condition. Cut marks associated with the working of the stones is present on all of the stone work, which indicates they have not eroded or degraded over time (see Plate 69 for example).

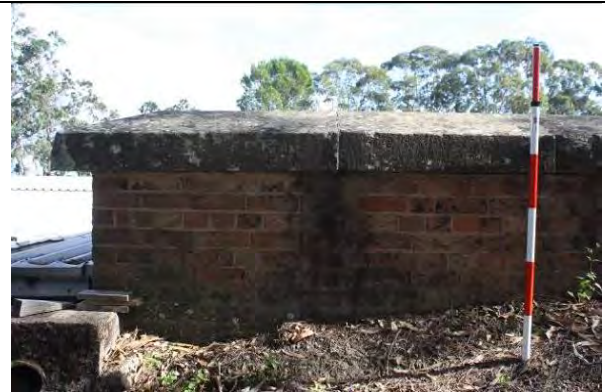
Plate 72

Along the bottom visible course immediately above the current ground level around the reservoir, there are sections where the mortar has severely eroded out between the horizontal and vertical joints. This does not appear to have caused any structural damage to the eastern façade (Plate 72).

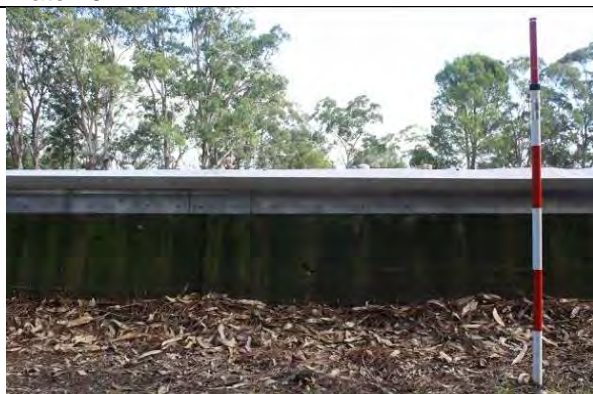
Plate 77

There is one casting joint present along this section of the concrete work. It appears to be a joint created during the construction works during the pouring phases. The joint is pronounced, but does not appear to be damaged or causing damage to the exterior of the structure (Plate 77).

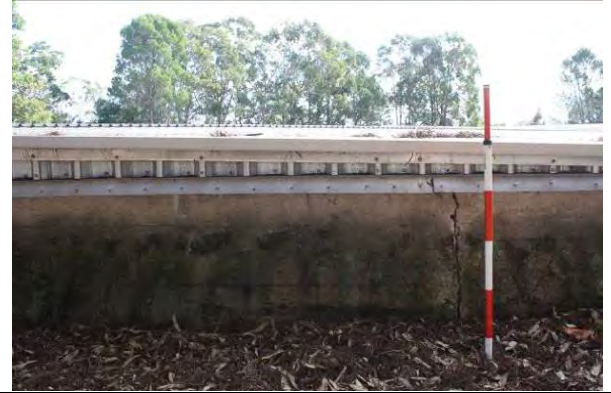
Plate 88

Similar to that on the eastern façade wall, there appears to be one casting joint in the concrete wall. There appears to be some separation between the joints of the two concrete walls. The separated sections also include fracturing to the joint edges between the two casting joints (Plate 88).

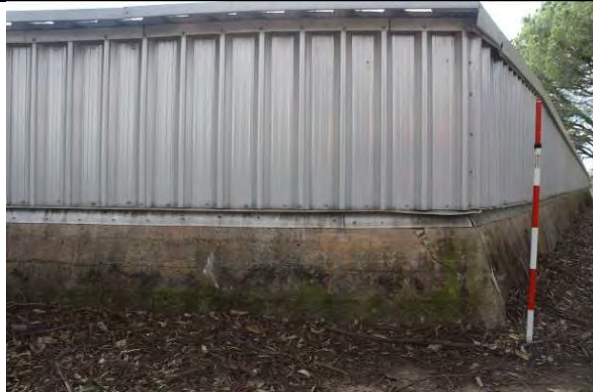
Plate 100

From the south-western corner of Reservoir No 2 the height of the roof is maintained and is no longer rising. There is cracking present near the corner of the concrete façade wall (Plate 100). There is also a large crack present approximately seven metres along this wall towards the northwest. This crack appears in a section that has been repaired along the top of the concrete wall, with the crack running from the top of the concrete wall to below ground (Plate 102).

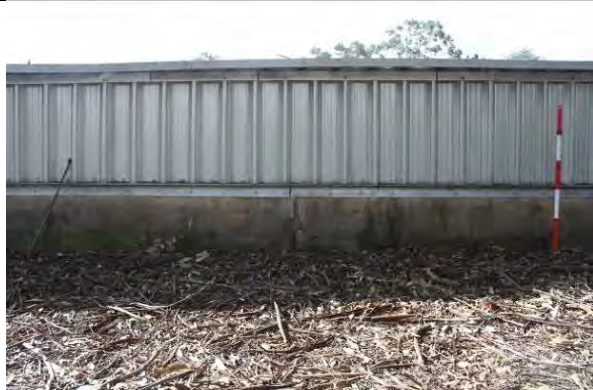
Plate 104

There is a casting joint present at approximately 12.4 metres from the south-western corner. The casting joint has some signs of exfoliation of the outer skin of the concrete, however, the damage appears to be only on the face of the concrete work (Plate 104).

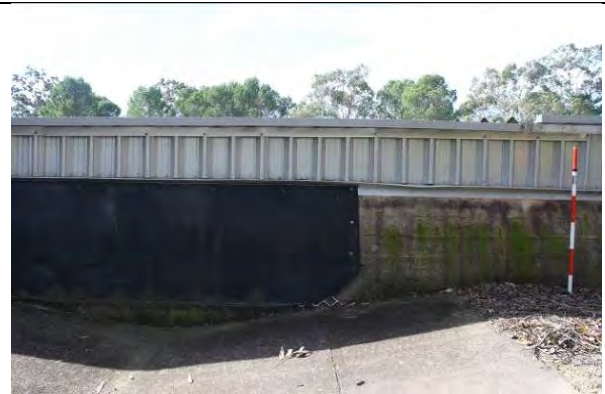
Plate 109

The spillway cover has been upgraded recently, likely at the same time that the new roof was installed. This consists of a black rubber cover over the top of a steel mesh. This has been bolted to the concrete façade wall (Plates 109 and 110).

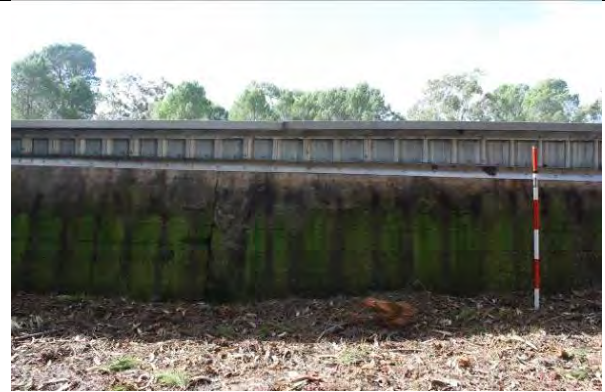
Plate 113

There is another casting joint present approaching the north-eastern end of this section of the western façade. The joint is in good condition, with only minor cracking present along the joint. Two reinforcing rods are exposed at the casting joint (Plate 113).

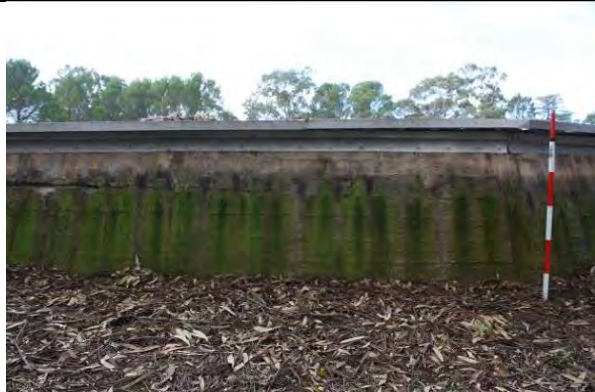
Plate 118

From the junction of the first western façade wall to the north-south orientated façade wall the roof of the reservoir is no longer higher than the metal flashing (Plate 118).

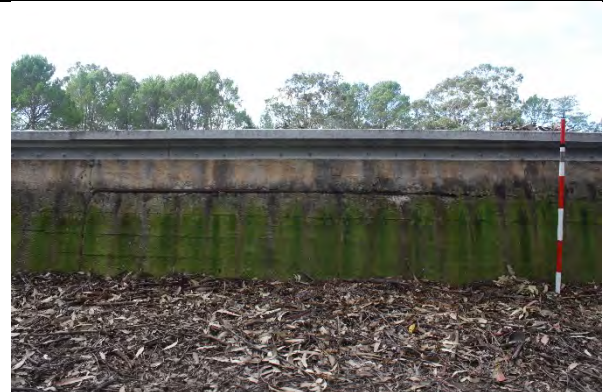
Plate 119

There is one major crack and exfoliation of the concrete skin immediately to the north of this corner of the reservoir where the reinforcing rod has been exposed. This crack extends to the casting joint where it was formed (Plate 119).

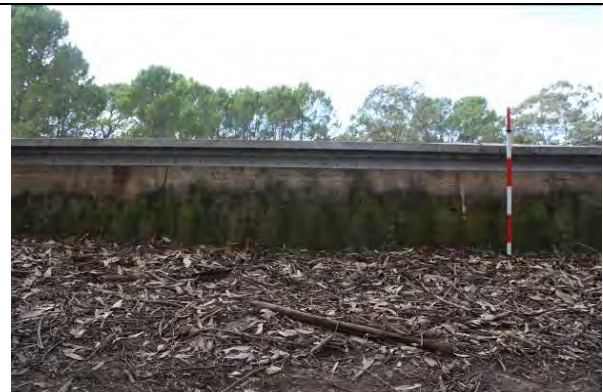
Plate 125

This is the only major cracking that appears along this section of the wall. There is another casting joint near the northwest corner of the reservoir. This casting joint shows minimal signs of damage to the corners of the joints (Plate 125).

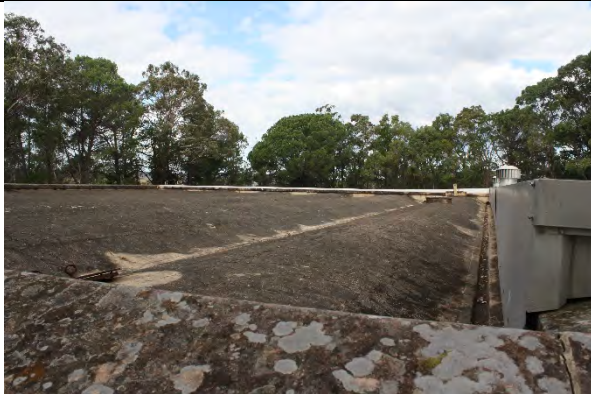
Plate 130

The roof consists of six brick arches that have been covered with bitumen (Plates 130 – 133). Between each of the arches are curved spoon drains that slope from the south towards the north, that exit through the terracotta pipes in the northern brick façade (Plate 133).

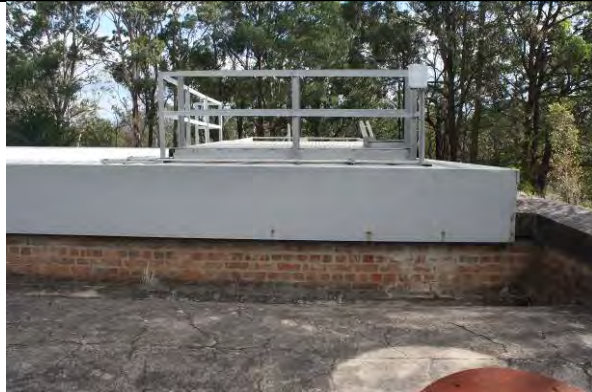
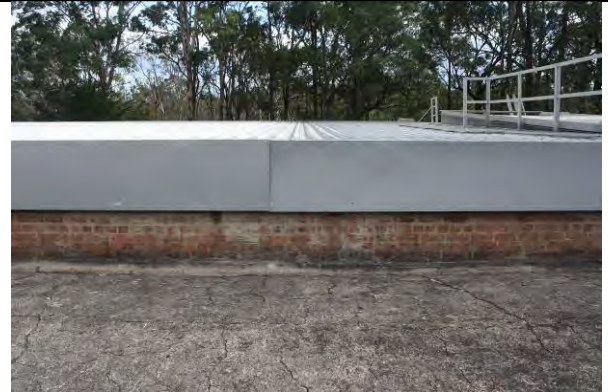
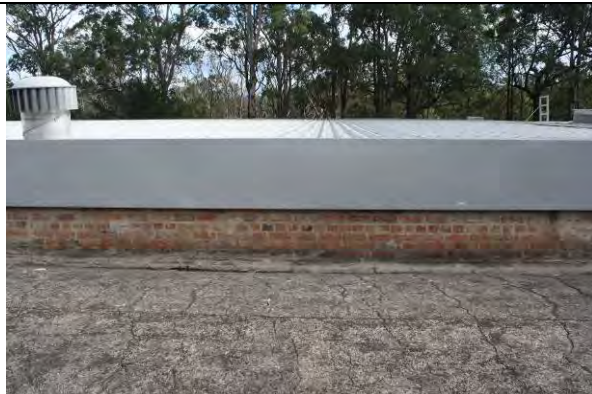
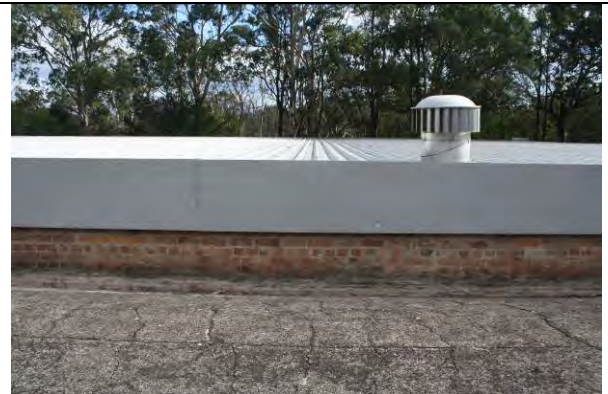
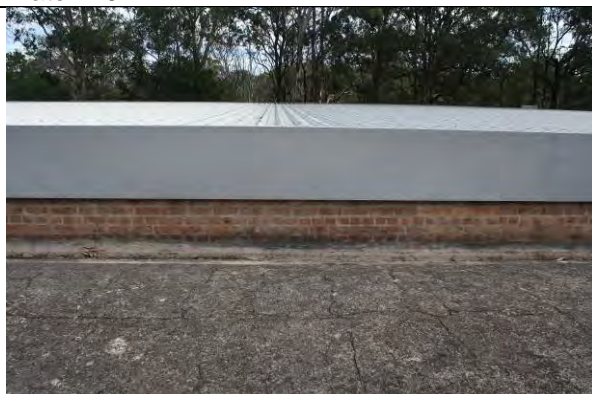
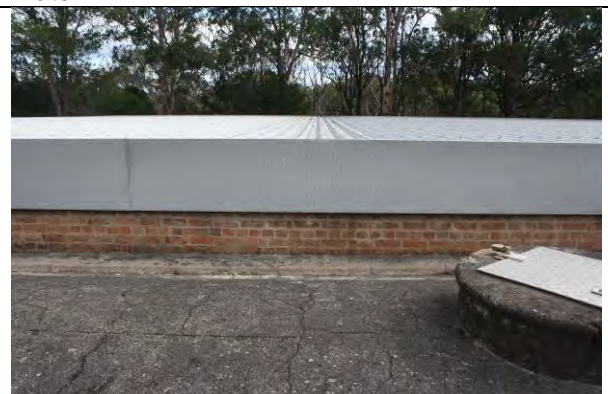
The brickworks associated with the second, inside, course of the façade walls associated with Reservoir No 1 have all been repointed. The repointing has been completed roughly in places and covers over whole sections of bricks. There does not appear to be damaged to the inside wall of the brick façade (Plates 138 to 159).

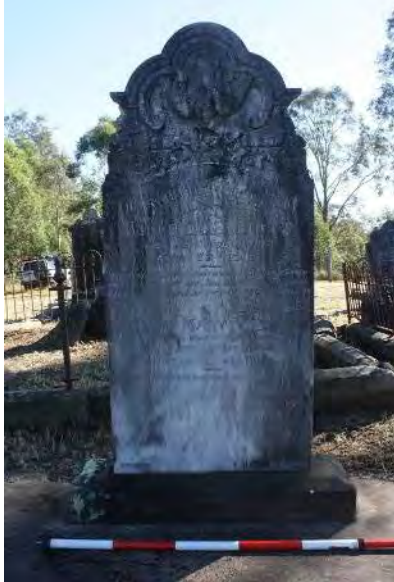
Plate 2

This burial consists of a single headstone and a double sized plot. The headstone is made of granite that is inserted into a sandstone plinth. The top is a decorative rounded end that includes a dove with an olive branch in its beak (Plates 2, 3 and 4). The inscription consists of lead embossed lettering attached to the headstone (Plate 5). The headstone is intact, and all edges and corners remain well defined. The face of the headstone does show some degradation and laminating from weathering.

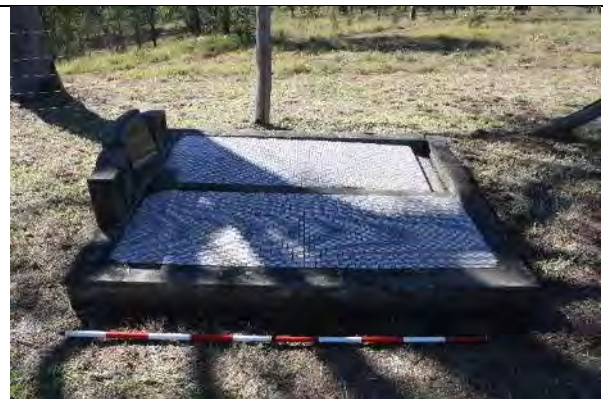
Plate 7

The top of the grave has been tiled over with decorative blue and white tiles. The bottom section of the northern grave has sunken over time. Also, the north-eastern corner of the southern grave has tiles that are missing (Plates 6 and 7). Otherwise the top of the graves appear to be in good condition.

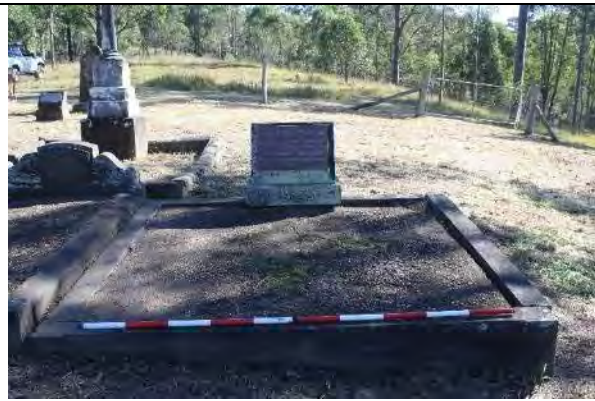
Plate 10

This is a double grave consisting of a kerbed grave site and a sandstone headstone with an inlaid granite stone with inscription (Plates 10). The headstone consists of two pieces, a lower plinth and a second forming the headstone with a raked face. The plinth and headstone section are both sandstone, and are covered with lichen. There is no evidence of damage from cracking or other fracturing (Plates 10, 12 and 15). The inscription is engraved into a separate granite stone that is inset into the top sandstone block, and appears to be in good condition.

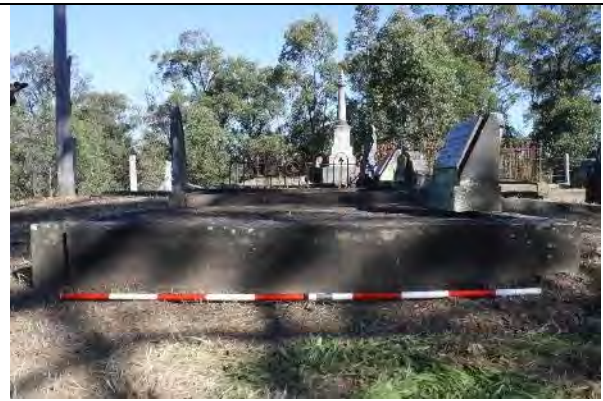
Plate 11

The grave site is marked by four sandstone kerb sections. Each of the four outside walls consist of a single piece of sandstone that abuts the two connecting pieces. The kerb walls do not appear to be joined together with any mortar or other pinning method. The northern kerbed wall has separated from the top (western) and bottom (eastern) kerb and is leaning outward towards the north (Plates 11 – 14).

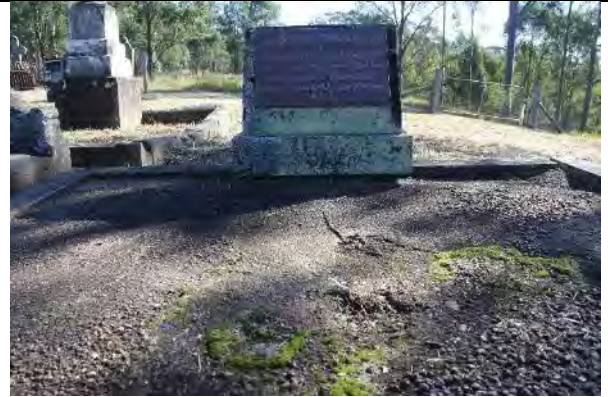
Plate 15

The top of the grave has been covered with a fine pebble aggregate concrete surface. The slab has been laid in one piece. The surface has cracked and there are signs of subsidence in the north-eastern corner and in the centre, as well as some upheaval around the cracks (Plate 15).

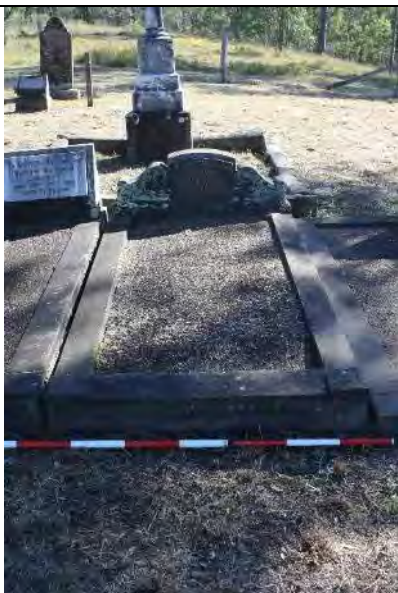
Plate 16

This grave is a single grave that has a sandstone kerb and headstone (Plate 16). The headstone consists of a single sandstone piece that spans the width of the grave that rests on top of the western kerb wall. The centre of the headstone is a rectangular section with a curved top, with two decorative side pedestals. The sandstone detail is still visible and complete, however, the sandstone is covered in lichen on the eastern face. The headstone has an inlaid granite inscription stone in the same shape as the central section headstone. The inscription has been engraved into the granite, and is still clear and legible. The headstone, including the sandstone and granite are in a good condition (Plate 16, 17 and 20).

The kerb walls of the grave are formed by four sandstone blocks. Each one abuts the other, and may have been joined with mortar. There is no evidence of mortar between the kerbing blocks, and the eastern sandstone kerb block has separated away from the western block in the south-east corner (Plates 16, 18 and 19).

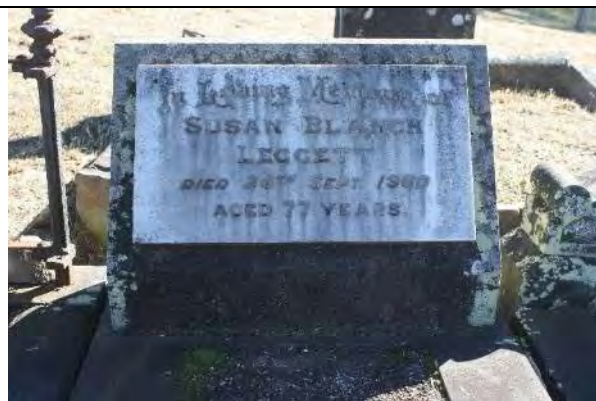
Plate 22

A granite inscription stone is inset into the sandstone headstone. The inscription is an embossed lead lettering that has weathered, but is still clearly legible (plate 22).

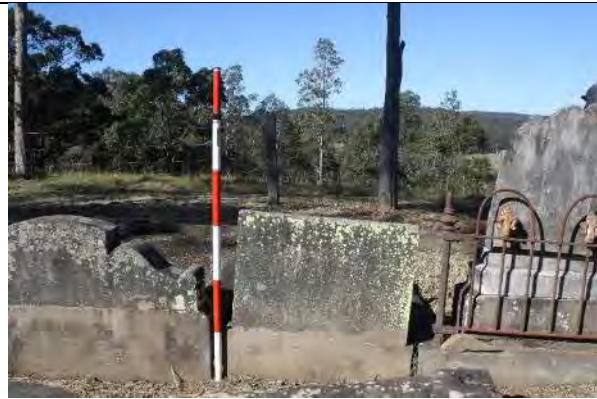
Plate 23

This is a single grave, narrower than others that are present within the cemetery. The headstone consists of a single piece of sandstone and is in good condition, with all of the edges and corners intact, with no chipping or other fracturing evident (Plates 21 and 23).

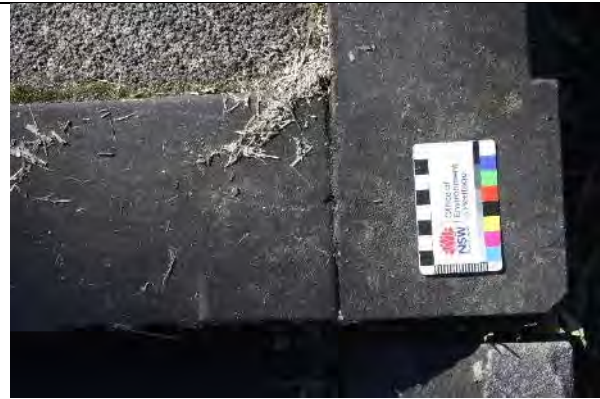
Plate 24

The sandstone kerb walls that form the grave consist of four sections that abut each other. The kerb walls are kept together by mortar at all four joints. There has been no separation between any of the sandstone kerb walls (Plates 21 and 24).

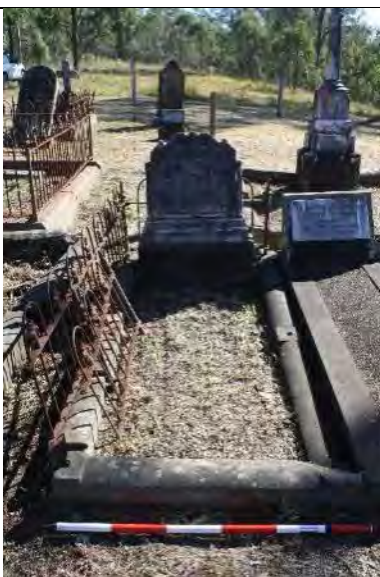
Plate 25

This is a single sized grave that includes a decorative headstone, rounded sandstone kerb walls and the remains of a former wrought iron fence (Plate 25).

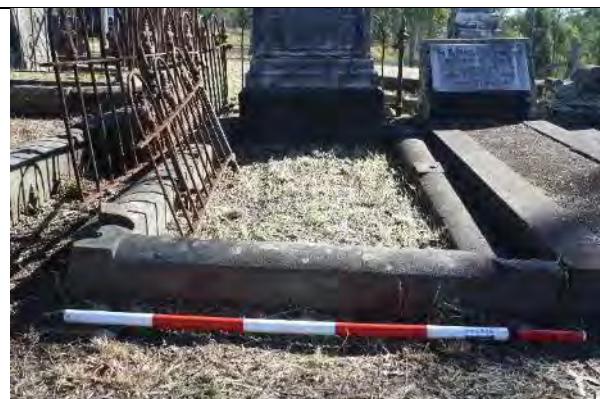
Plate 26

The kerb walls have rounded tops and are squared on the corners which support the wrought iron bow and picket style fence. The northern kerb has subsided at the north-east corner, and has fractured at the south-east corner. The remainder of the kerbed wall is intact and completed. The fence remains installed in the kerbed wall at the western end, and partially installed on the southern kerbing. The lower, eastern end, fence is presently leaning against the southern portion of the remaining fence. The northern kerb wall fence has been removed and is no longer on site (Plates 26, 28, 29 and 31).

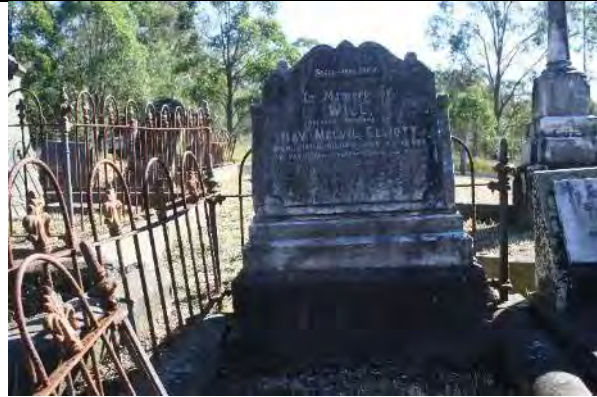
Plate 27

The headstone consists of a sandstone plinth and two granite plinths resting on top that support the granite headstone. The headstone has a slight cracked face. The headstone also includes decorative scroll on each side and along the top. The corners and some of the edges of the headstone and plinths have worn smooth, however the detail is still visible. There are patches of lichen on the sides and front eastern portion of the granite, however, this has not caused any damage to the stone. The inscription consists of lead stencilling embossed onto the granite headstone. All lettering is still present, and the inscription is legible (Plates 27, 30 and 31).

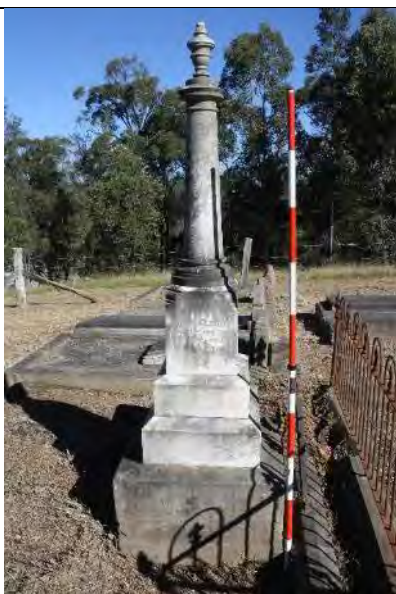
Plate 34

This grave site is a larger, triple plot sized grave with a monument gravestone marker (Plate 33). The monument headstone consists of a sandstone plinth with a bevelled top edge, which supports two additional granite plinths (Plates 34 – 37). The fourth course is a rectangular block of granite that contains the inscriptions, along with the two granite plinths below. The top of this block forms rounded corners at the top (Plates 36 – 38). This is part of the transition to a tapering column that has a granite urn carved into the top (Plate 39).

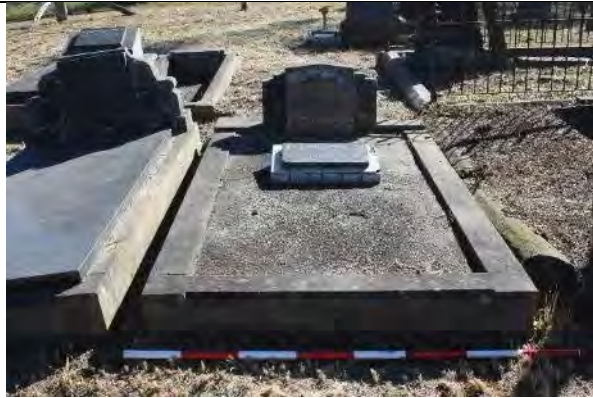
Plate 44

The second headstone is situated in front of the first and is laid on a slight upright angle on top of the concrete surface of the grave. The headstone consists of a white tiled plinth with a granite headstone resting directly on it. The tiles are cracked and are missing in the north-western corner, exposing the sandstone plinth the tiles are laid on. The headstone is covered in lichen and the inscription is engraved. Other than the covering of lichen, the headstone is in good condition (Plates 44, 48 and 49).

The kerb wall has been made of four sandstone blocks. The walls are still joined together with mortar present between all four of the joints. The wall has not separated or subsided (Plates 44 and 50).

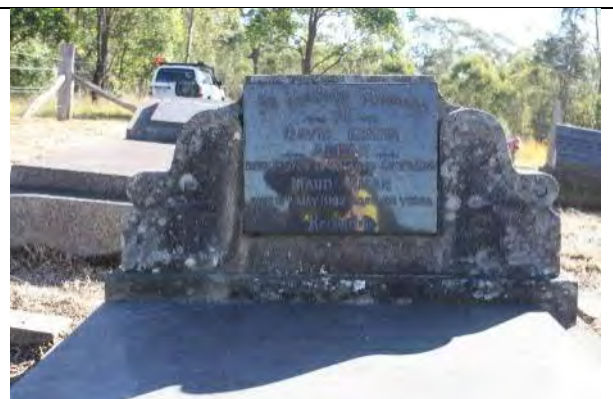
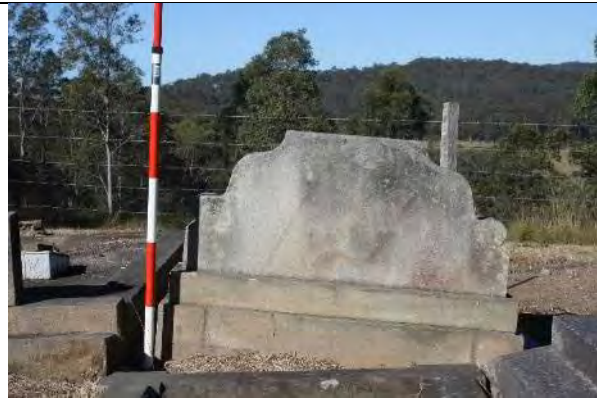
This is a single plot grave site, with a single headstone, kerb walls and a granite slab cap. The grave has subsided to the south (Plate 51). The headstone is a single sandstone block that has decorative scrolled edges that lead off from the central section of the headstone. These also contain embossed crosses on both sides. Some of the sharp edges of the original stonework have weathered, however the remainder of the stonework is in good condition, with all decorative detail still visible. There is some lichen covering (Plates 52 and 53).

The central section of the headstone has a granite inscription stone inlaid. The inscription is engraved into the granite, and there is no other damage or deterioration present (Plates 52 and 53).

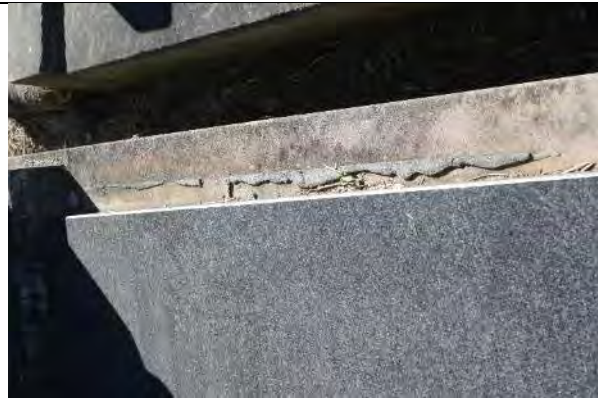
Plate 54

The sandstone kerb walls are all intact and are connected, despite the subsidence that has occurred. A single granite slab forms the cover to the gravestone. The granite slab is intact and does not have any visible cracking. The slab has shifted to the south, however the granite slab has not fallen into the grave (Plates 51 and 54).

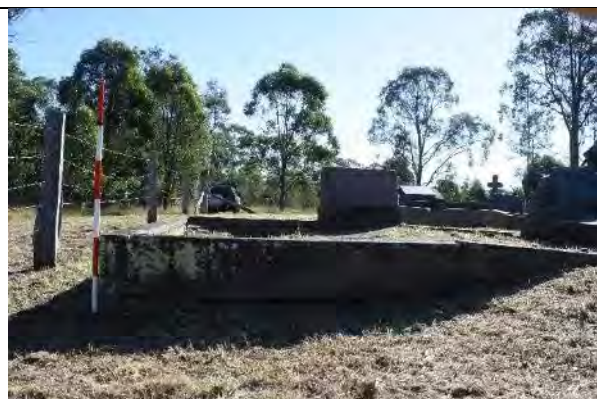
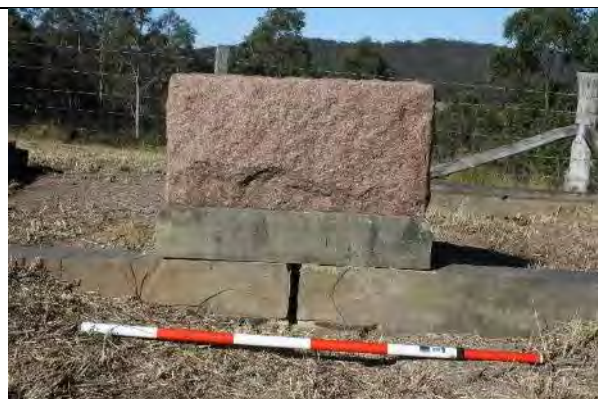
This site is a triple grave plot that consists of a single granite headstone, sandstone kerb walls and a concrete and grassed surface. The headstone is made up of a sandstone plinth that supports a granite headstone. The granite headstone has a smooth raked face that is engraved with the inscription, with rough cut top, sides and back. The sandstone plinth does not have any evidence of fracturing, cracking, or any other damage other than lichen cover in places. The granite headstone is also in good condition (Plates 55 and 56).

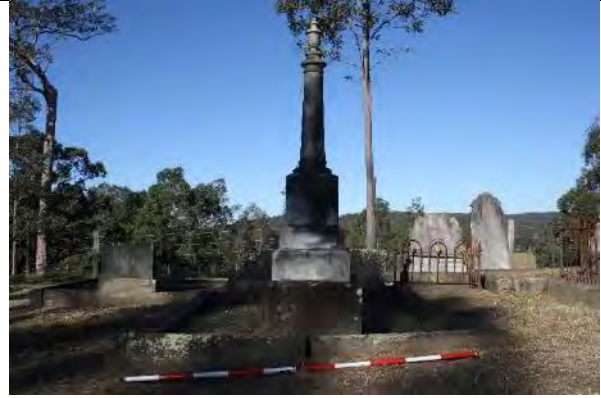
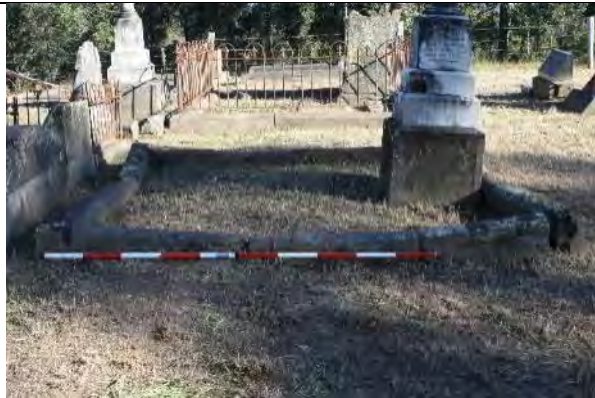
There has been substantial cracking and fracturing of the sandstone kerb wall blocks at the corners and along the mid-point on the eastern wall. There is evidence of a former fence that was installed on top of the kerb wall, however this has been removed and is no longer on site (Plates 61 – 63, 70 – 74).

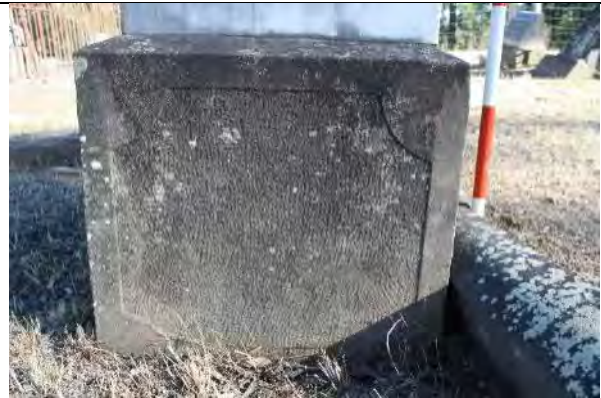
Plate 64

This grave site is a double sized plot with a monument headstone (Plate 61). The monument headstone consists of a sandstone plinth with a bevelled top, which supports two additional granite plinths (Plates 64, 67 – 69). The fourth course is a rectangular block of granite that contains the inscriptions, along with the two granite plinths. The top of this block has rounded corners at the top. This is part of the transition to a tapering column that has a granite urn carved into its top (Plate 66).

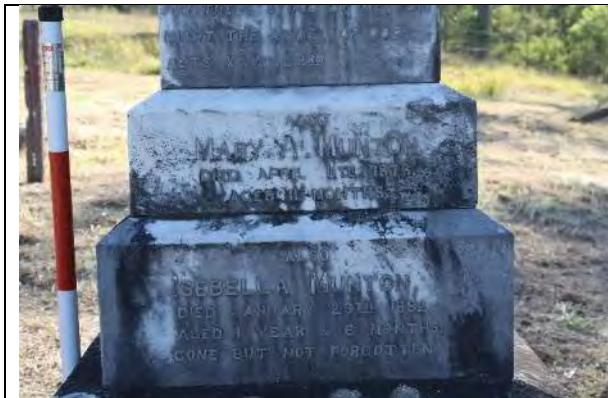
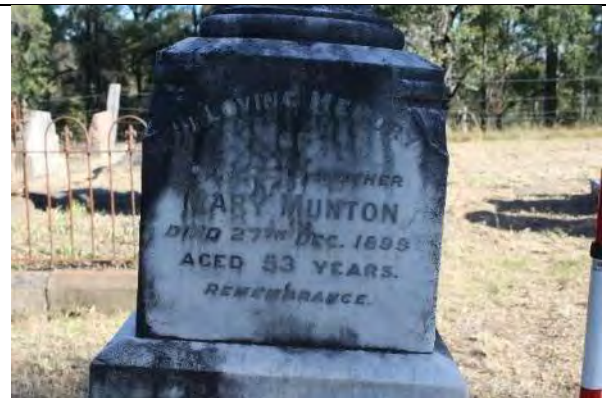
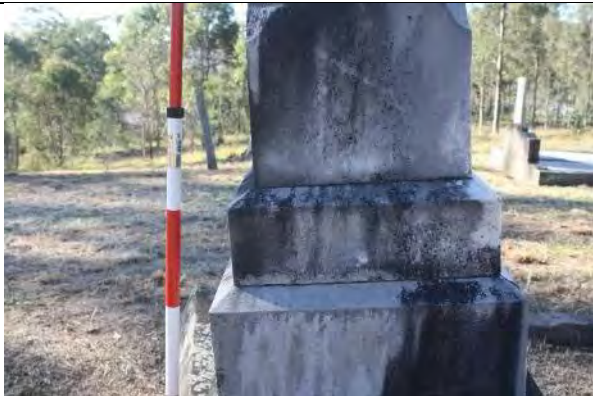
The inscription has been laid using lead lettering on all four panels of the monument stone, and on some of the panels on the two granite plinths. All inscriptions appear to be intact and can be read. There is some general weathering and lichen that has discoloured the granite in sections, but not the lead lettering (Plates 67 and 68).

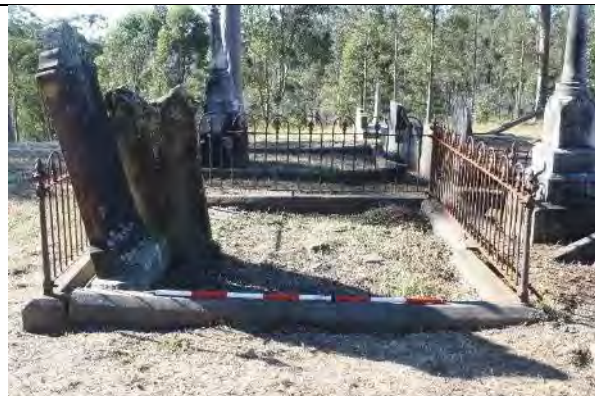
Plate 75

Both headstones 3-2 and 3-3 are located within one double sized grave site. Both headstones are highly decorative sandstone headstones that are surrounded by a single sandstone kerb walls and a wrought iron fence (Plates 75 – 78).

The William (?) headstone is still intact but has subsided back towards the west (Plate 75). The inscription and decorative features associated with the William (?) headstone had also weathered and the inscription has been lost in places.

The sandstone kerb wall around the grave has been made up of two sandstone blocks on each side. The top of the kerb has chamfered edges on both the inside and outside edges. The blocks also have recesses in the corners and one in the middle that holds the iron fence posts around the site. The kerb walls have subsided and separated at the joints from the other sandstone kerb blocks. The iron fence is still present along the western, northern and eastern walls of the grave site, with the southern fence section missing, and is a bow and picket style fence (Plates 75 – 81).

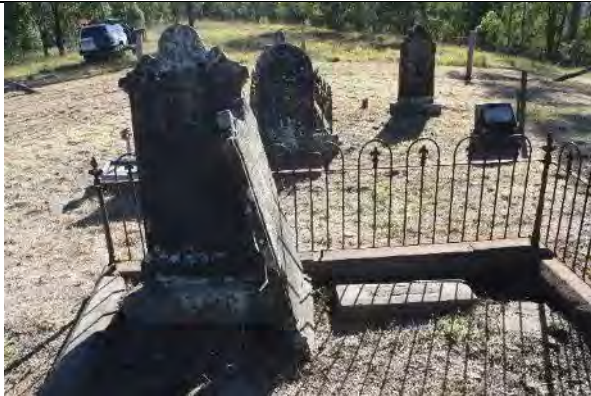
Plate 85

John Elliott and Martha Elliott's headstone was made from sandstone that has fractured off at the Mortis and Tenon joint, and the headstone is resting against the adjacent headstone (3-3) (Plate 85). The plinth of the headstone is still *in situ* with the mortis joint still present. The headstone of both John Elliott and Martha Elliott and William (?) are identical, with a rounded and scrolled top that includes a dove with an olive branch in its beak. The central portion of the headstone has a raised centre where the inscription has been engraved (Plates 88 and 89). The dove and the olive branch portion of John and Martha's headstone has broken off and is missing (Plate 86). Sections of the inscription are also weathered or covered in lichen and are no longer legible.

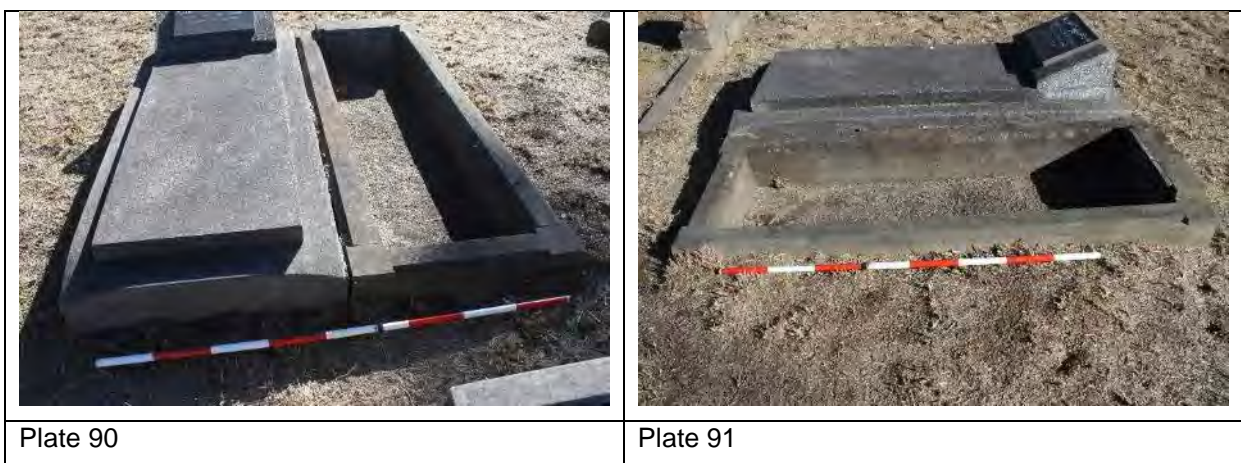
Plate 90

This is a single grave site that abuts immediately against grave 3-5 (described below) (Plate 90). The grave has a sandstone headstone that sits inside and low within the grave. A separate granite stone with the inscription has been attached to the sandstone block. The sandstone and granite components of the headstone are highly weathered and covered in sections with lichen. The inscription is an embossed lead lettering that has faded but is still attached and legible (Plate 93).

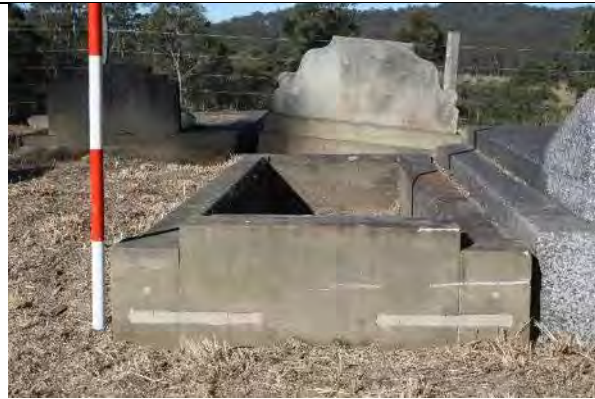
Plate 92

The sandstone used for the kerb walls are intact and are in good condition. There are chamfered corners on all inside and outside edges, except at the corners, where they are square (Plates 91 and 92).
