### Bloomfield Open Cut

### MANAGEMENT PLAN

Doc No: EMP001- Historical Heritage Conservation Management Plan

### Heritage Condition Assessment

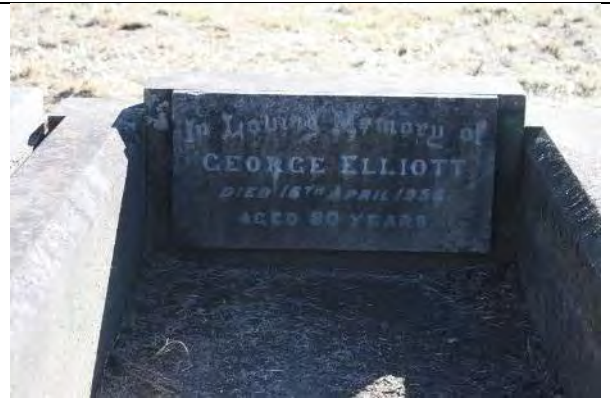
Plate 93

This is a single grave site that abuts immediately against grave 3-5 (described below) (Plate 90). The grave has a sandstone headstone that sits inside and low within the grave. A separate granite stone with the inscription has been attached to the sandstone block. The sandstone and granite components of the headstone are highly weathered and covered in sections with lichen. The inscription is an embossed lead lettering that has faded but is still attached and legible (Plate 93).

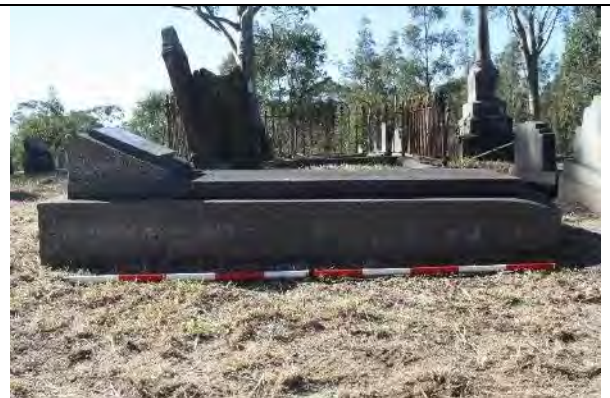
Plate 95

The kerb of the grave appears to be a single piece of granite. There does not appear to be any joins to the kerb section. There is also no cracking or other damage present to this wall (Plates 94 – 97).

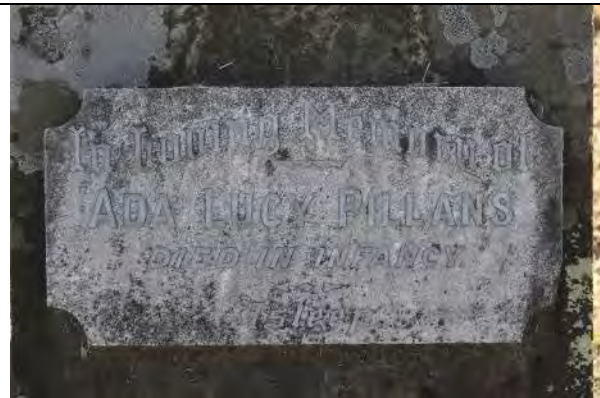
Plate 99

This is a single grave site that includes only the headstone and no other features (Plate 98). The headstone consists of a sandstone plinth at the base that is rectangular with a bevelled edge around the top. The headstone is on top of a single, separate, rectangular sandstone block. A separate granite inscription block is attached to the headstone. The granite piece is rectangular with cut-out rounded corners. The inscription is made of lead lettering, with all lettering present and legible. There is no cracking, fracturing or other damage to the plinth, headstone or granite inscription stone (Plates 98 – 100).

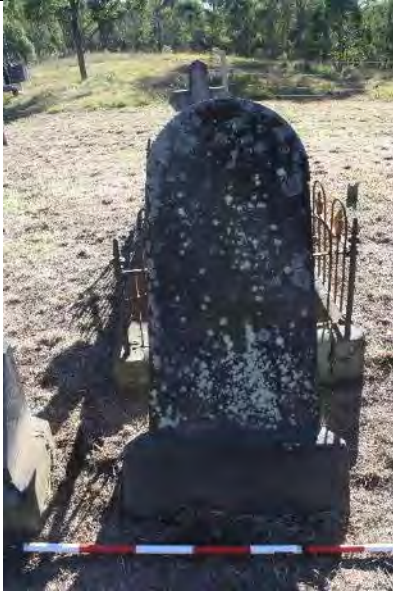
Plate 101

This grave consists of a headstone only. The headstone is made up of a sandstone plinth that supports the sandstone headstone. The headstone has subsided and leans back towards the west onto the iron fence of the grave behind it (5-2). The plinth is similar to the others that are present in the cemetery, being rectangular base with chamfered corners along the top. The condition of the plinth is good, with only minor fracturing at the corners (Plates 101 and 102).

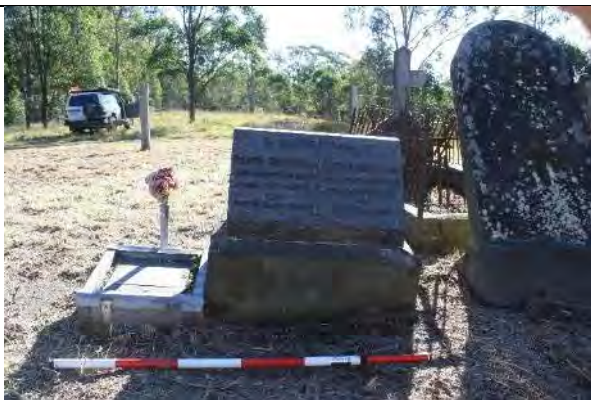
Plate 103

This grave site consists of a headstone only. The headstone is made up of a sandstone plinth with chamfered top. This supports the granite headstone. The headstone includes the engraved inscription with no other decorative styling (Plate 103 – 105).

The headstone has subsided to the north but the plinth and headstone are still joined and are not damaged.

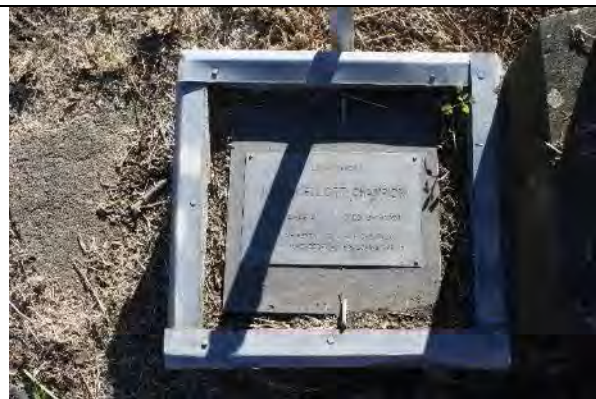
Plate 106

This grave consists of a headstone as a grave marker. The headstone is a single piece of granite laid flat on the ground. The inscription has been made onto a metal plate, possibly lead, that is screwed to the stone below. The headstone is surrounded by a timber kerb with aluminium flashing tacked onto the timber kerb (Plates 106 and 107).

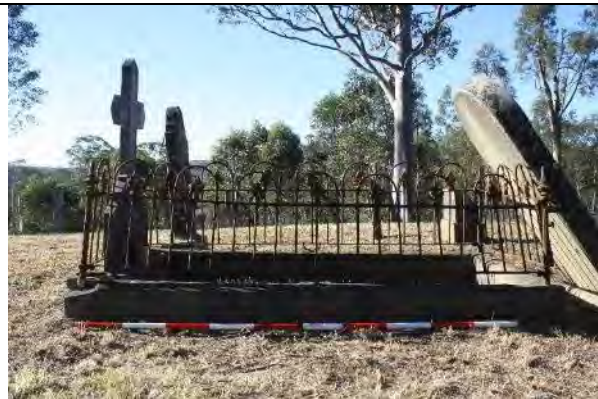
Plate 113

The sandstone kerb walls are made of four sandstone blocks, one on each side of the grave. The sandstone kerb has been shaped to have a curved surface along the top, with squared ends. These are to support the iron fence on top of the kerb wall. The top surface of the kerb walls have exfoliated, but the stones remain intact. The north-west corner of the kerb wall has fractured (Plates 112 and 113). The wrought iron fence is present all around the grave site. The fence is a bow and picket style that has been damaged and pushed inwards and is heavily rusted (Plates 112 and 113).

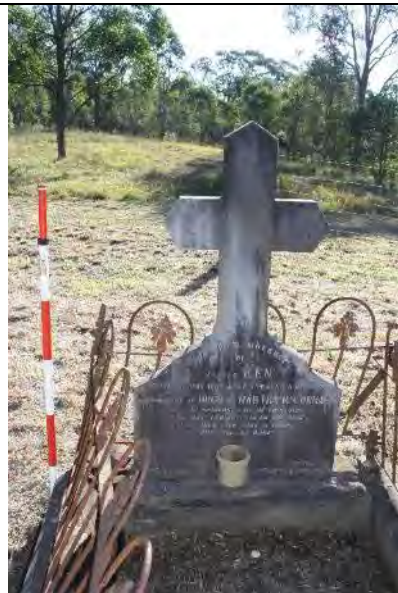
Plate 114

This single grave site consists of a headstone, sandstone kerb walls and a wrought iron fence. The headstone is a two-piece construction, being a sandstone plinth and a granite headstone. The plinth is a simple rectangular sandstone block. The corners and edges of the block have weathered and fractured. The headstone is a single piece of granite. The headstone includes a lower rectangular section with double peaked top that transitions into a crucifix head. The inscription is made up of lead lettering. All lettering is present and can be read. The granite piece has some discolouration on the front, eastern facing side, but there is no other damage to the stone (Plates 114 and 115).

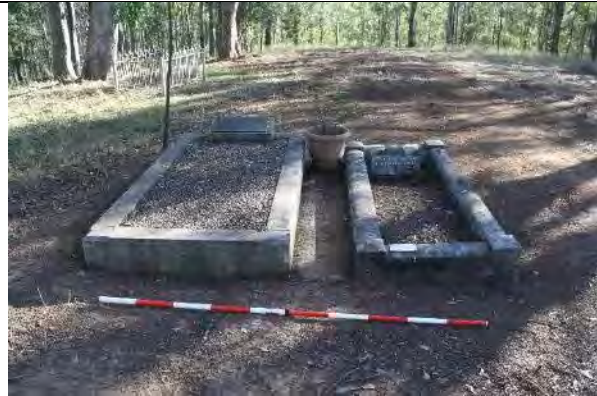
Plate 116

This is the first of two graves located in this area. The grave has a granite headstone that is inset inside the kerb wall. The headstone is a rectangular granite piece with lead lettering for the inscription. The granite has discolouring but is considered to be good condition (Plates 116 and 117).

The sandstone kerb walls are formed by four separate sandstone blocks joined together. The tops of the sandstone kerb is rounded with raised rectangular corners. There is some cracking present in the tops and sides of the kerb walls, but they are intact and complete (Plates 116, 118 and 119).

This grave also once had a cast iron fence associated with it. The fence has been removed and remains intact behind, southwest, of the grave and is not associated with a separate grave site (Plate 116). The fence is a bow style with a decorative alternate bow design (Plate 120 and 121).

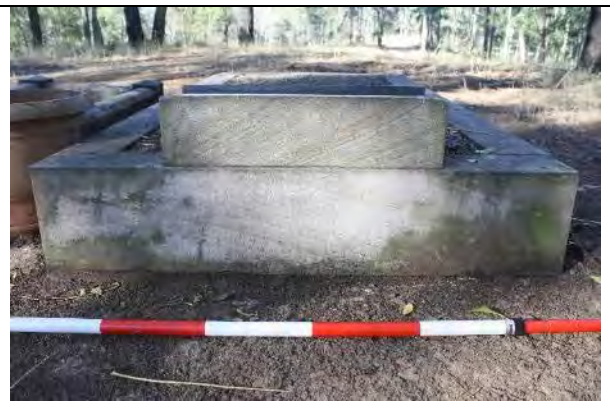
Plate 123

The sandstone kerb walls are made from four separate sandstone blocks joined together with mortar. The blocks are a simple rectangular style, except for the corners that have a bevelled edge along the outside face. The individual blocks are in good condition and the kerbing as a whole is intact (Plates 122 and 123).

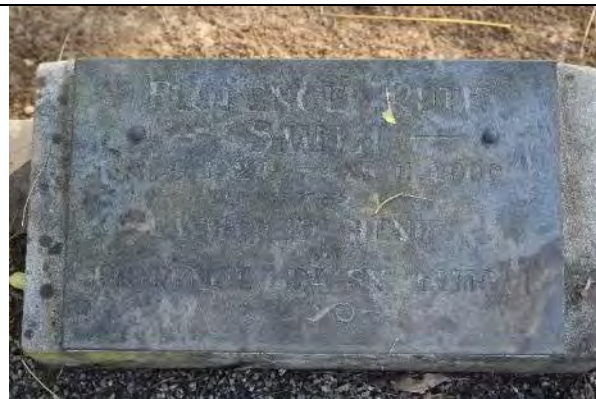
Plate 124

This is a single grave sized plot that includes a headstone, sandstone kerb walls and gravel surface (Plate 122). The headstone is a two-piece sandstone and granite style, with a low-profile sandstone plinth that holds a granite inscription stone. The granite stone is a simple rectangular piece that sits on top of the plinth. The inscription is engraved into the granite and is in good condition (Plate 124).
