# BLOOMFIELD COLLIERY

# Annual Review Report 2017

# **Bloomfield Collieries Pty Ltd**

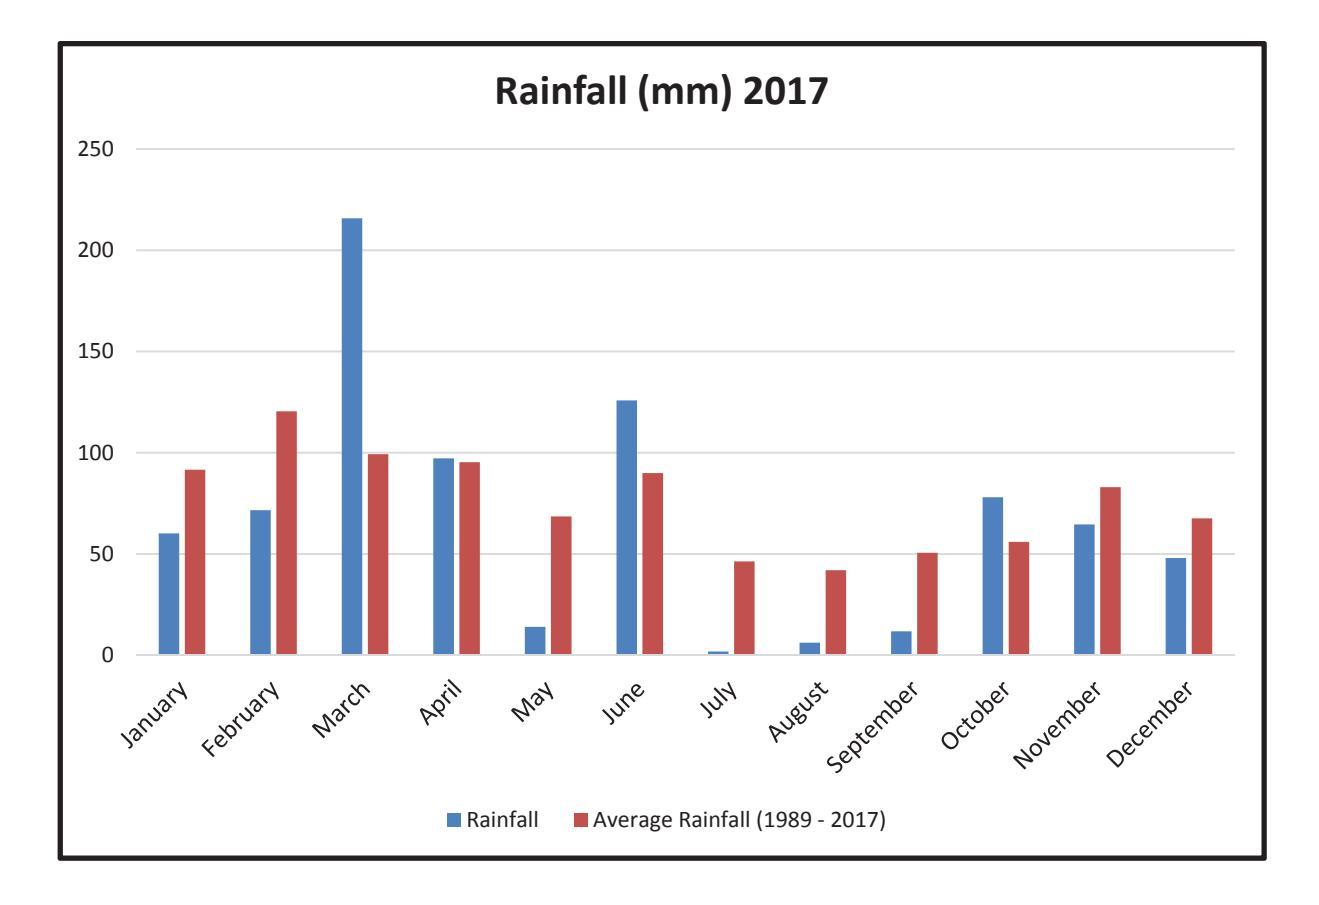
A comparison of monthly recorded rainfall for the 2017 reporting period and annual average data is shown in Figure 1. The total rainfall for the twelve month period was 795 mm. This was 116 mm below the annual average of 911 mm. The second half of 2017 was extremely dry with the mine site only receiving 40% of the average rainfall for that period.

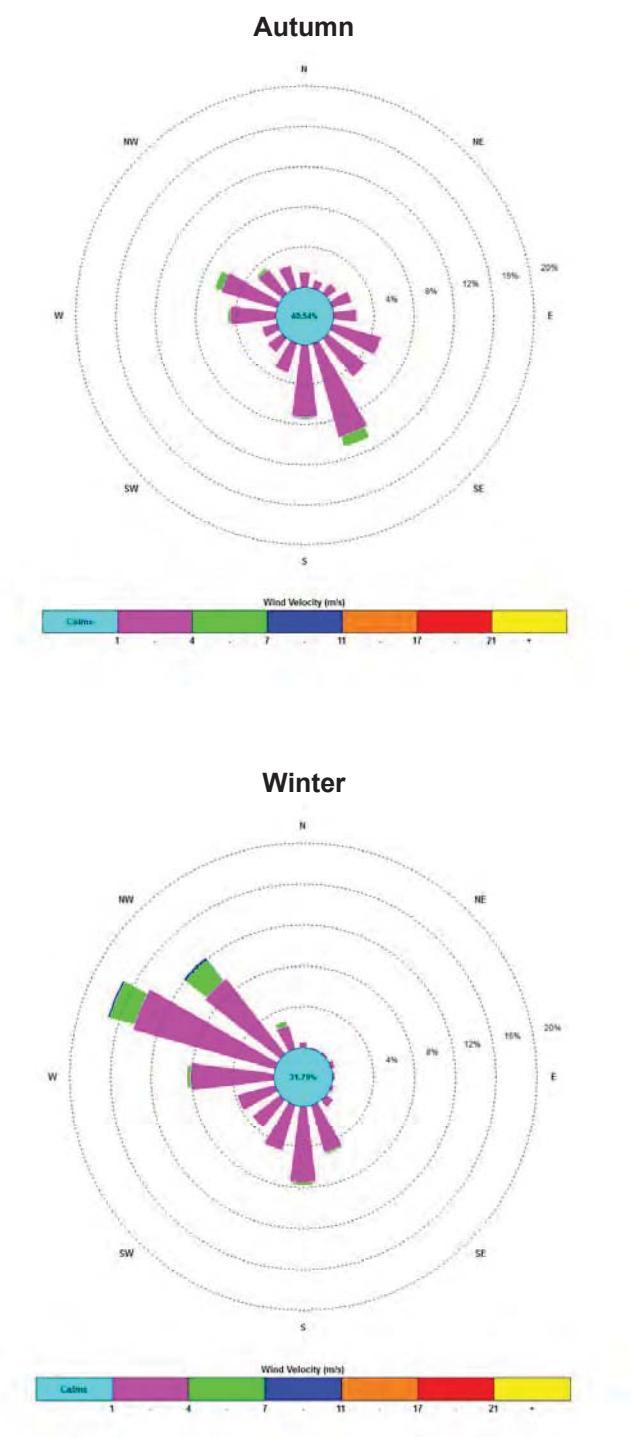
Figure 2: Windroses for Bloomfield 2017

The results of wind speed and direction monitoring shows a pattern typical in the Hunter Valley. During summer the winds predominate from the south east and winter the west-northwest. Autumn and spring are transitional seasons with winds distributed between both northwest and south-easterly directions. Figure 2 shows the seasonal windroses generated for the site on a seasonal basis.

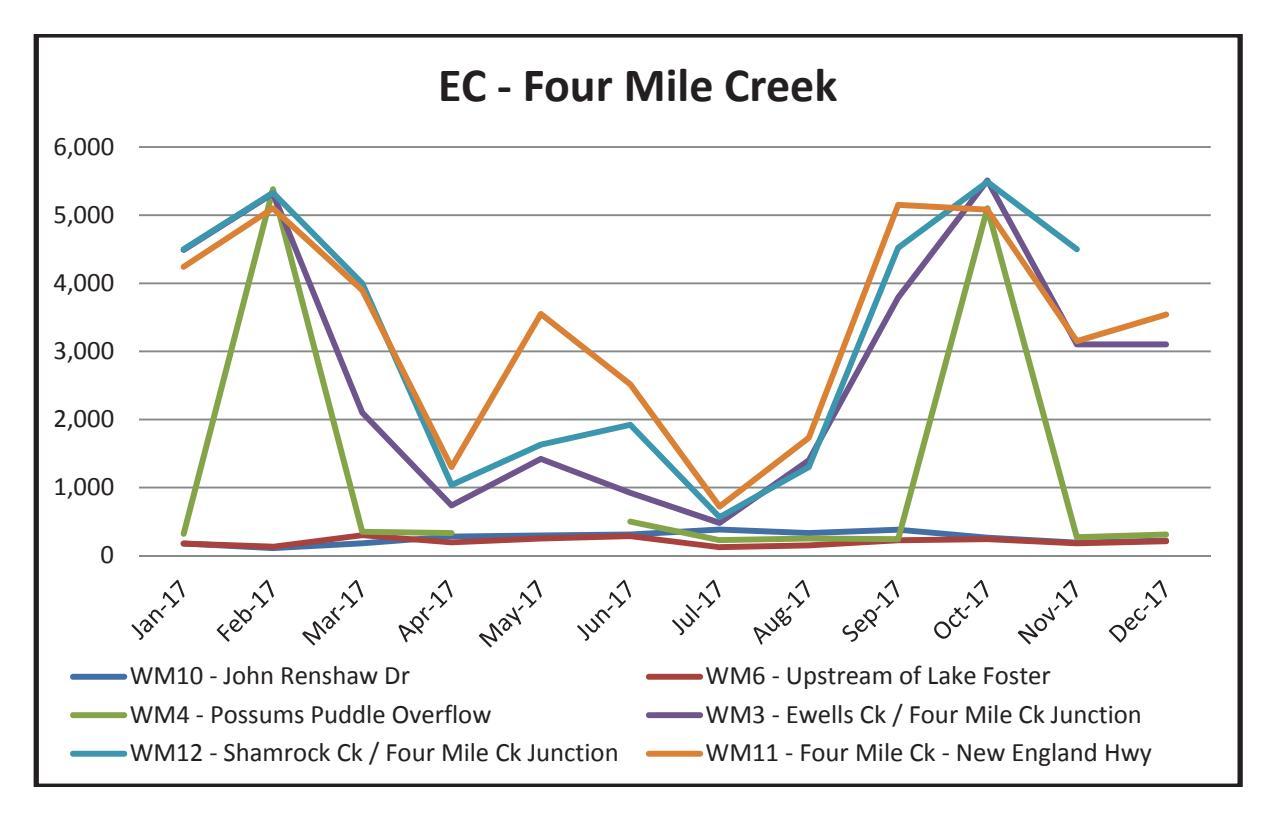
Figure 3 and 4 shows EC and pH results for the Four Mile Creek sites. Figure 3 shows salinity levels are slightly elevated in the lower end the catchment. Four Mile Creek is ephemeral and the EC level varies due to rainfall and mine discharge. The higher salinity results along Four Mile Creek (Elwells Creek and Shamrock Creek junctions and New England Hwy) reflect concentration of solutes in ponds during low flow periods and from licensed discharges in addition to offsite sources such historic underground workings.

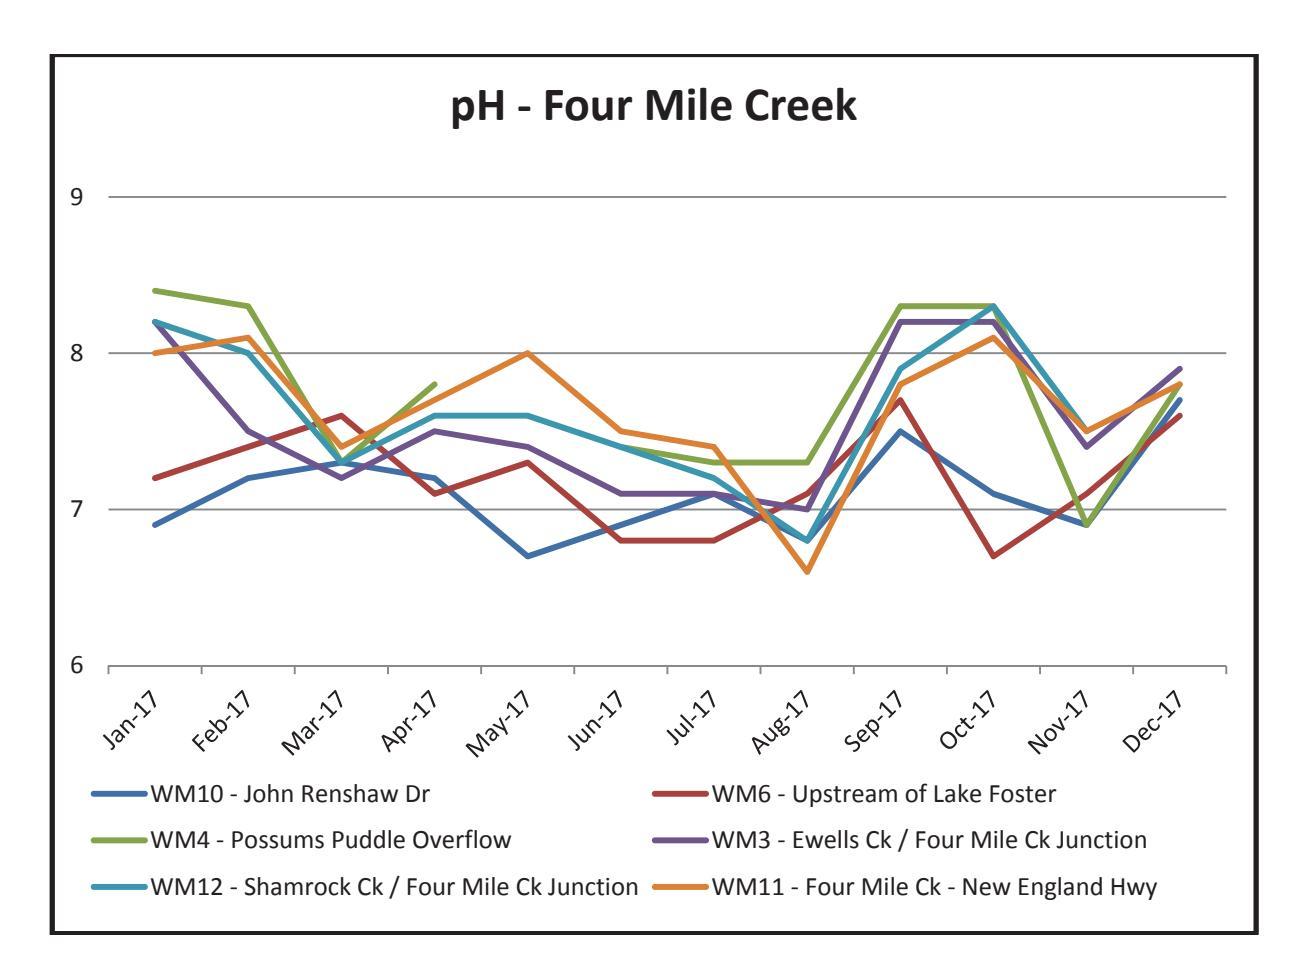
Figure 4: pH of Four Mile Creek

Figure 4 shows the pH levels in Four Mile Creek are generally consistent with ANZECC water quality guidelines (pH 6.5-8.5). pH levels vary due to rainfall and mine discharge therefore monthly and yearly trends cannot be assessed.

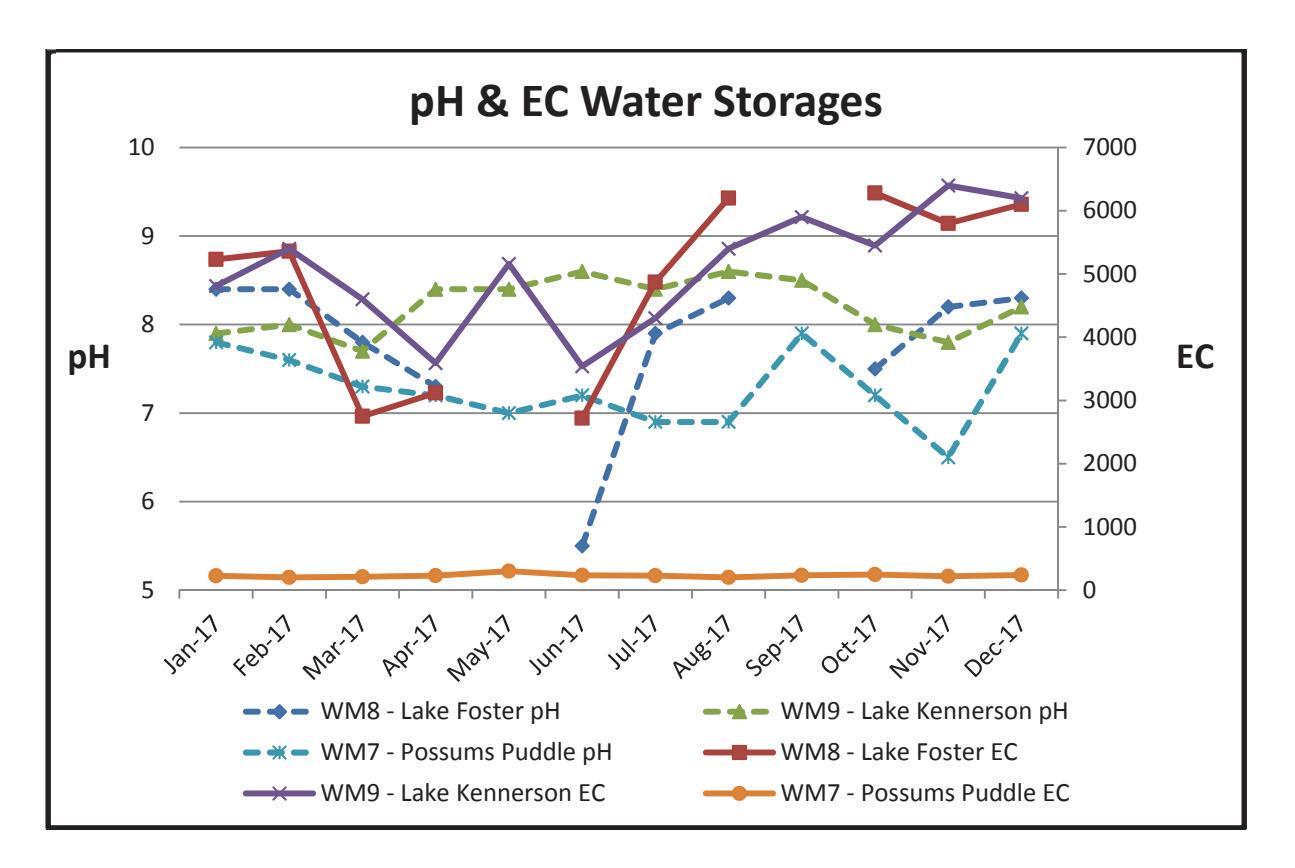
Figure 5: pH & EC in Site Water Storages

Figure 5 shows EC and pH results for water storage dams. Water quality within the mine water storage dams (Lake Kennerson and Lake Foster) varies throughout the year depending on rainfall capture in the open cut pits, CHPP water usage and frequency of licensed discharge events, which are also rainfall dependent. The freshwater dam (Possums Puddle) remains fairly constant throughout the year as it is separate from mining influences.

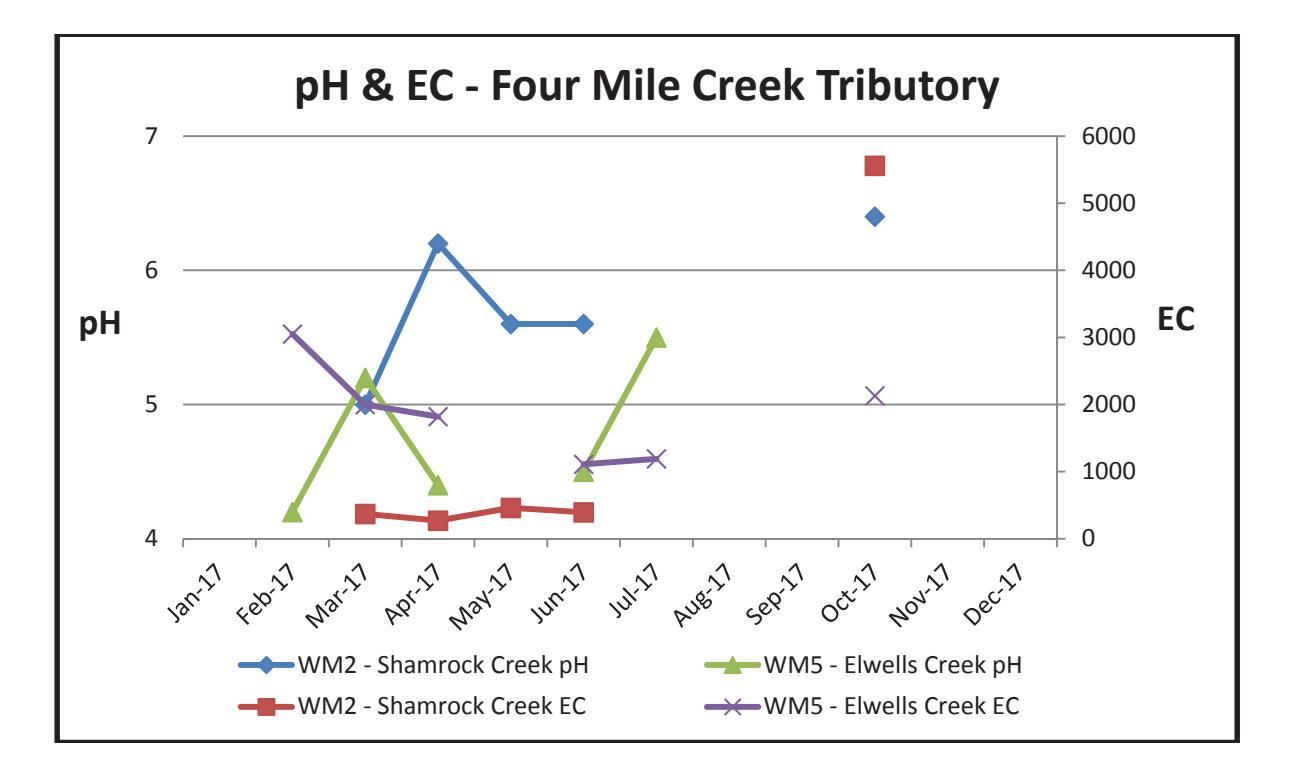
Figure 6: pH & EC in Four Mile Creek Tributory

Figure 6 shows the pH and salinity levels in Four Mile Creek tributaries are generally consistent with ANZECC water quality guidelines. These tributaries are ephemeral streams and are often dry or not flowing (evaporating) resulting in gaps in the graphed data. The low pH levels are attributed to stagnate evaporating pools throughout a dryer than normal year. The higher EC for Shamrock Creek in October is attributed to the incident referred to Section 8.2.

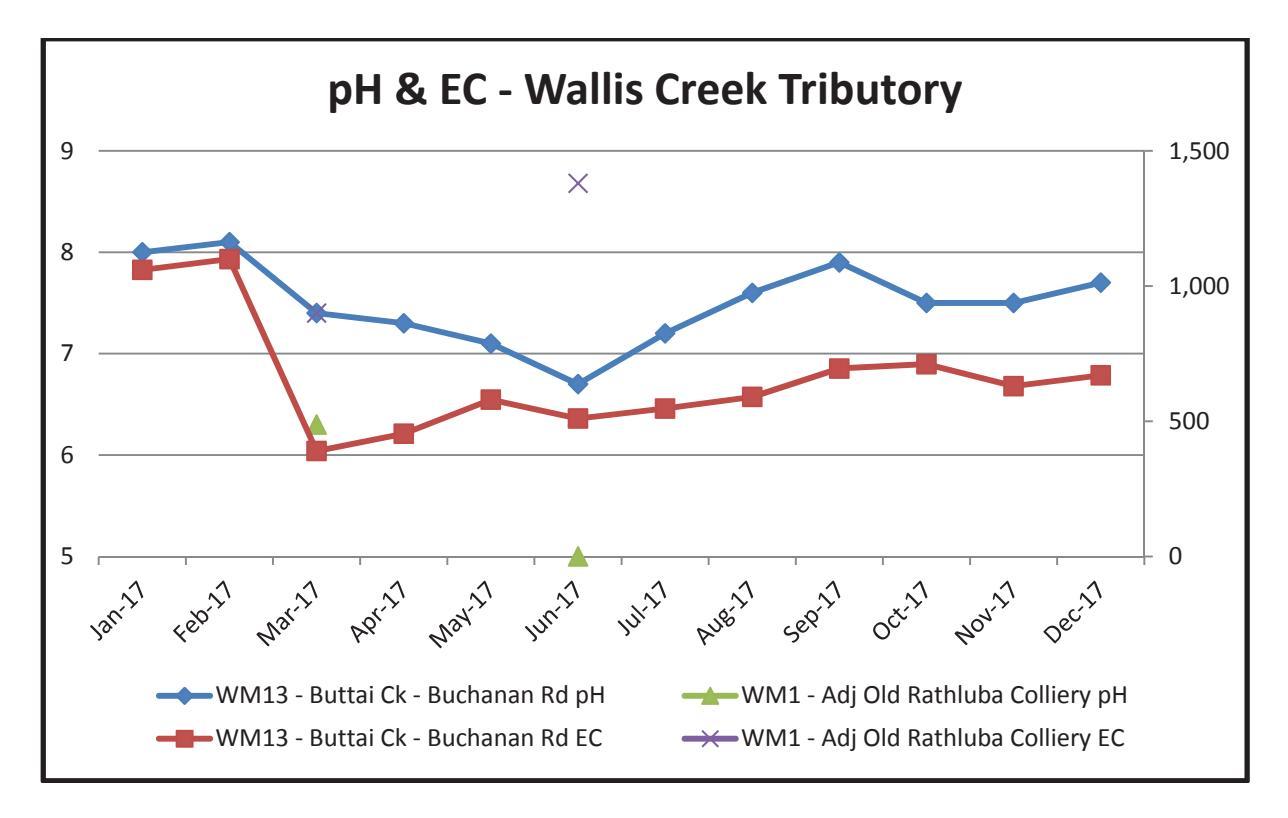
Figure 7: pH & EC in Wallis Creek Tributary

Figure 7 shows the pH and salinity levels in Wallis Creek tributaries are generally consistent with ANZECC water quality guidelines (pH 6.5-8.5 & EC 125-2200).

Previous results indicate that the surface flow adjacent to Rathluba has historically been of low pH, regardless of mining impacts. Prior to 2006 pH results were less than 4 however pH levels have been steadily increasing since then. This drainage line carries surface flow from non-mining land and rehabilitated mining land, indicating that other off-site effects may be influencing the water quality in the area. The drainage line is ephemeral and is usually dry or evaporating resulting in gaps in the graphed data.

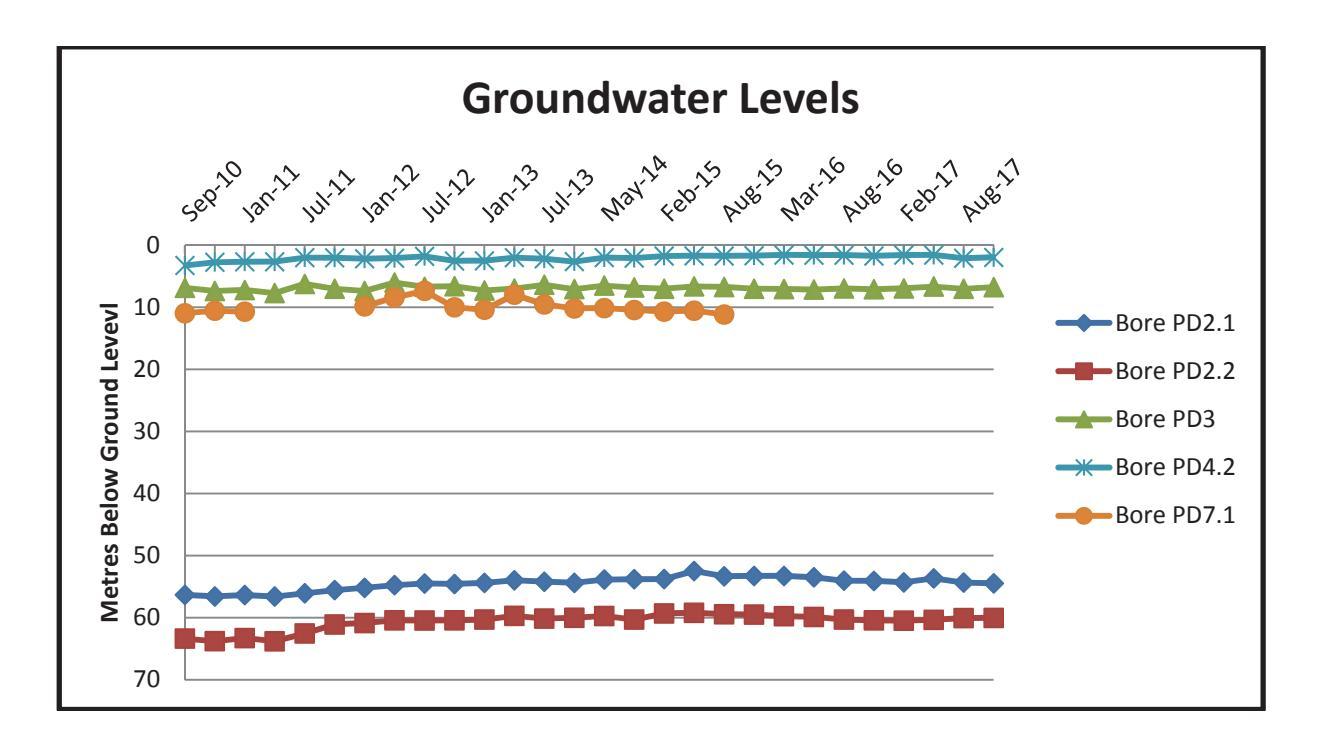
Figure 8: Groundwater Levels

Monitoring was undertaken during the period and the results for 2017 and previous years are summarised in Figures 8 – 10, with the full data set provided in Appendix C. The results are fairly consistent and do not show any real trends. The S Cut high wall has moved west and is now within a few metres of Bore PD7.1. Bore PD7.1 was 11 metre deep in alluvium/weathered Permian and is now dry.

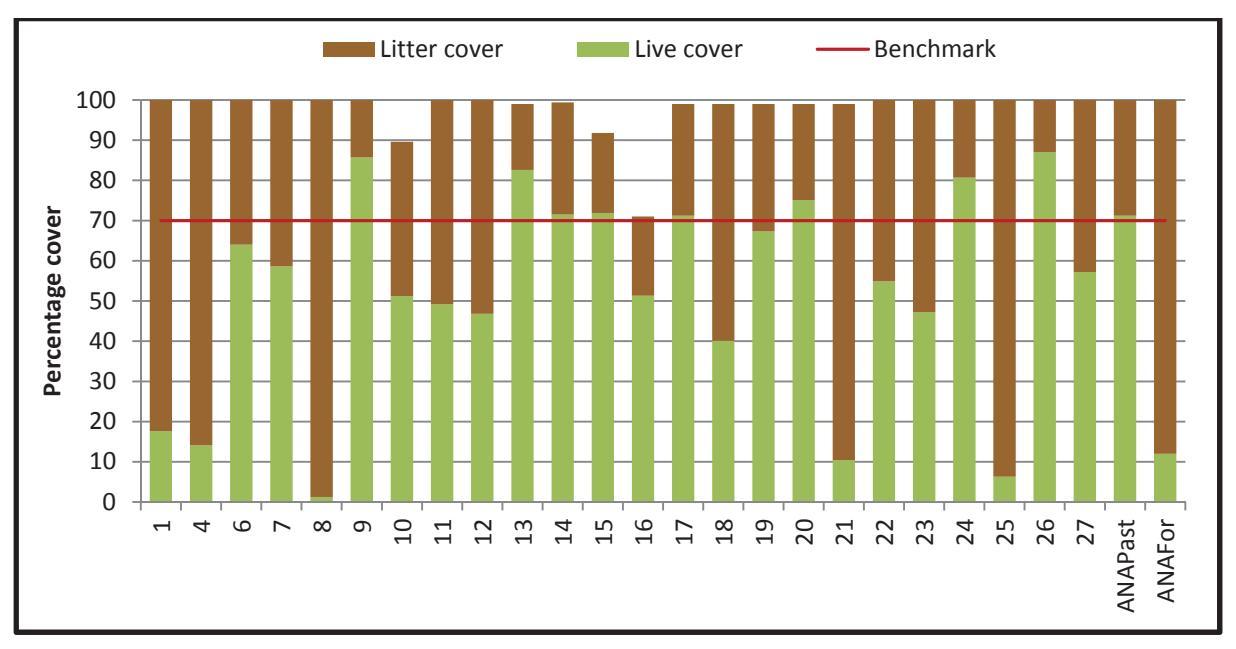
Figure 12: Ground Cover

The 2017 monitoring results showed that ground cover protection was excellent across all monitoring sites and comprised within 71-100%, indicating that the 70% cover target was consistently achieved / exceeded. Ground cover in areas of tree rehabilitation was typically dominated by deposited leaf litter with only low amounts of vegetative live cover present. Conversely, ground cover at the pasture sites was generally dominated by live vegetation (i.e. grass cover), although moderate levels of grass litter were also present, reflecting the prolonged dry weather conditions experienced in the region throughout 2017 (i.e. leading to the wilting/haying off of grasses). Ground cover type and distribution at the rehabilitated sites were well aligned with those recorded at the analogue areas for the respective vegetation community types. The results of the grown cover monitoring are summarised in Figure 12.

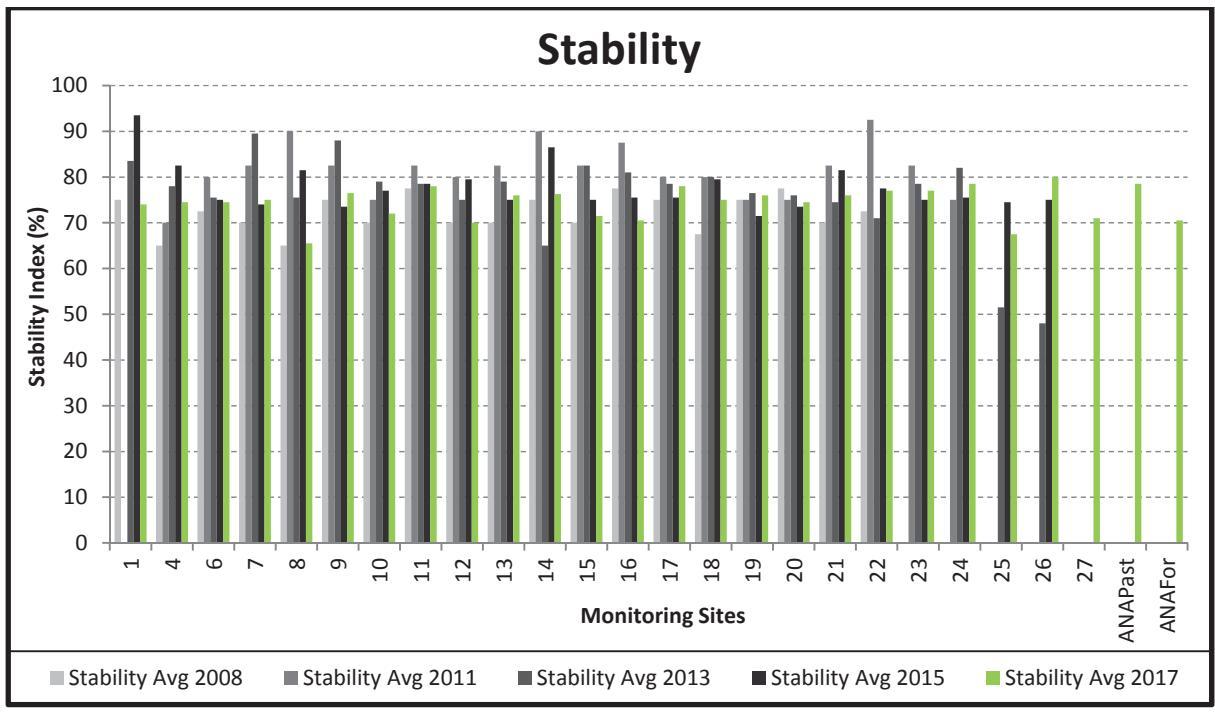
Figure 13: Stability

Stability is defined as the ability of the soil to withstand erosive forces, and to reform after disturbance. The results of the stability monitoring are summarised in Figure 13.

Despite some minor annual natural variations in index scores, soil stability remained excellent across all rehabilitated areas in 2017, and scores were generally within comparable range of

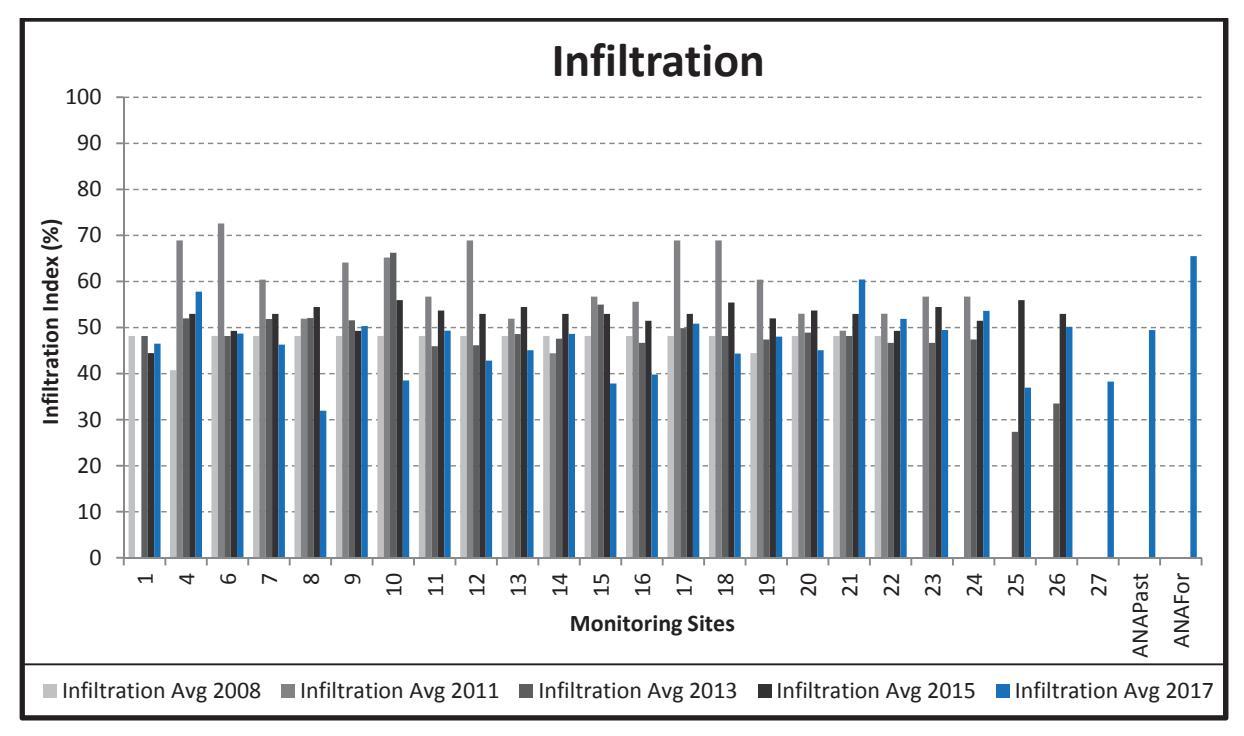
Figure 14: Infiltration

Infiltration is defined as how the soil partitions rainfall into soil-water (water available for plants to use), and runoff water which is lost from the local system, or may also transport materials (soil, nutrients and seed) away. The results of the infiltration monitoring are summarised in Figure 14.

The infiltration index is to a great extent influenced by the existing levels of vegetative cover (ground + woody vegetation), which slow down surface water runoff allowing higher infiltration rates and water uptake by plants (whereas in areas of sparser cover the soil surface has a greater tendency for hard-setting/crusting which promotes runoff). Reflecting the very dry conditions leading up to the 2017 monitoring event, several monitoring sites showed a decrease in infiltration index scores compared to previous years' results.

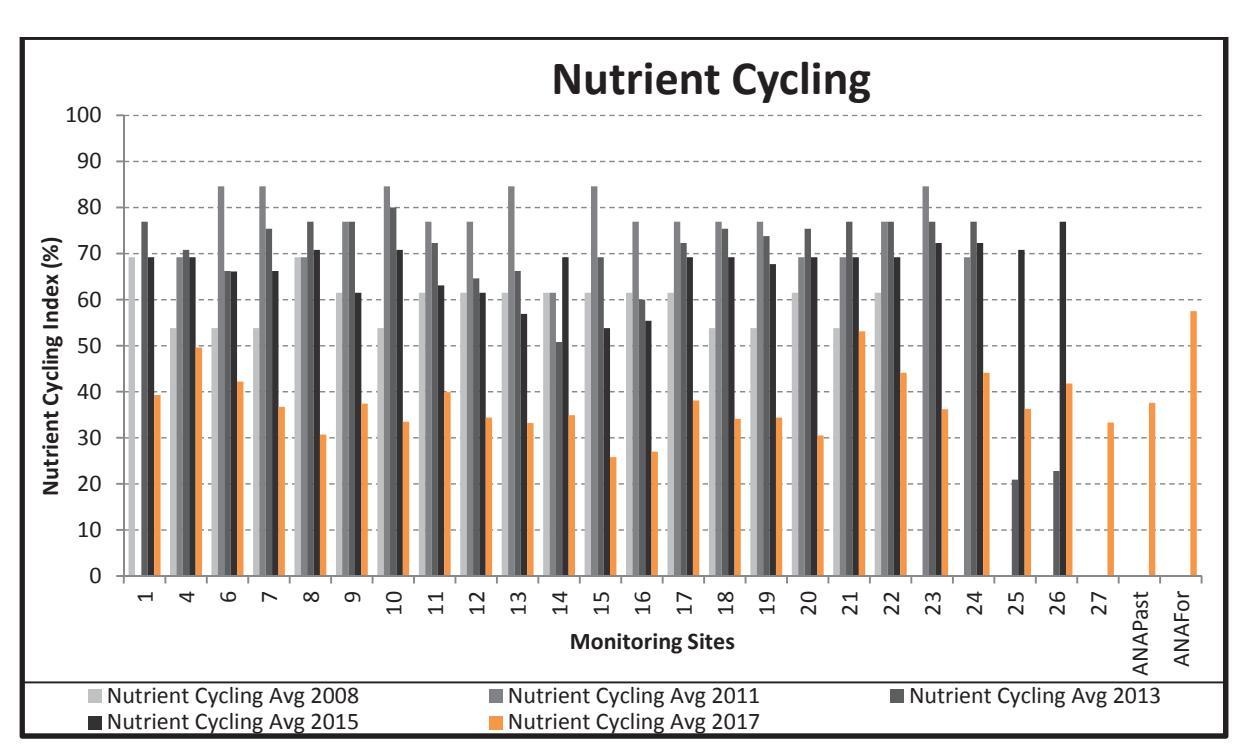
Figure 15: Nutrient Cycling

Nutrient cycling is defined as how efficiently organic matter is cycled back into the soil. The results of the nutrient cycling monitoring are summarised in Figure 15.

The 2017 monitoring results showed a significant decrease in nutrient cycling performance across all monitoring sites, which could not be solely attributed to the recent dry weather conditions (although these would have contributed to some extent to decrease in index scores). Rather, all datasets from previous monitoring years were investigated and it appeared that this change was not due to an actual decrease in site condition or performance, but clearly to a different interpretation of the observers during field data collection (particularly in relation to scores awarded to litter and cryptogram abundance, which are key drivers of the nutrient cycling index).

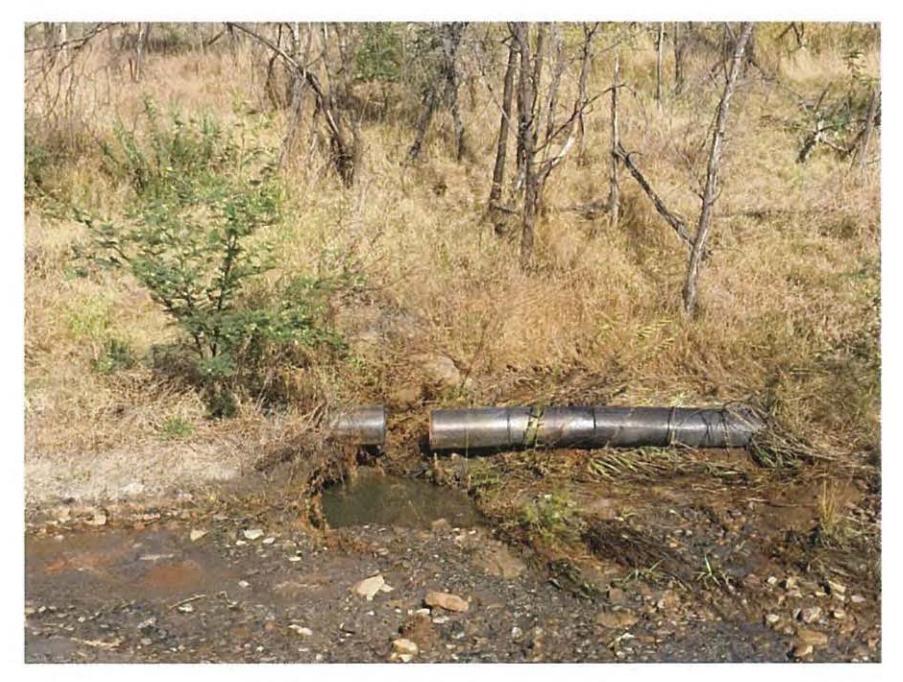
- The pipeline and pump was inspected at 2:00 pm on 12 October 2017 and everything was intact and functioning properly.
- A review of pump amp records indicated that the pipe may have ruptured at approximately 2:30 pm on 12 October 2017. See Photo 1.

Photo 1 - Ruptured Polypipe

- The ruptured pipeline was discovered at 6:30 am on 13 October 2017, indicating it may have been running for 16 hours. The pump was immediately shut off.

- The new pipeline to the tailings dam will be double skinned to direct any flow from a potential rupture back into the sump.
- Inspect the junction of Shamrock and Four Mile Creek after the next rainfall event/s to monitor and sample the quality of any water flow to assess any environmental impact of the discharged waters. It is expected that rainfall will dramatically reduce the electrical conductivity of any water which enters Four Mile Creek.

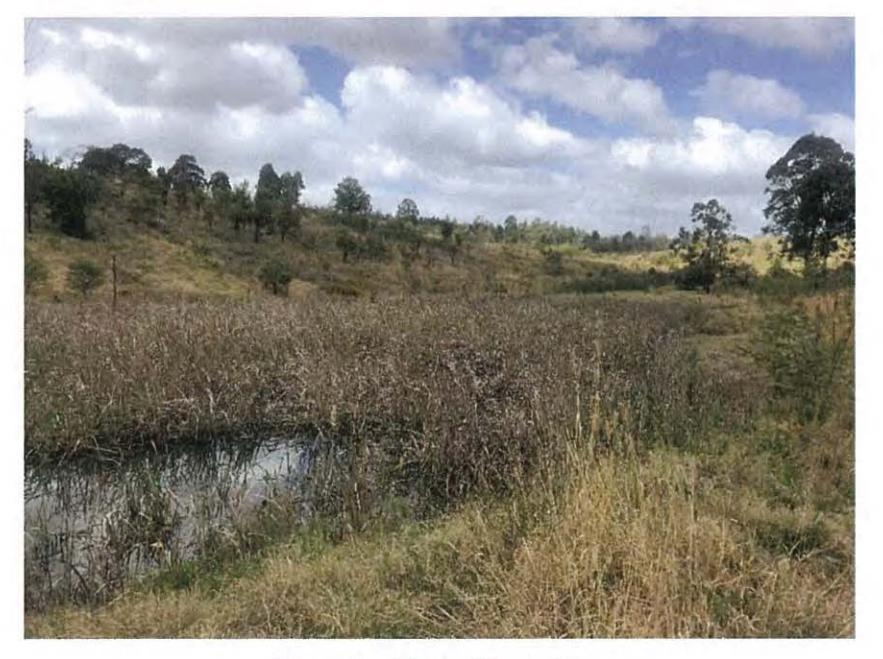
Photo 2 - Clean Water Dam

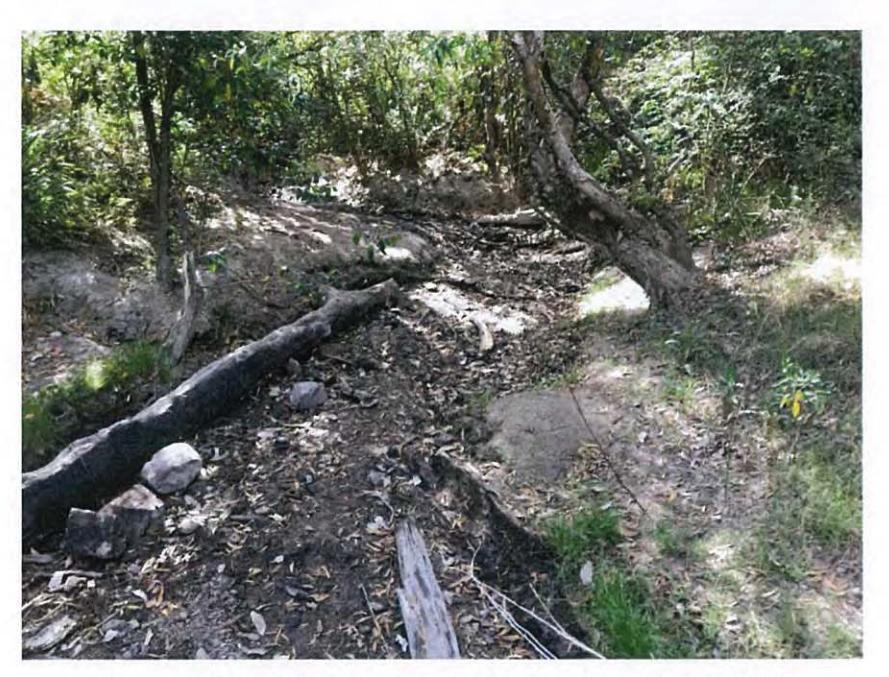
- An inspection was undertaken which confirmed that the water did not reach Four Mile Creek. Due to low rainfall both creeks were dry at the time of the incident. The Shamrock Creek / Four Mile Creek junction was inspected after the incident and later that day. See Photo 3.

Photo 3 - Four Mile Creek and Shamrock Creek junction

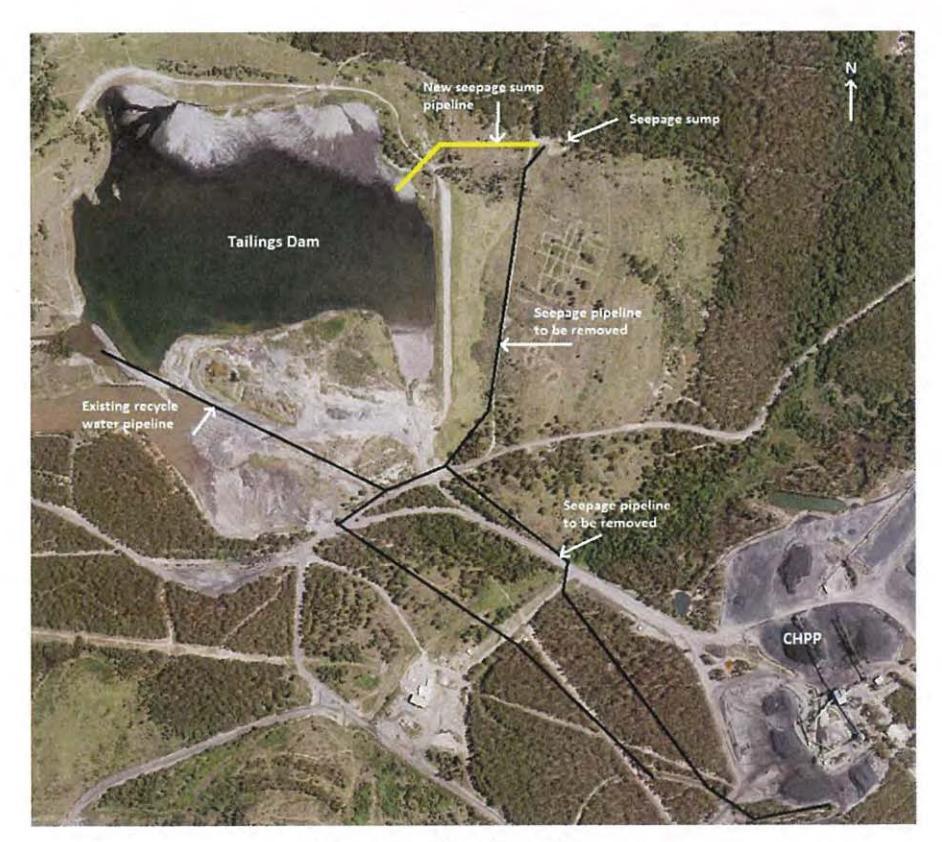
Figure 2 - Pipeline Changes

- A review of the raw water reticulation system to identify any other potential areas where a pipe failure could result in discharge offsite. These areas will risk assessed and controls implemented to reduce the risk of accidental discharge. This may include the installation of leak detection systems and alarms, revision to pipe location, and double skinning of current pipes.

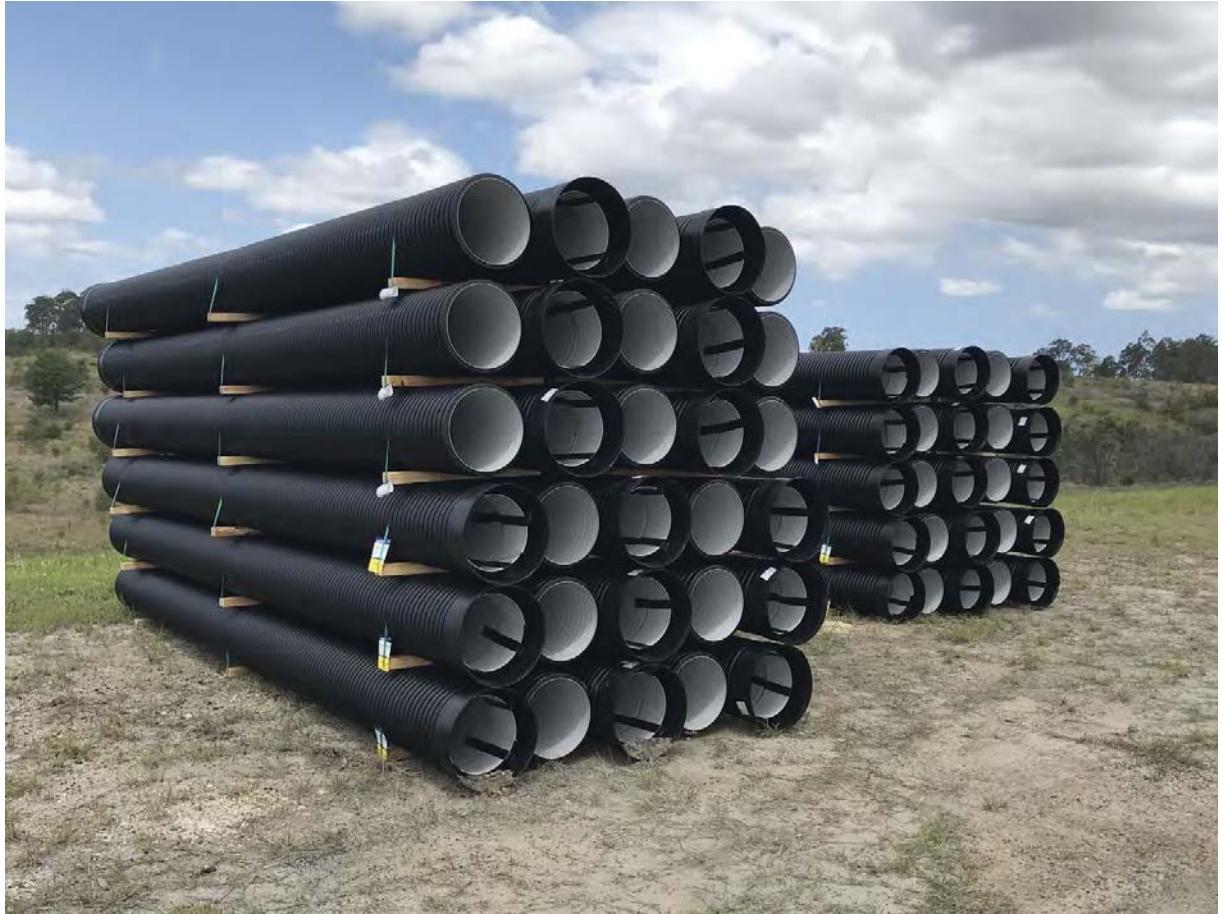
Photo 2: pipeline for "double skinning" onsite. (Dated 14 November 2017).

- Daily inspections are undertaken while pumping form this location by the pump crew.
- The pipeline to provide a second skin has arrived at site and will be installed commencing by 24 November 2017. (see photo 2).

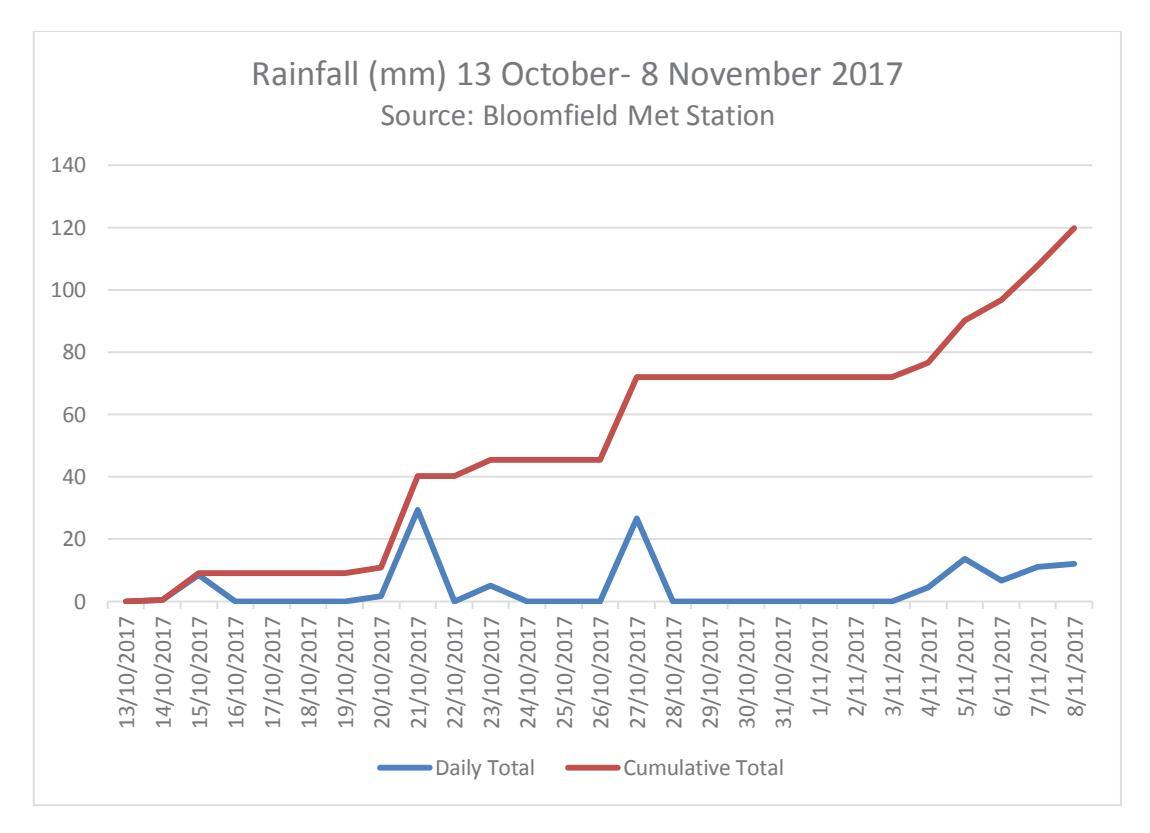
Sampling of the discharge water at the date of the incident (13 October 2017) exhibited electrical conductivity results of 6,600 microsiemens. Electrical conductivity results from the samples obtained on 8<sup>th</sup> November showed that dilution of the discharge water had occurred due to recent rainfall resulting in a reduction of EC to 5,500 microsiemens. Downstream results of the sample from Four Mile Creek showed that the addition of water from Shamrock Creek increased the electrical conductivity in Four Mile Creek by 340 microsiemens. Rainfall from 13 October (discharge event), till 8 November inclusive totaled 119.8 mm which diluted the water prior to entering Four Mile Creek. A graph detailing rainfall for the period is shown in graph 1.

Graph 1. Total and Cumulative rainfall for the period 13 October - 8 November 2017.
